Building Report | Whitman Center Roof Restoration

9.4.20

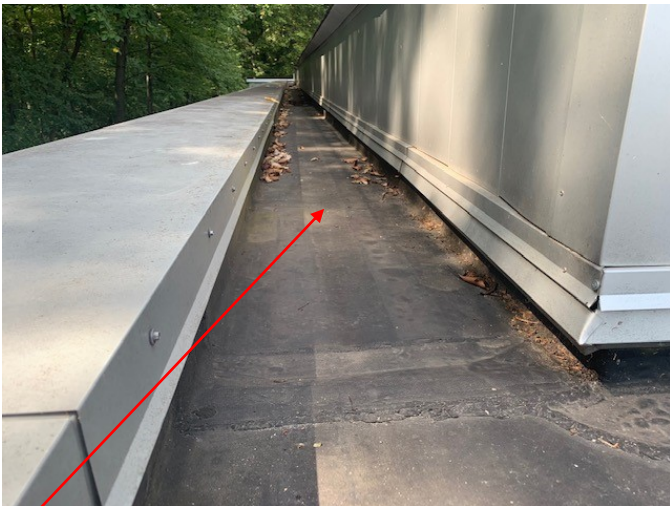
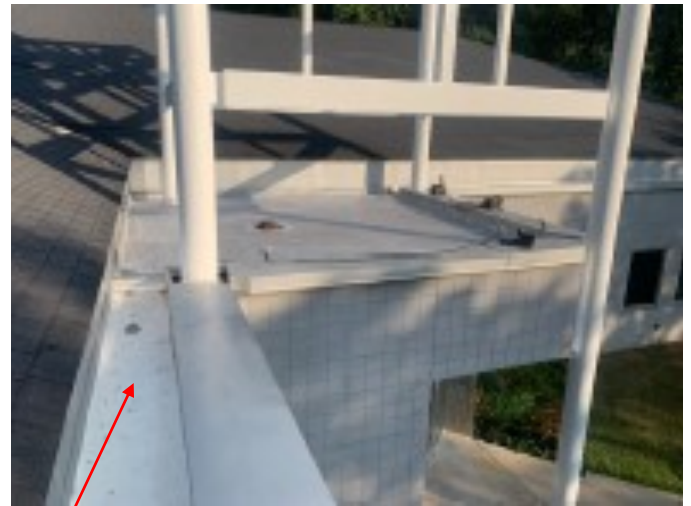
The top-left and right photos show a portion of the low-slope (flat) gutter portion of the roof before the restoration project was completed. You can see the original EPDM roof membrane showing its age. The seams (numerous which had been resealed) were separating, the roof was punctured and patched due to surrounding environmental conditions, cracking due to age of the material, etc. Part of the restoration process consisted of cleaning the existing membrane, reinforcing the joints, and placing a liquefied multi-layered coating that bonds to the original. Changing the color also serves as a means of helping to eliminate the "heat island effect", that is, by changing the color from black to white helps keep the building cooler and keeps it from unnecessarily returning unwanted warm air into the surrounding area which is aligned with the College's environmental conscience and sustainable practices operating practices.

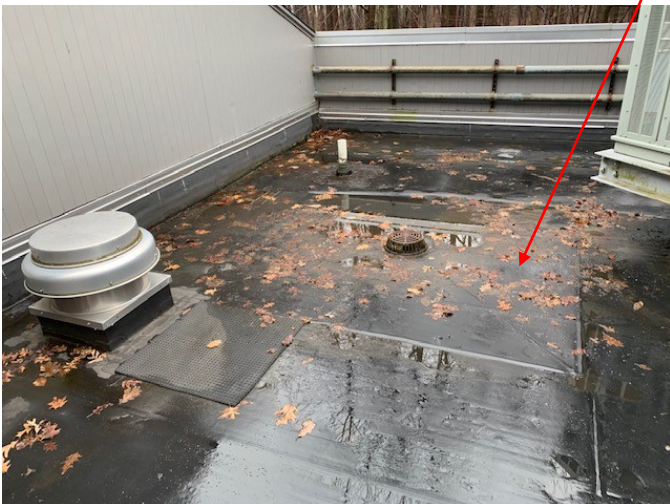
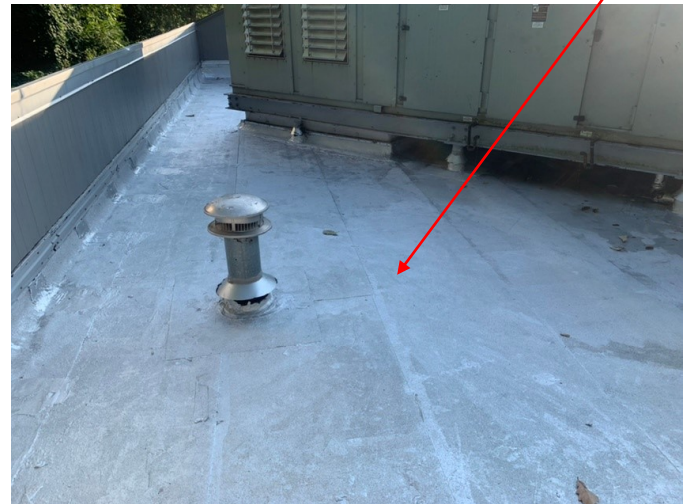
The bottom-left and right photos show the low-slope roof area near the air-handling unit in the mechanical well before and after the recently completed roof restoration. This area needed attention to help address some legacy drainage concerns. This area was not properly sloped and retained too much water which was causing some roof leaks in the building interior below. The taper of the rigid insulation below the membrane roof was adjusted and the drains cleared and now the roof drains properly and all the penetrations in the area were properly sealed which should all but eliminate the legacy leaks.
