Building Report | CLRC Renovations and Additions Project

01.28.22

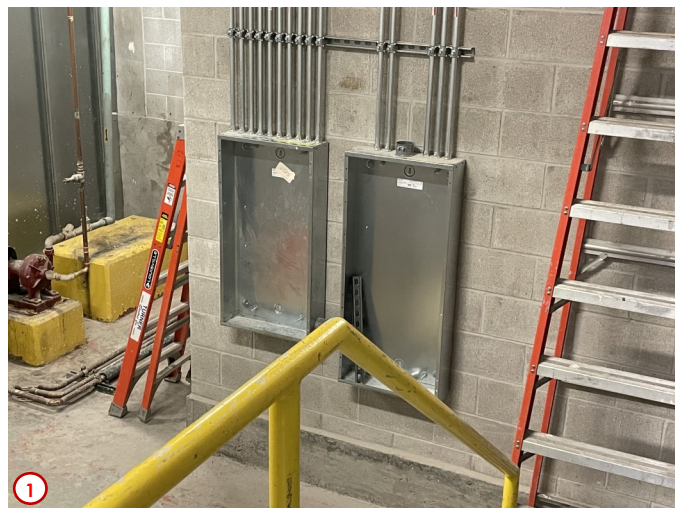
Photo #1 shows the future home of the building power and lighting panels in the Mechanical Room in the Basement. Thanks to the construction of the new Janitorial Closet the bare wall was able to be used to house these new panels where they will be both accessible and centrally located for maintenance reasons.

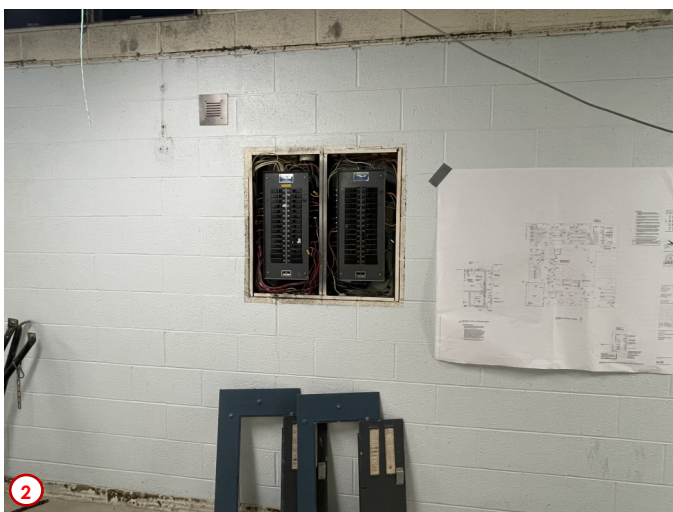
Photo #2 is a complimentary photo to the first. These are the two current panels in the existing north corridor of the Basement. As with all our other construction projects it is our goal to remedy certain maintenance and safety legacy items such as this situation. It has been our charge that all panels be removed from public spaces and housed properly and safely in either new or existing mechanical or electrical rooms.

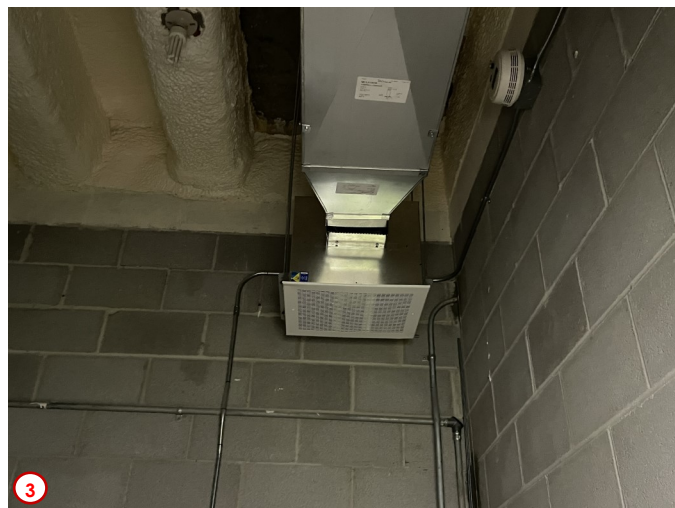
Photo #3 was taken in the existing Elevator Equipment Room in the Basement. This space and all the existing equipment in it will be redone as part of the renovations project due to the fact that the current elevator will be totally replaced. To start the mechanical exhaust systems for this room is the first piece of infrastructure to be replaced and updated. Featured in the photo is the new ductwork and exhaust hood that was installed this past week.

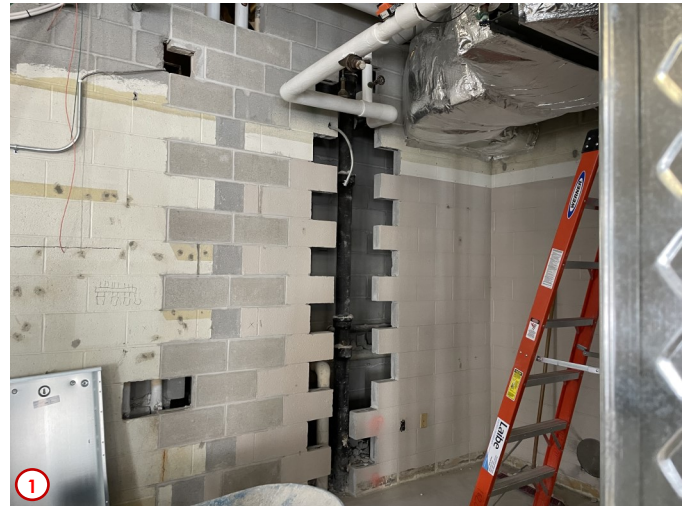
Photo #1 was taken inside the existing Janitorial Closet on the first floor where we are adding some new electrical panels. Here the wall has been opened up so that some existing infrastructure can be relocated and/or changed. This is preparation for the installation of a new stub wall that will be constructed to separate the new electrical panels from the new mop sink for obvious safety reasons.

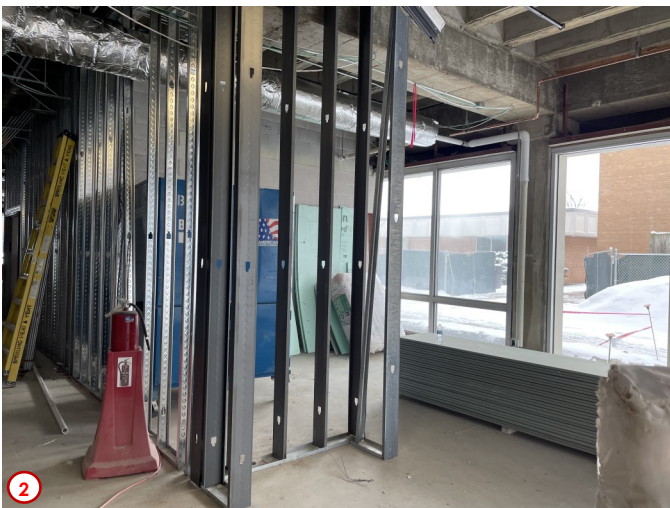
Photo #2 shows more rough framing being installed on the first floor. The area featured in this photo is in the future Student Lounge/Vending Area and will house the new electric water coolers.

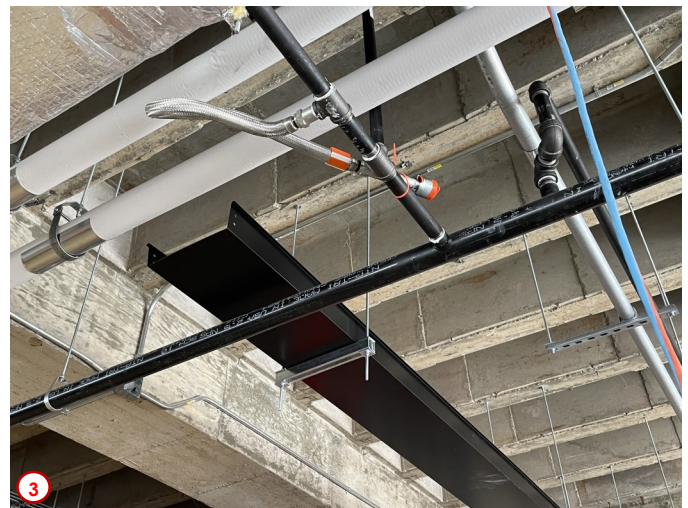
Photo #3 shows the new fire sprinkler system finishing up on the first floor. Here one can see the head with flexible connection installed and waiting for the ceilings to go before being moved to its final location. Next week the contractors will start in the basement. All the needed materials are now onsite and were moved downstairs in preparation.

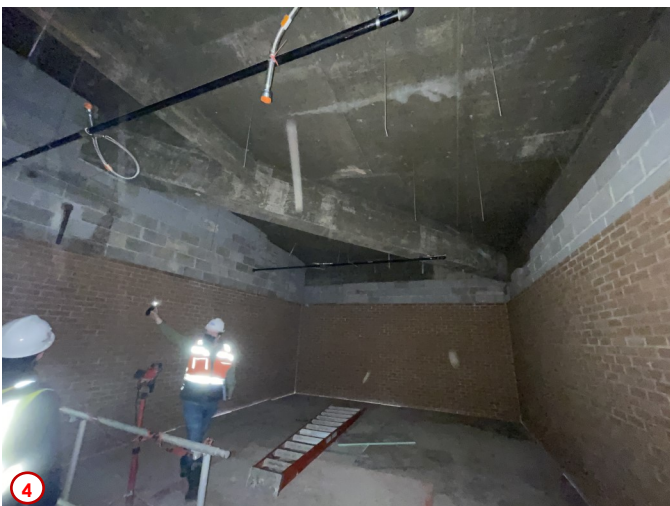
Photo #4 was actually taken at the top landing of the east stair well. Here temporary scaffolding was installed to support the contractors as they removed old mechanical and electrical infrastructure that was no longer needed and also to fill in where the block walls terminate into the existing roof structure above. This is so that the existing stair tower meets or exceeds all current building codes in regards to fire safety and egress requirements.

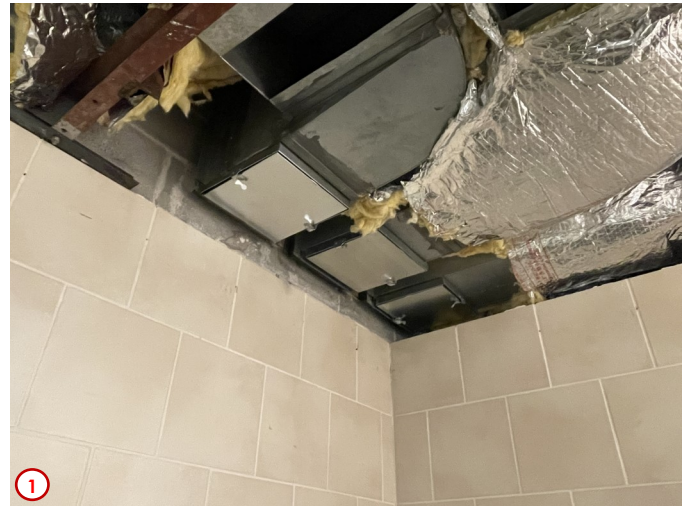
Photo #1 was taken inside one of the existing restrooms and shows some new work that has happened to the existing mechanical infrastructure. Here access hatches have been added that were not there before that will allow our maintenance teams to better service the HVAC systems located above the ceiling in this area.

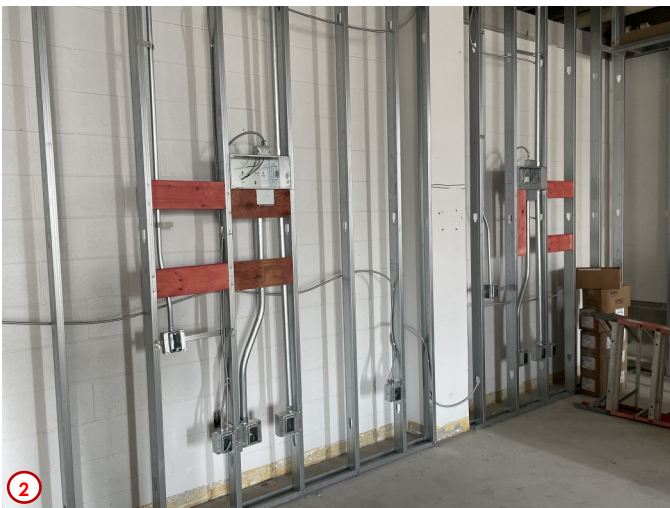
Photo #2 was taken inside of the future TEAL (or technology enhanced active learning) classroom on the second floor. Here one can see the supporting in-wall electrical/data boxes and wood blocking in place that is for the future flat panel televisions that will be installed later as part of the overall building A/V package.

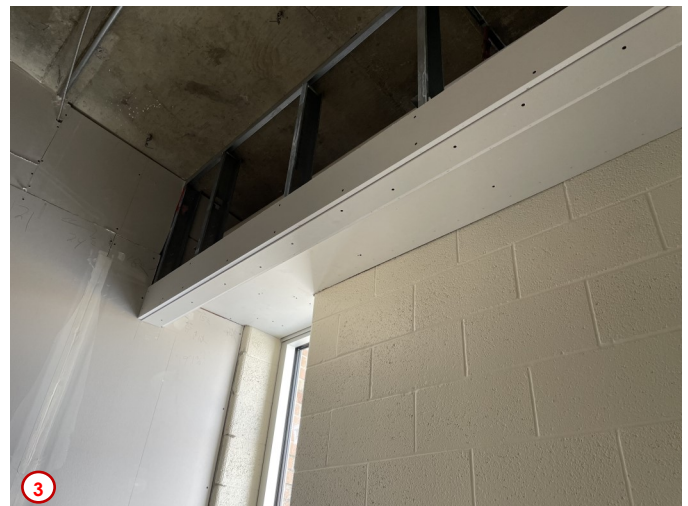
Photo #3 highlights the progress of some of the finer finish work happening as far as the installation of the wallboard is concerned. Here the soffit that will serve as the transition from the suspended ceiling to the hard ceiling near the window has received its board and will be finished after.

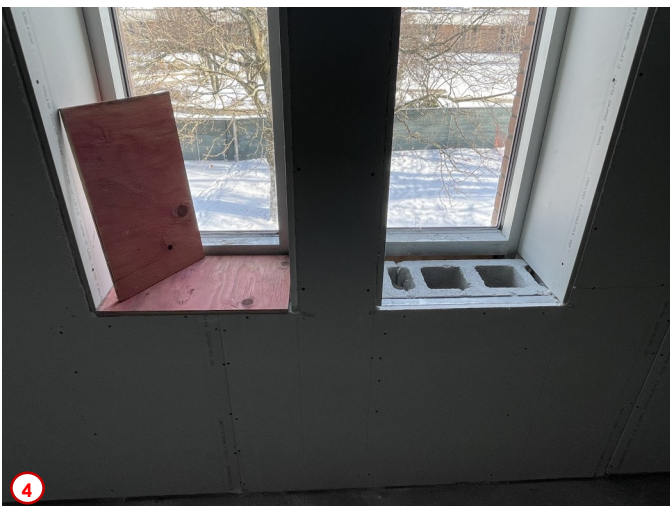
Photo #4 is located at one of the exterior windows in the future Staff Lounge on the 2nd floor in the H/SS Office Suite. Here one can see the installation of the fire-treated wood blocking at the new windows that will eventually receive and support the finish solid surface window sills.
