Building Report | CLRC Renovations and Additions Project

04.22.22

The following are pictures from the week ending in 04.22.22 in regards to the CLRC Renovations and Additions Project. With the roof replacement basically done I have switched the roof plan back to the basement plan on the first page for reporting purposes. Overall the project is now at 75% complete. The FM 200 fire extinguishing system that was installed in the main server room in the basement passed all inspections and testing today. This means the overall building fire sprinkler/extinguishing system is nearly complete minus its connection to the monitoring and alert system. The 2nd floor will see the first areas receiving the remainder of the ceiling tiles next week as well as the first sections of carpet tile and plank, and wall base, being installed. Most of this material was delivered today which worked out well as the elevator goes down Monday officially for replacement. The 1st floor is coming along well as all the rough and fine framing is nearly complete which will allow the remainder of the wall board and accent wood veneer panels to be installed.

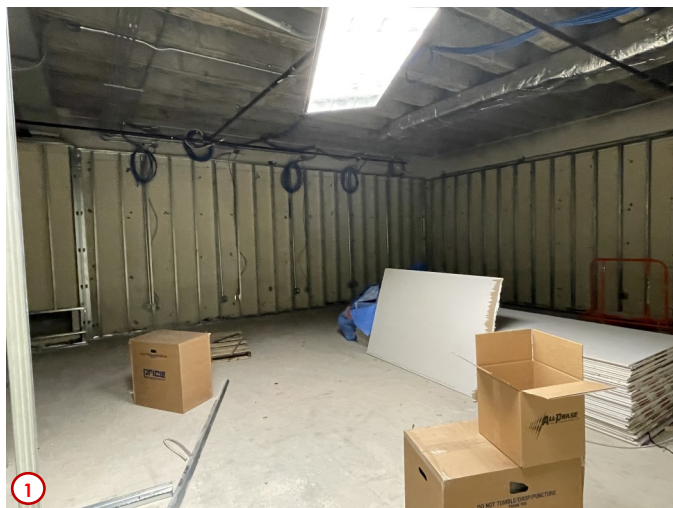
Photo #1 was taken in the old distance learning classroom in the north-west corner of the basement. This space is designated as a computer lab, however first all the walls are receiving metal furring channels and a layer of wallboard to create a smooth finish. This space like the rest of the basement will also receive new suspended acoustical tile ceilings and LED lighting.

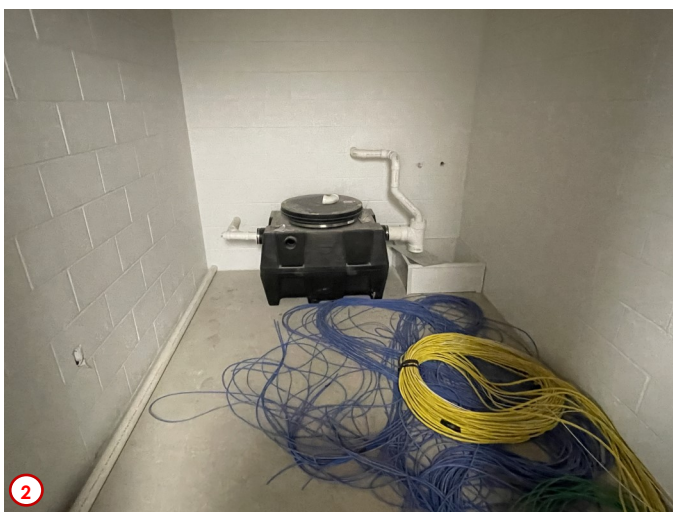
Photo #2 shows the plumbing fixtures being installed in the new janitors closet in the basement. On the left is the oil separator that takes what drains from the elevator shaft floor drain next door and filters any fluids per code and then pumps out the waste into the storm sewer system on campus. To the right of it is the new mop sink that will be used by the custodial staff when cleaning the basement.

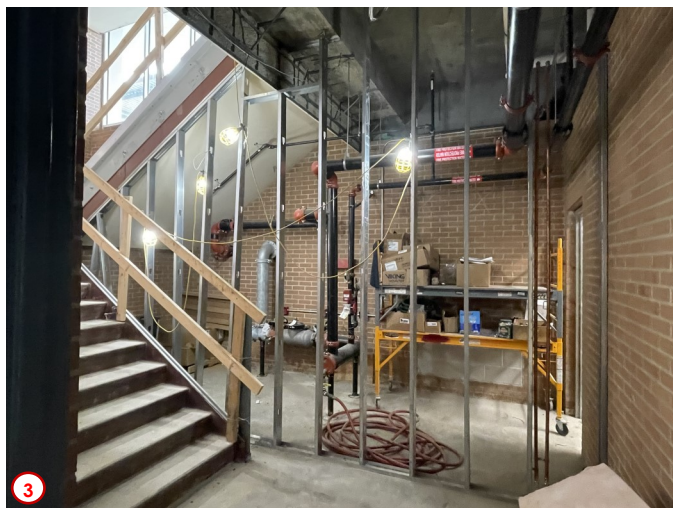
Photo #3 highlights the progress of the installation of the new wall framing for fire sprinkler room underneath the west stair tower in the basement. This wall will be of rated construction and will help protect the equipment from not only fire, but secured as well for safety reasons. This new room will be accessible via a locked door at the southwest corner of the adjacent classroom.

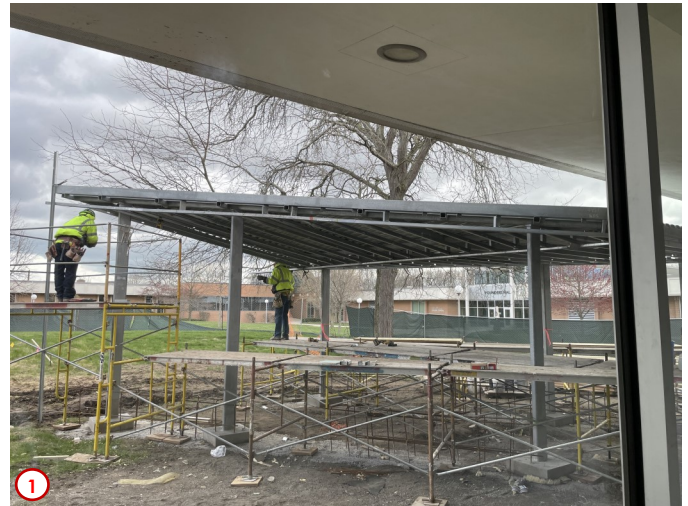
Photo #1 shows the contractors at the beginning of the week starting the rough framing for the new east entrance canopy. The underside of the canopy will be finished so that it appears similar to that of the building's soffit. Then the face will receive a light-gauge metal flashing, and then the roof a fully-adhered membrane roof. Once the building roof replacement is complete and the contractor off site then the work on the new west entrance canopy will begin.

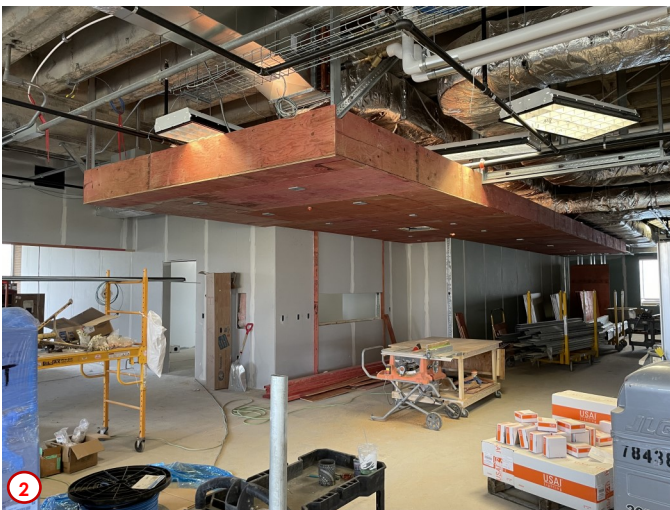
Photo #2 was taken from inside the Library looking towards the Reference Desk/Entrance Gallery area. Here you can see the fire-treated sheathing in place now on the ceiling cloud which will later receive a panelized wood veneer.

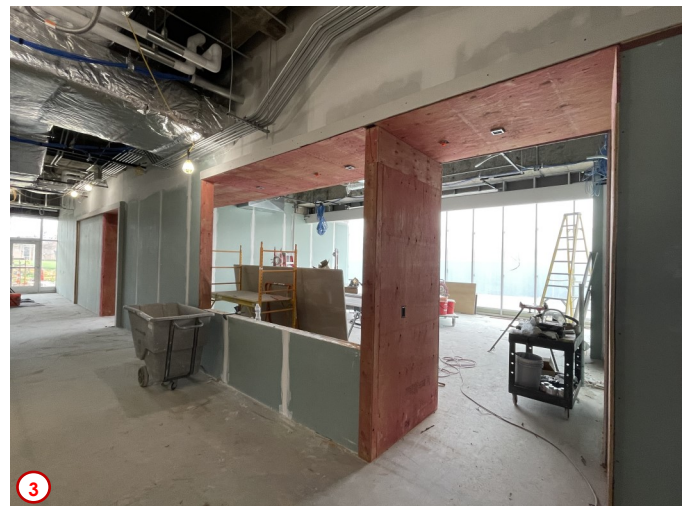
Photo #3 features the entry into the future computer lab that is part of the southeast addition. This entry will receive a wood veneer finish which will help bring some warmth into the space similar to what is happening on the 2nd floor.

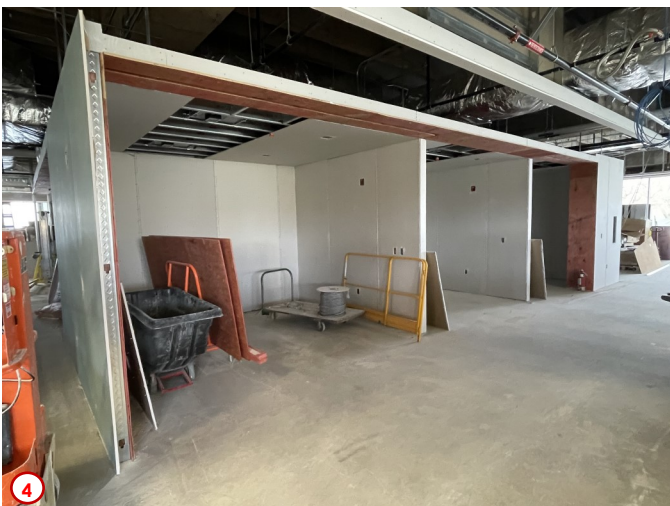
Photo #4 highlights the progress of the installation of the wallboard in the new huddle room along the south wall of the Library. The two outside rooms will have solid walls on three sides with a floor-to-ceiling glass facing the library. The center room will be totally open to the rest of the space.

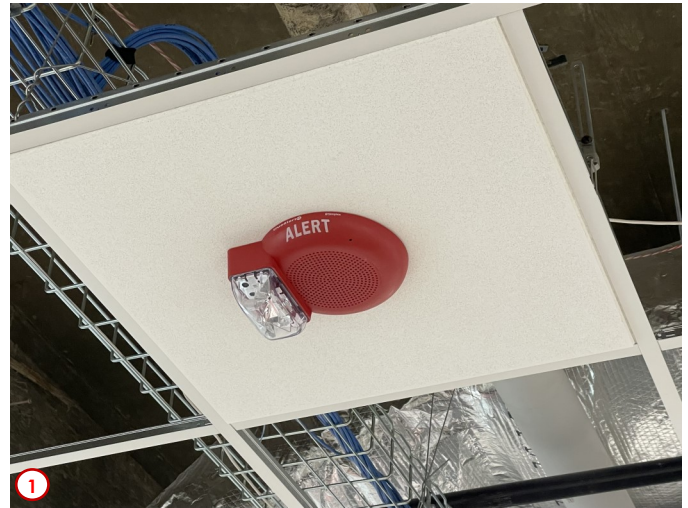
Photo #1 highlights one of the many new warning strobes and annunciators that are part of the new building-wide safety systems. With all of these in place and the proper inspections have taken place this week the contractors will begin to “pad” out the rest of the ceiling tiles to finish the ceilings on the 2nd floor.

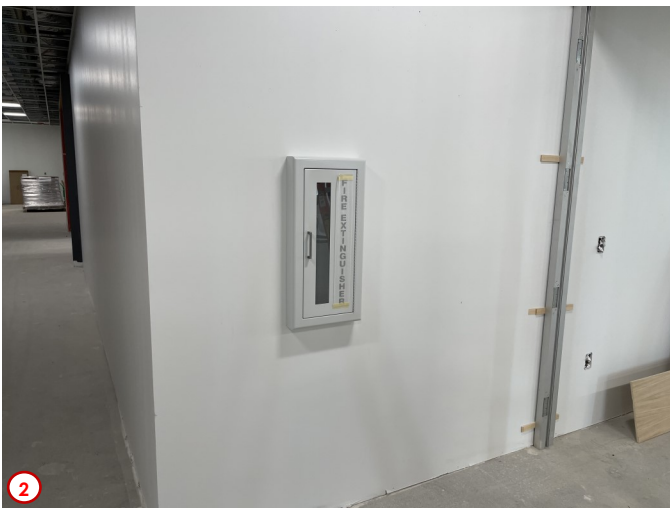
Photo #2 features one of the many new fire extinguisher cabinets that are now in place on the 2nd floor. Seeing as the layout on the 2nd floor has changed quite dramatically all the old cabinets were removed as the new versions needed to be mounted in different locations so that are in compliance with the building code.

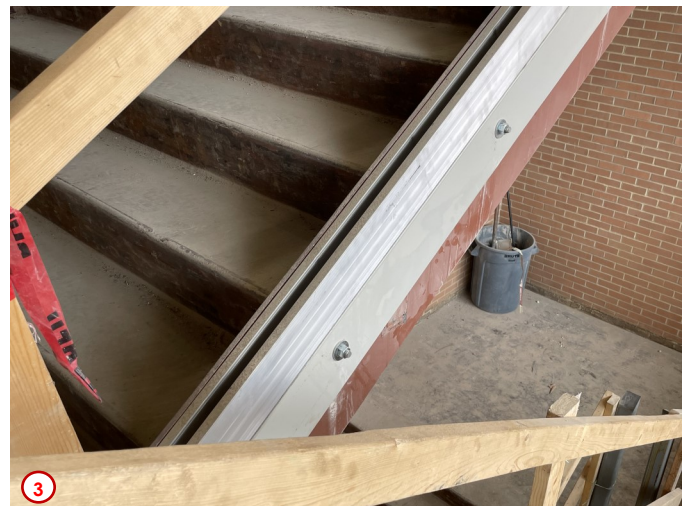
Photo #3 shows the progress of the installation of the new stair railing system in the western stair tower. Here you can see new base section in place that will hold the bottom of the glass in-fill panels in place.

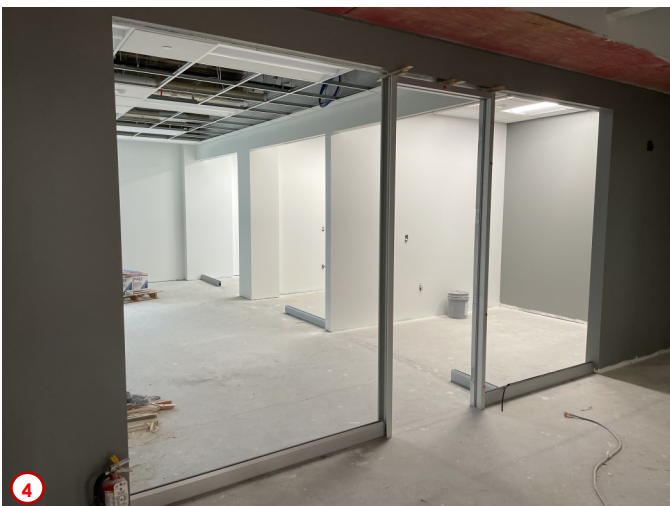
Photo #4 shows the beginning of the installation of the entry system into the future Writing Center. Here you can see the aluminum frames in place awaiting the glazing panels that flank both sides of the new entry door, and then the full-light entry door as well.
