Building Report | CLRC Renovations and Additions Project

10.1.21

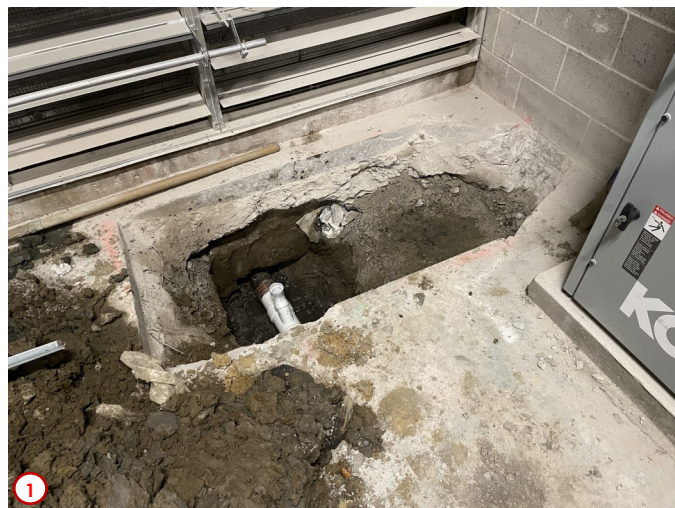
Photo #1 was taken in the existing basement electrical room. Here you can see a drain line has been exposed that was under the concrete floor slab. The new drain line from the sink that will be installed in the second floor staff lounge will eventually tie into this line. Additionally, this has been a legacy issue for us as the it also connects to the floor drain in the exterior area way just on the other side of the wall. Having this line exposed will allow us to replace the old rusted drain line and eliminate any potential flooding issues in this area.

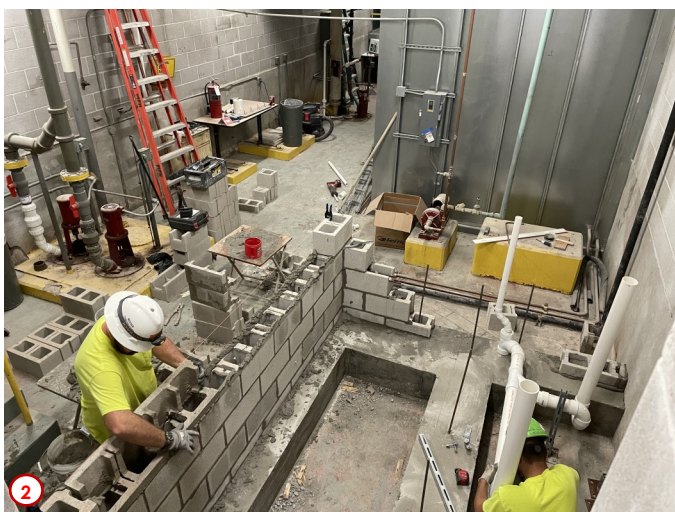
Photo #2 was taken earlier in the week and shows the masonry contractors starting the construction of the new concrete block walls of the future janitor's closet. Again, this area of the existing mechanical room opened up when the old pumps were removed as part of the campus-wide geothermal HVAC project a few years ago. This allowed the architects to utilize this "dead space" and put it to good use.

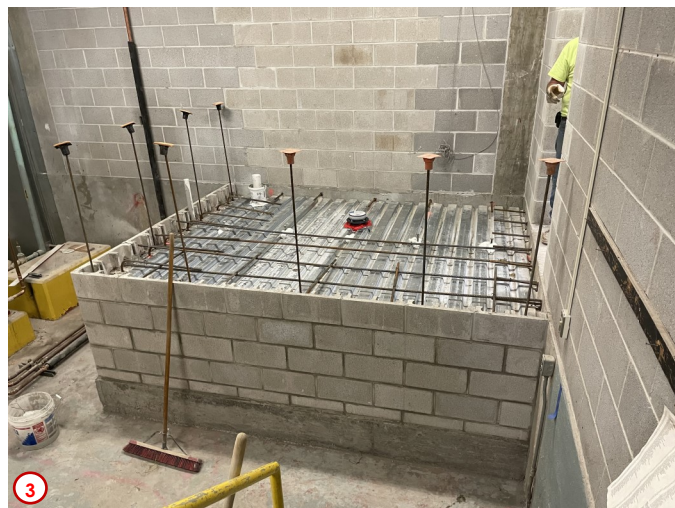
Photo #3 is of the same area as Photo #2 but taken later in the week and from a different viewpoint. Here you can see the walls are finished up to a certain point and the metal decking has been installed. Next week the new concrete floor slab will be placed on the metal decking so that the floor level in the new janitor's closet will match in elevation that of the adjacent corridor in the basement. Then once the slab is cured enough the masonry contractors will come back in and finish laying the remaining portions of the block walls up to the floor deck above thus separating this new space from the rest of the existing mechanical room.

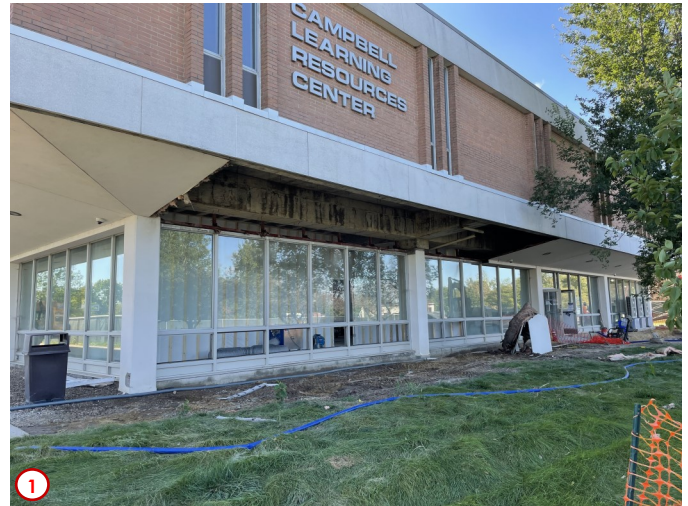
Photo #1 was taken outside the exterior northwest corner of the CLRC, and shows the completed demolition to the existing soffit that will allow the new addition to start in this area. This addition will hold three of the five new huddle rooms planned for the Library when all of the building renovations are complete.

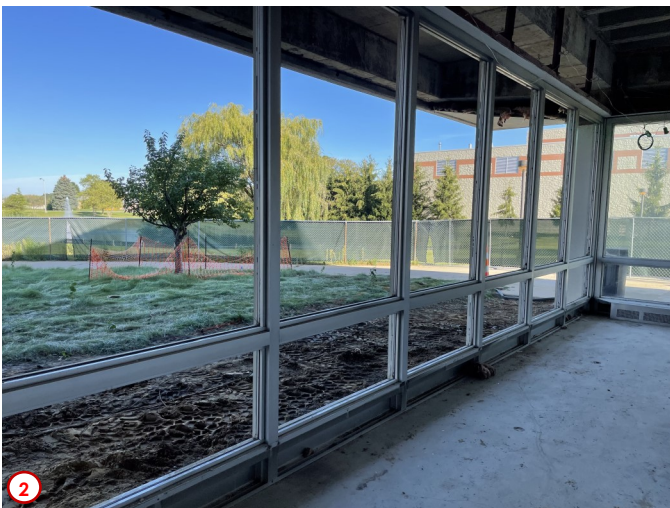
Photo #2 is of the same area as Photo #1, but is taken from the interior of the building looking out to the northwest. Also this picture was taken later in the week. Here you can see all of the old sections of glazing have been removed from the existing curtain wall. Next all the old frames of curtain wall in this area, and around the entire perimeter of the first floor, will be demoed in preparation for the installation of the new and more energy efficient curtain wall system.

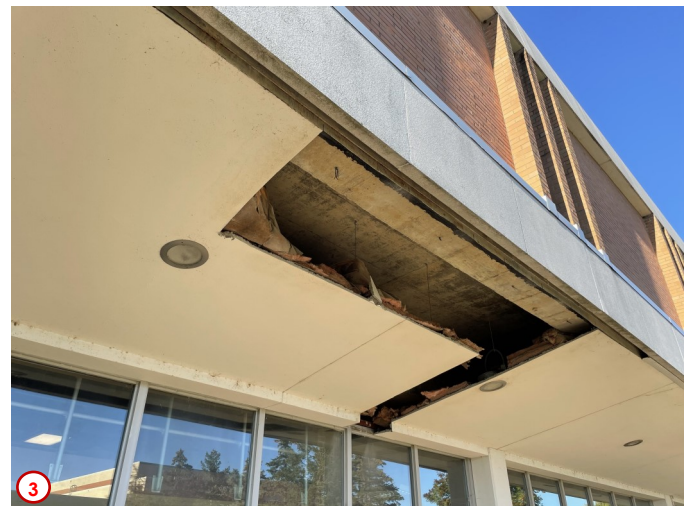
Photo #3 was taken on the exterior northeast corner of the building and shows some demolition that was needed of the existing soffit. With this area now exposed the plumbing contractor can run the new drain line down from the second floor from the new staff lounge to the basement to the drain in basement as feature in Photo #1 on the previous page.

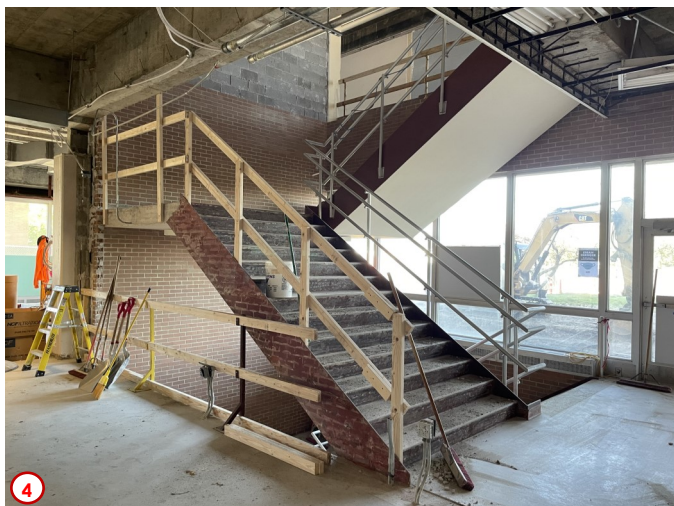
Photo #4 shows the completely exposed west stair tower now that demolition of the old masonry walls is complete in this area. One of the goals during the design process was to allow more natural light to filter into the interior of the building, and with all the old walls in this area now removed one can see just how bright this space will be. Another item to consider is that this photo was taken without the future LED building interior lighting on and working either!

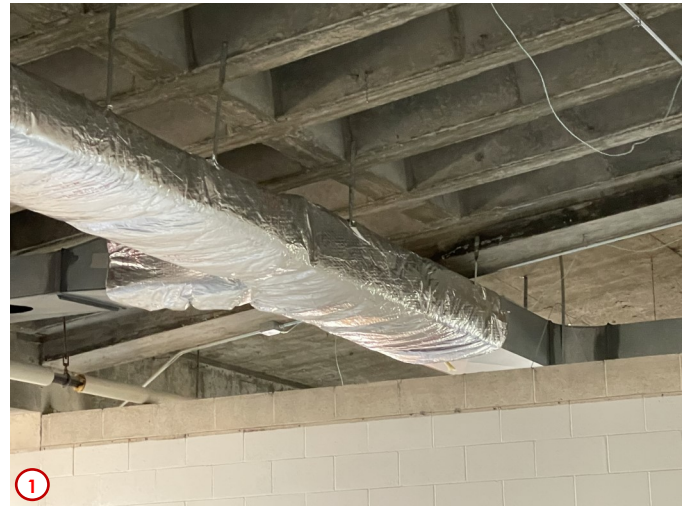
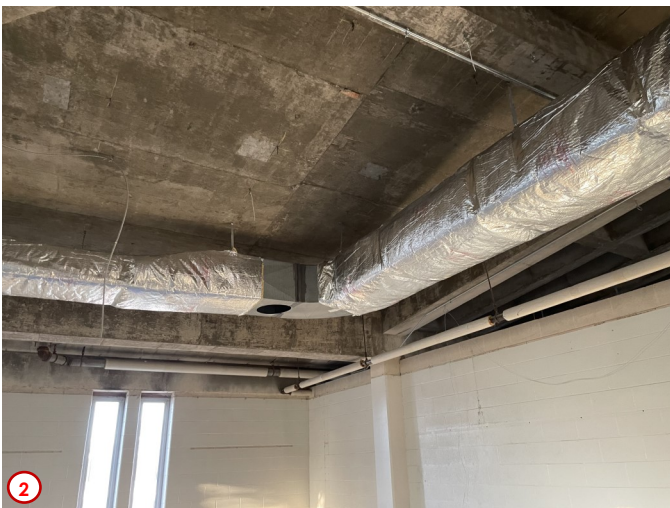
Both Photos #1 and #2 were taken on the 2nd floor in the area of the classrooms along the south wall. Here you can see that the existing ductwork has had it's joints sealed and is now being wrapped in foil-faced insulation which will bring this existing mechanical infrastructure up to current building code energy standards. This will also increase the efficiency of our already efficient geothermal HVAC system in this building which will allow for easier heating and cooling of this building and hopefully garner even more savings.

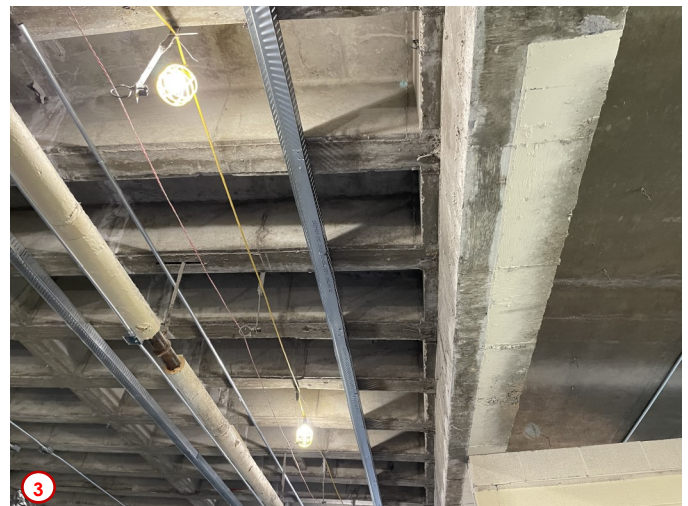
Photo #3 shows the beginning of the installation of the top track for the new metal stud walls that will eventually enclose the future H/SS Division Office Suite on the 2nd floor. Next week the contractors will start to install the floor track and then eventually the individual studs.

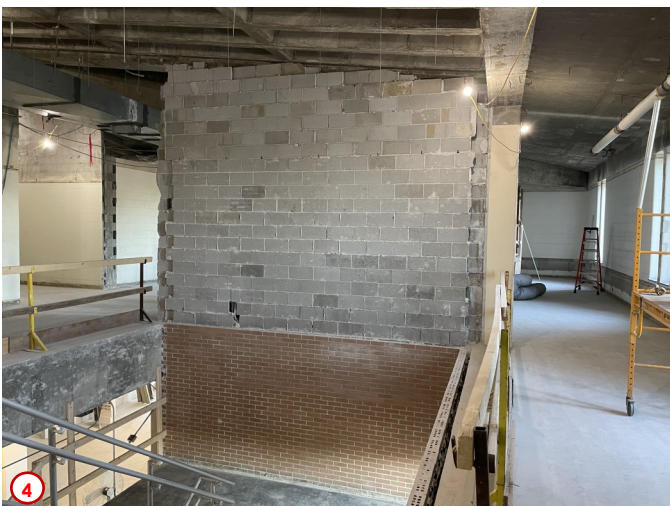
Photo #4 shows the now completely exposed west stair tower on the 2nd floor. The bare concrete block wall in the background will receive metal furring studs and wallboard. The College is already considering what could be mounted on this large surface like a large painting or perhaps some other sort of art installation piece that will enhance the interior environment in this area.
