Building Report | CLRC Renovations and Additions Project

10.29.21

The following are pictures from the week ending in 10.29.21 in regards to the CLRC Renovations and Additions Project. Despite some weather challenges presented by the heavy rains earlier in the week this project continues to track well. Even though the site conditions were less than ideal this week the excavation contractor was able to complete more of their assigned work. The excavation on the south side of the building will be slow on purpose as there are a lot of utilities and the mechanical tunnel to work around. Nearly all the new stud walls are installed on the second floor and now the contractors are focusing on installing miscellaneous items such as blocking. Some of the areas that will be less accessible once all the various infrastructure is in has received its wallboard already. This way it can be taped and mudded so that the drywall installers are not in the way of others trades that are trying to complete their work. The floors are marked on the first floor and their installation will begin next week, so the spaces in that area will soon start to take shape.

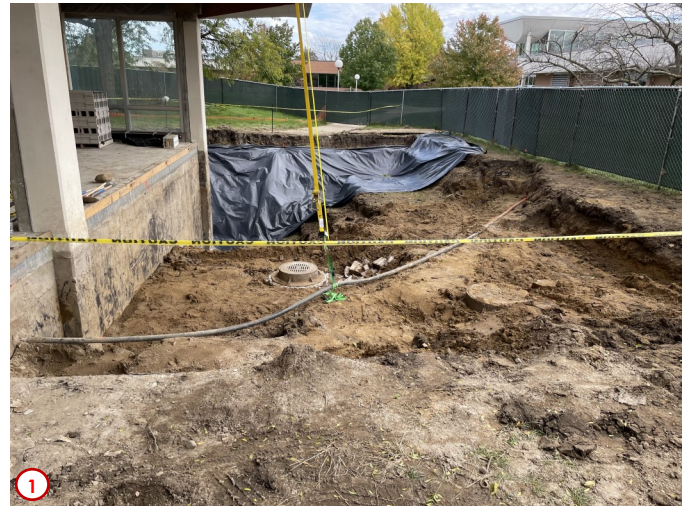
Photo #1 shows the progress of the excavation around the southern perimeter of the basement. Despite the heavy rains earlier in the week the contractors were still able to complete the work needed on the east face to expose the basement walls for waterproofing. Additionally, the existing utility vault was exposed and lowered. As more excavation is done the vault will be lowered more and then finally abandoned and grouted solid as, again, it is no longer needed.

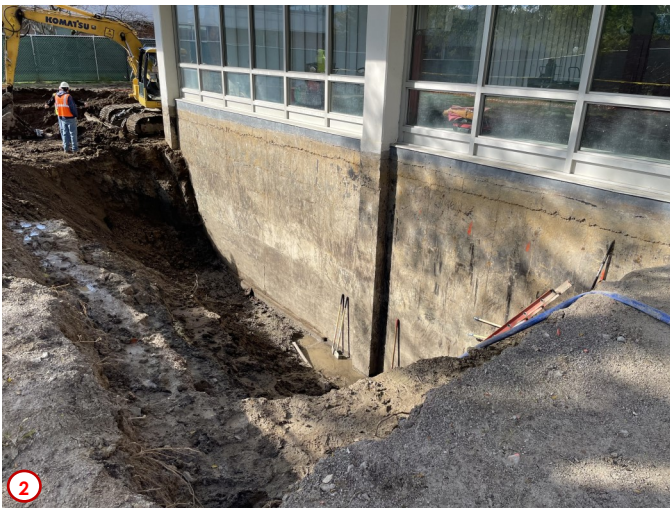
Photo #2 was taken on the east side of basement and shows the entirety of the wall surface exposed that will eventually receive the waterproofing treatment. The treatment will be done in stages and similar to how the excavation is being carried out in layers the installation and backfilling will happen in parts as well. This will happen for two reasons: 1) to be able to control the installation so as to work in smaller and more manageable sections, and 2) to allow for proper compaction of the backfill as it is being placed.

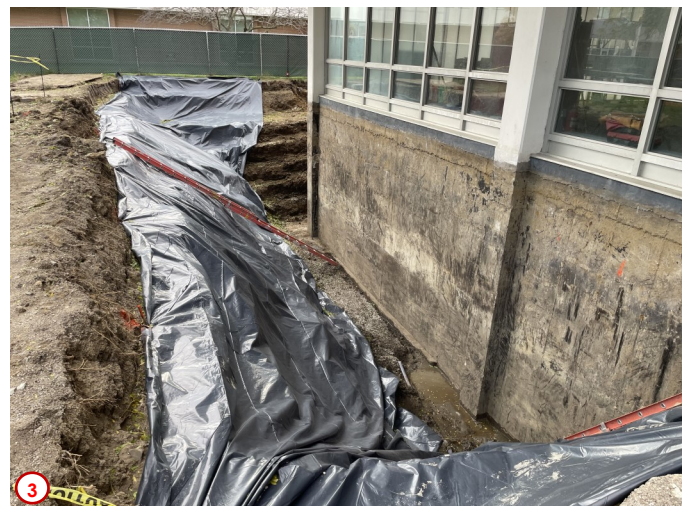
Photo #3 was in the same location as Photo #2 but later in the week. The contractors have placed some sediment control measures to help prevent what happened earlier in the week and have the rain wash the soil back into the work area.

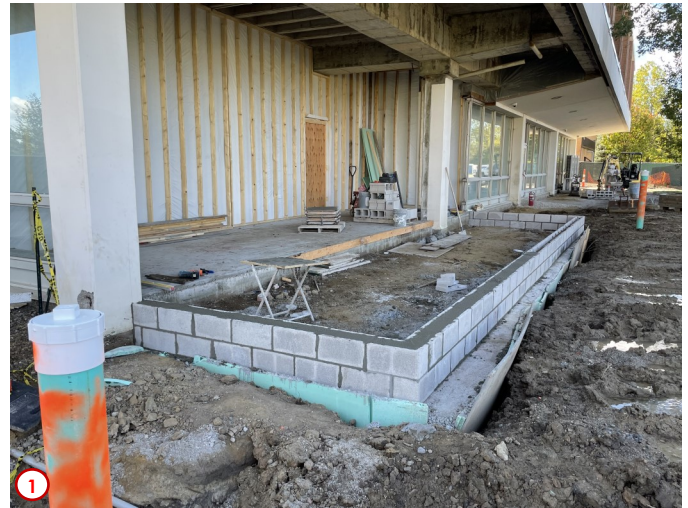
Photo #1 shows the now completed foundation system for the addition off of the northwest corner of the first floor. Next week the contractors will fill in the depressed area between the foundation and existing walls with compacted stone and place the new concrete floor slab on top of the fill. After the new floor slab has time to properly cure the new curtain wall system can start being installed in an effort to weather-proof this portion of the first floor.

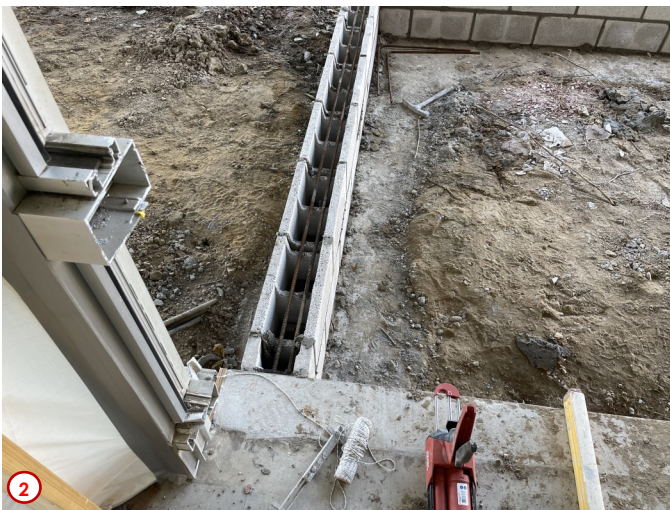
Photo #2 was taken earlier in the week of the new foundation system and highlights the top row lock course of concrete block. This course essentially acts as a lintel and contains the reinforcing bars that will help control the lateral movement of the addition's foundation system.

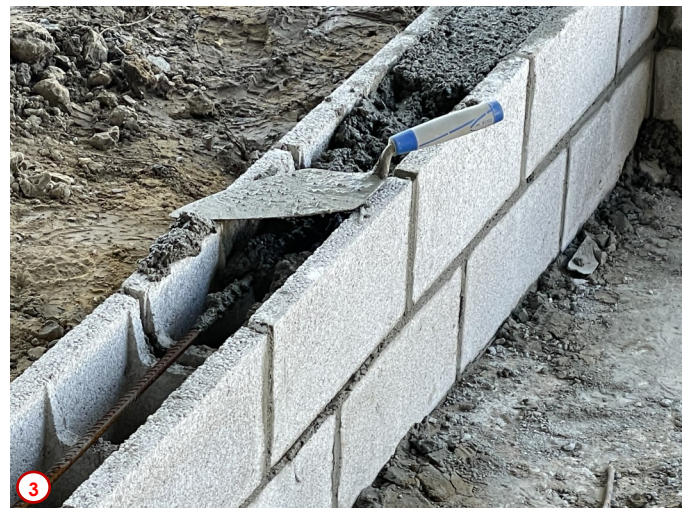
Photo #3 was taken later in the week after Photo #2 and shows the cores of the concrete block being grouted solid so that the individual units act like one unit, or similar to if the wall had been constructed of a poured concrete wall.

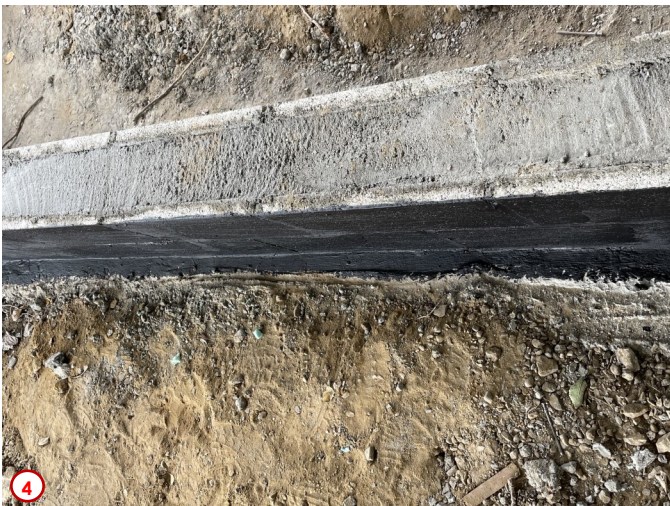
Photo #4 highlights the last step for the foundation system installation and that is the application of the waterproofing. It is important to the future interior humidity levels of the addition that there are control measures in place so that moisture doesn't seep through the concrete block and then up through the floor slab into the interior of the building. This can happen as concrete is a very porous material.

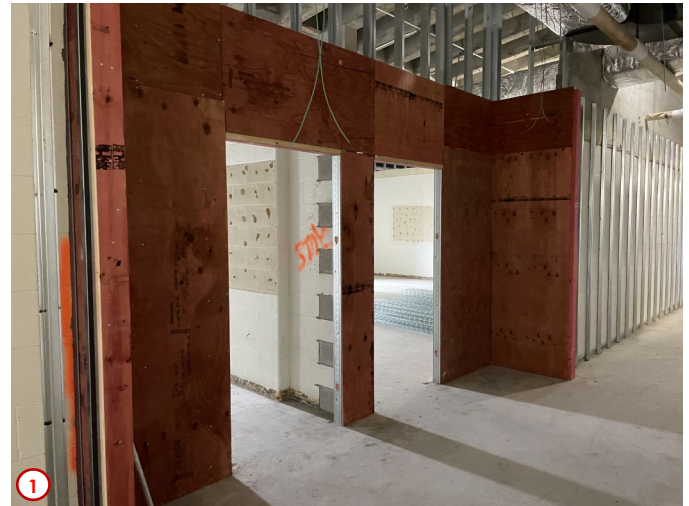
Photo #1 is of the new fire-treated wood backer board that is being installed at many of the classroom entrances on the second floor. This backer board is needed to properly support the final wood accent finish that will be applied later in this area.

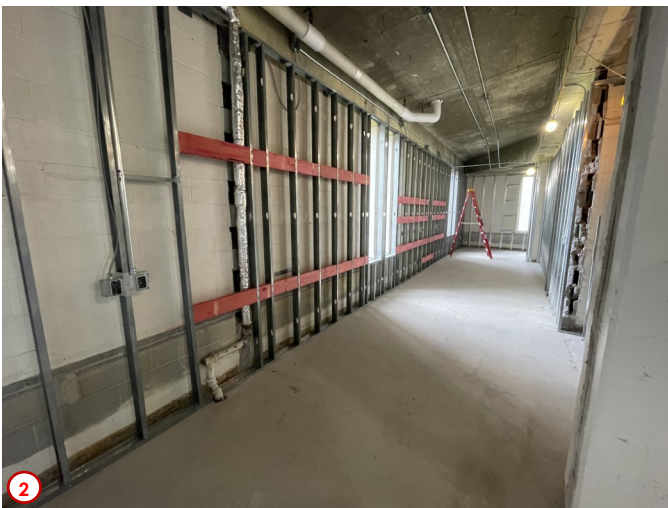
Photo #2 shows more blocking being installed prior to the future wall-board installation. Here 2x fire-treated wood blocking is being installed that will help support the future cabinetry in this area which is set to become the kitchenette for the adjacent staff lounge.

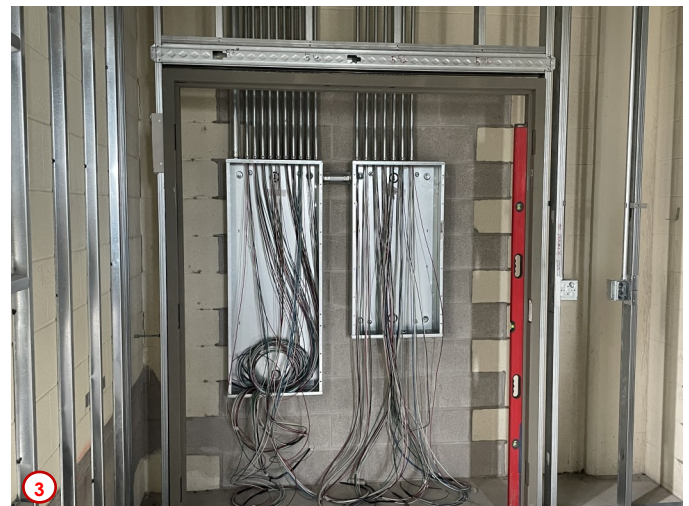
Photo #3 was taken at the end of the future staff lounge where an electrical closet will be located. The frames of the future electrical panels have been installed, a lot of the many new electrical conduits have been terminated into them, and even some of the new wiring has been pulled that will eventually terminate into new circuit breakers.

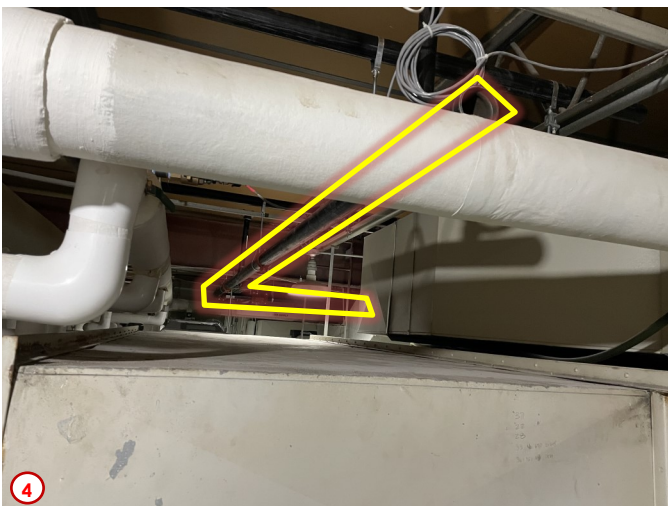
Photo #4 was actually taken in the mechanical penthouse on the "third floor" of the CLRC. The highlighted area shows some of the new fire-sprinkler lines being routed through the space. The fire-sprinkler contractors are nearly done with the penthouse and when finished will move down to the second floor, then onto the first floor, and then eventually into the basement where they will connect everything to the fire riser in under the western stair tower.
