Building Report | CLRC Renovations and Additions Project

12.3.21

The following are pictures from the week ending in 12.3.21 in regards to the CLRC Renovations and Additions Project. This project is going well again after the Thanksgiving Holiday break last week. The targeted waterproofing is nearly completed, and in fact the subbase is set enough that next week the foundations for the addition on the southeast corner can started to installed. The fire protection installation has now moved down from the mechanical penthouse to the second floor. In fact the majority of the main and trunk lines are in already, and then all of the new drops and heads can be installed. Next week a lot of materials will be coming in from the suppliers and then in the following weeks items such as the new curtain wall on the second floor and the windows for the second floor will be installed. We also received good news and that is the new elevator and associated equipment will be in sooner than originally expected and so that it might targeted for installation in February as opposed to March. Overall this project has surpassed the 40% completion mark.

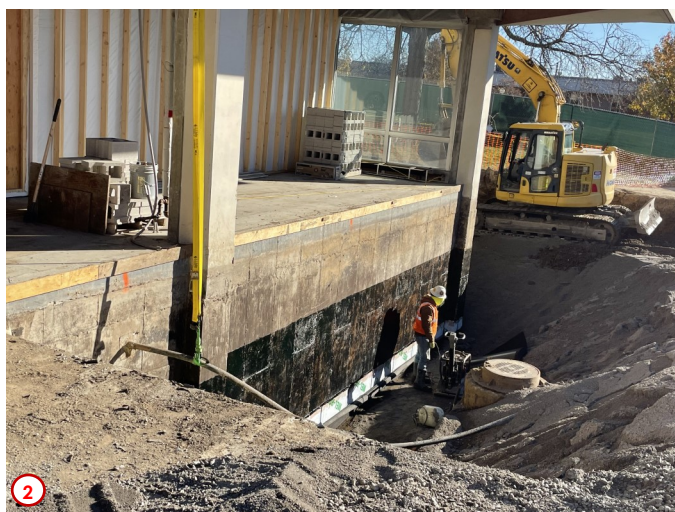
Note: for reference I have highlighted the portion of the basement walls that are receiving the waterproofing for reference on the floor plan on this page.

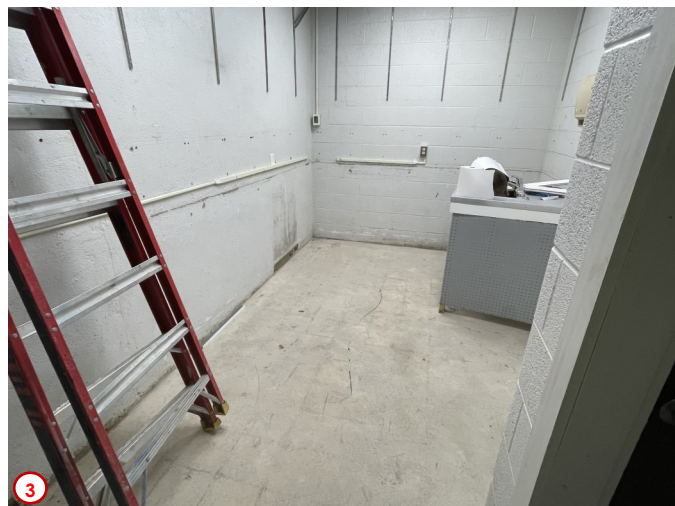
Photo #3 shows the results after some additional asbestos abatement was recently completed. This storage area was once the dark room for the photography lab and contained asbestos laden flooring and mastic. Both have been successfully removed and now just the bare concrete floor slab is leftover. This among many areas that have been remediated, and is part of the ongoing process to make the building safer and healthier from an environmental perspective.
