Building Report | CLRC Renovations and Additions Project

8.27.21

The following are pictures from the week ending in 8.27.21 in regards to the CLRC Renovations and Additions Project. Due to the amount of work happening on the first and second floors I have reordered the sequence of the floors and now they are in sequential order starting from the basement up to the second floor. As there will be a lot of work happening on the first and second floors this will allow me to better cover all the activities that are, and will be, happening throughout this project. This project continues to progress well, and as the necessary demolition is nearly wrapping up this will allow new construction to begin. Again since majority of the abatement has been completed this frees up the demolition work to be completed. In the next few weeks new construction will begin in certain areas of the building which will definitely be an exciting start to the next phase of work needed to finish this building renovation.

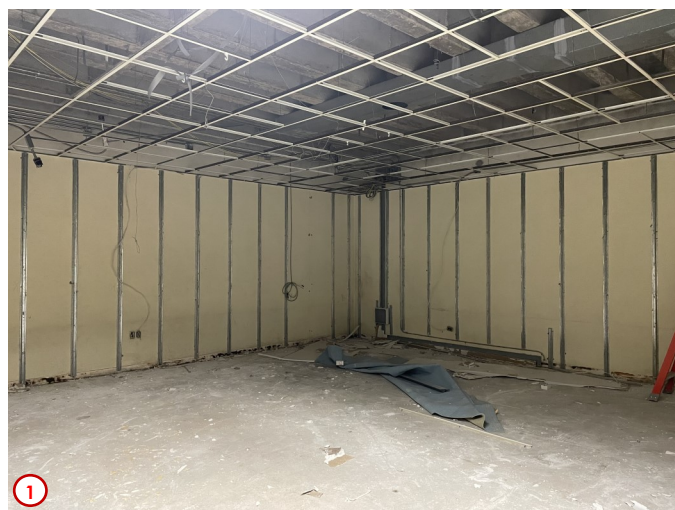
Photo #1 highlights the progress of the demolition of the existing finishes in the classrooms that are being redone as part of the overall project. In this particular classroom (C-8) there was more finishes to remove as this room had extra acoustical treatments due to it being used for web conferencing and learning.

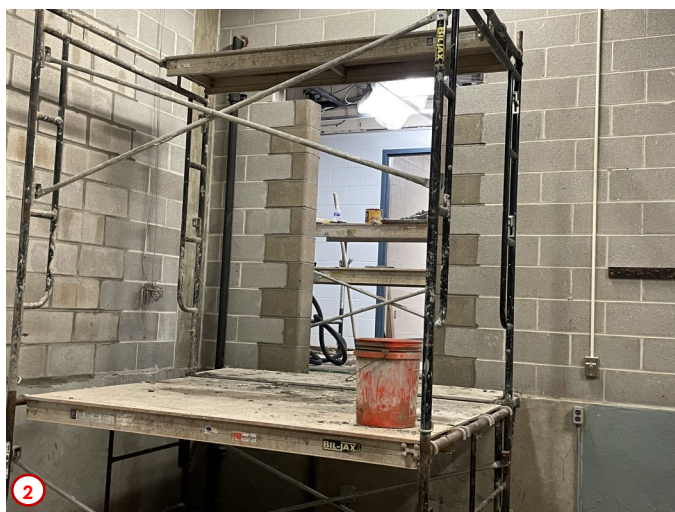
Photo #2 shows the progress of tooting in the concrete block so that the new door and frame for the new Janitor's Closet can be installed later. The irony of this photo is that the level of the scaffolding is where the new floor will be later (once erected) for the new closet, however you won't be able to see it from inside the existing mechanical room as it will be covered and held in place by perimeter walls made of concrete block.

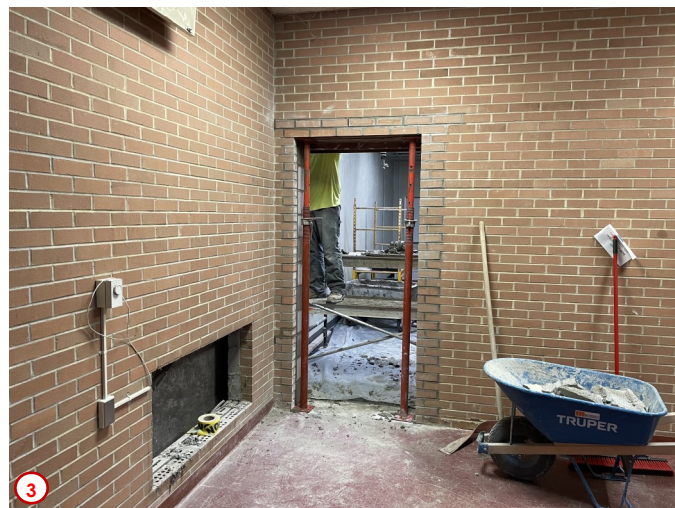
Photo #3 is a snapshot of the new entrance from Classroom C-10 into the landing of the west stair in the basement. The existing area under the stairs is being captured to create the room that will house the main fire riser for the new building-wide fire sprinkler system that is being installed to assist in bringing the structure up to current regulations. In the end this space was ideal for this as again it helped us repurpose some dead space in the building, but also because of its proximity to the main domestic water line coming into the CLRC. Having to run less piping to connect the riser to the water main ended up being a considerable costs savings over trying to connect into the old limited fire riser that is in the northeast corner of the building.

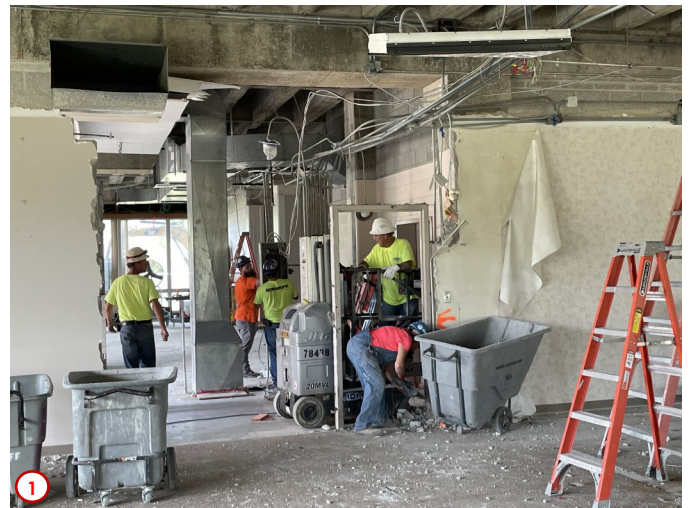
Photo #1 was taken in the area of the old reference section of the Library. Here one can already see the beginnings of the formation of the new main corridor that will connect the future east and west entrances on the first floor and provide the critical barrier free entry to the elevator which will help this building to finally be fully ADA compliant! Once the old infrastructure (mechanical and electrical) systems are removed the new framing required for the corridor walls can start to be erected.

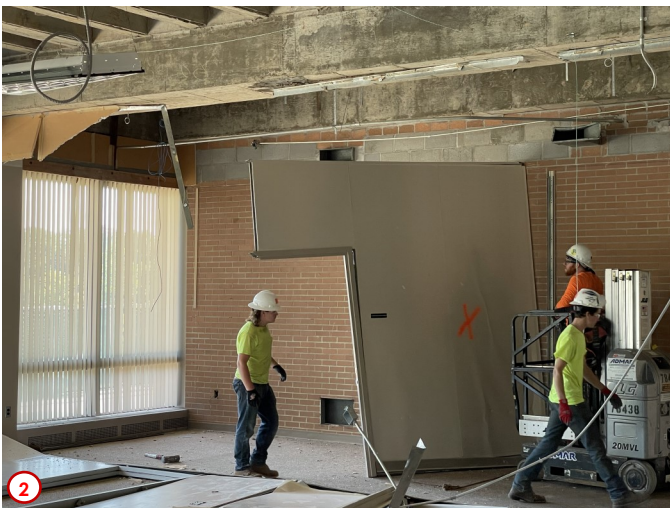
Photo #2 shows the contractors removing the last of the wall systems that used to comprise the Director and Administrative Assistant Offices in the northeast corner of the library. This space will be captured and will come part of the new library as it is reconfigured to fit the new layout of the first floor.

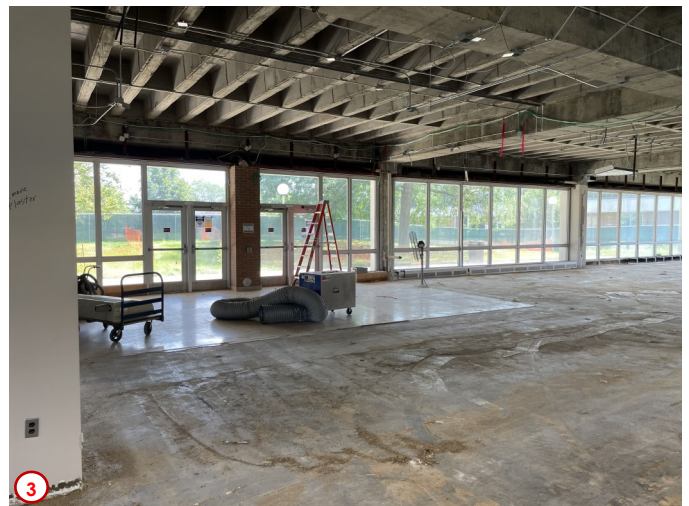
Photo #3 shows the completion of the old entry way into the Library. The only remaining portion to remove is the existing terrazzo flooring that was located in the entry vestibule. Again, this entrance will be removed and a new curtain wall system installed that will serve as the exterior barrier for the future student conference room and staff office suite.

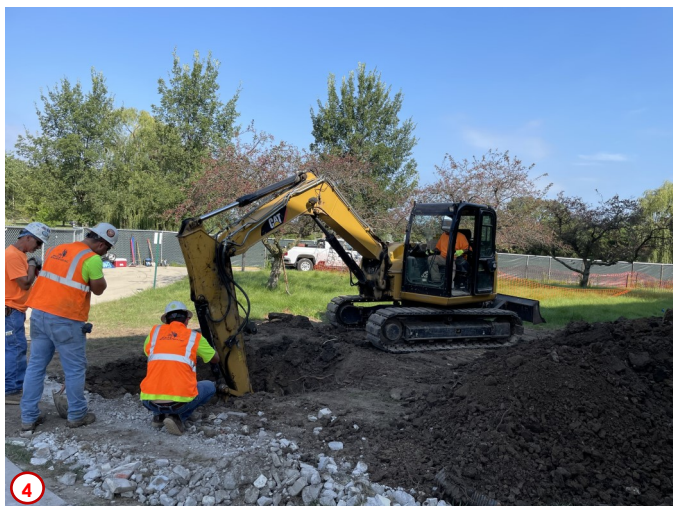
Photo #4 was actually taken outside the southwest corner of the CLRC. Here you can see the contractors "daylighting" or carefully digging to expose existing underground utilities in the area. This process was done for two reasons: 1) to verify the location and depth of the utilities in this area as this is where some footings will be installed for the new entrance canopy, and 2) to verify that there are no other unmarked utilities in the area as well (which does happen).

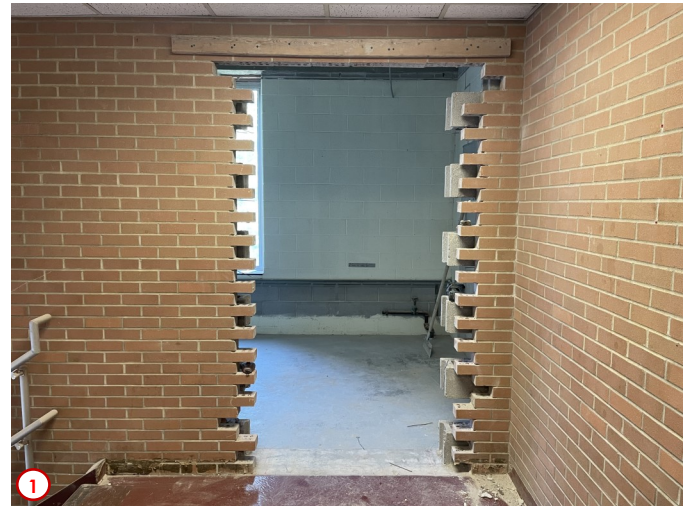
Photo #1 was taken on the top landing of the eastern stairwell. Here you can see the contractors have started creating the new opening that will serve as the emergency exit out of the new faculty lounge in the H/SS Division Office Suite.

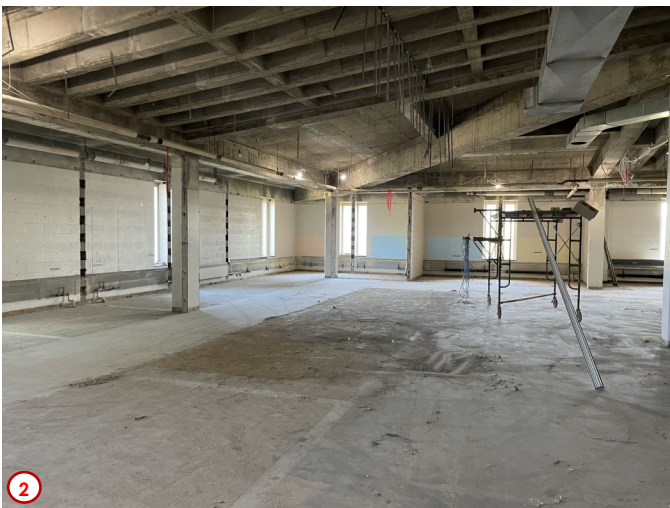
Photo #2 shows the current status of basically the northern half of the second floor. All wall, floor finishes, and existing mechanical systems that needed to be demoed have been removed. Cleanup is nearly complete and soon new construction will begin. The first step in the new construction will be to mark the floors and start erecting the new framing. From there the new mechanical, plumbing, and electrical infrastructure will be installed. This will allow the new wallboard and finishes to be completed at a later time (not until early in 2022).

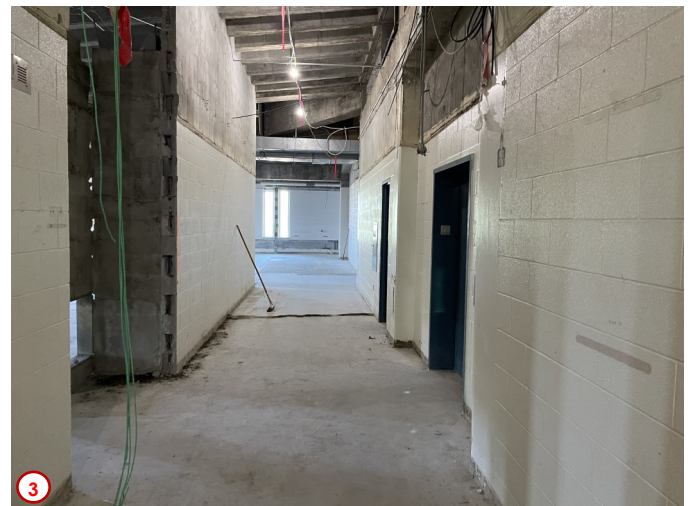
Photo #3 was taken looking west in the southern corridor on the second floor. Unlike the northern half of the floor more of the existing walls will stay in this area. However some demolition and new construction was necessary in order to create ADA compliant entrances to all of the existing classrooms that were set to remain.

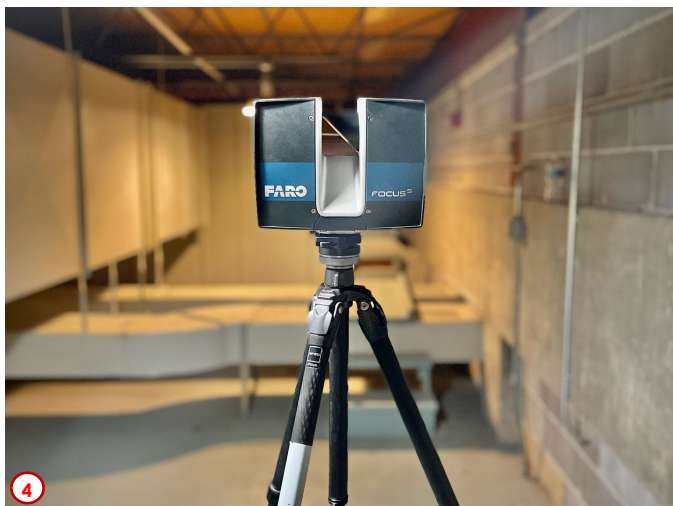
Photo #4 shows an innovative process that is happening with the CLRC project. Here you can see a 3D scanner at work creating a virtual model of the building. This virtual model of existing conditions will be merged with the already created version that the architects have been using for the construction documents. This will allow the architects and engineers to see if any adjustments need to be made to the design based on true existing conditions now that demolition is nearly complete, and hopefully avoid any unnecessary construction issues on the job site.
