Building Report | Life Sciences Façade & Addition

11.10.17

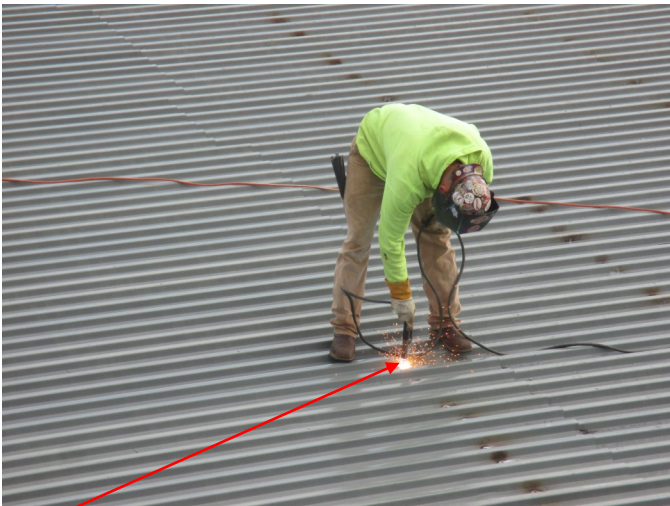
The top-left photo shows an ironworker welding the sections of metal decking for the roof of the addition. The pieces of metal decking are welded together and to the support bar joists.

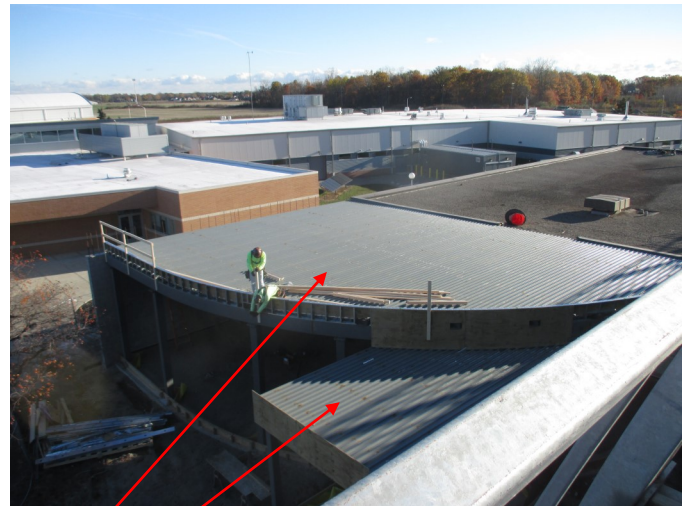
The top-right photo shows the finished metal decking for the addition roof system. The necessary preparations, such as wood blocking, are being done to the roof in order to place the concrete slab on top about the middle of next week.

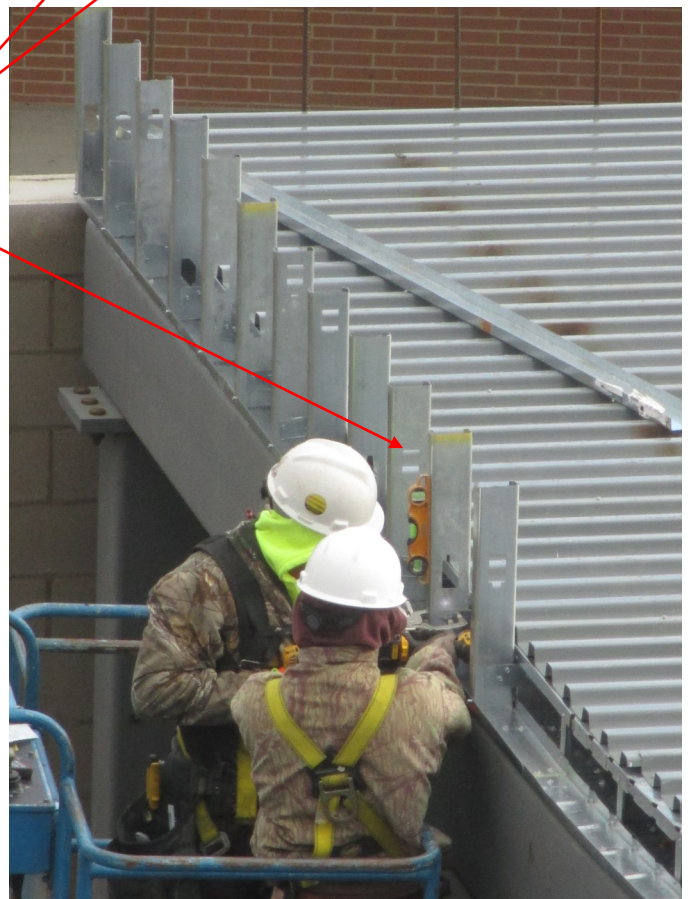
The bottom-right highlights the progress of the installation of the light-gauge metal framing for what will be the parapet wall on the curved face of the addition.

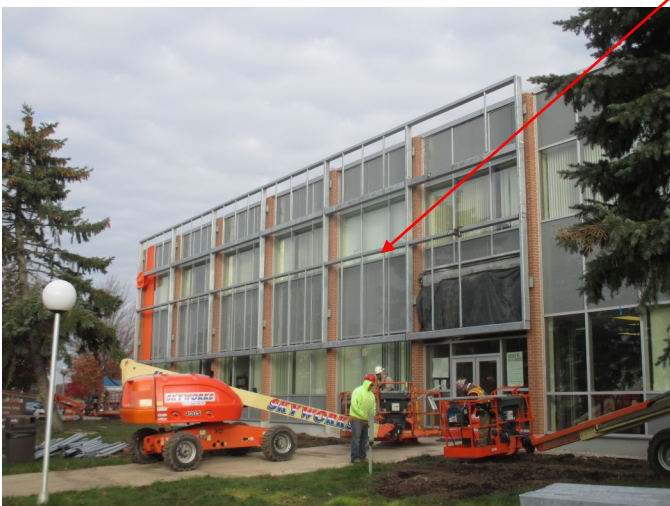
The bottom-left photo shows the progress of the installation for the support system for the new sunshades on the south face of the building. This system is different from that on the north face and will have both vertical and horizontal members that combined will act as a passive solar system and increase the efficiency of the building's HVAC systems.

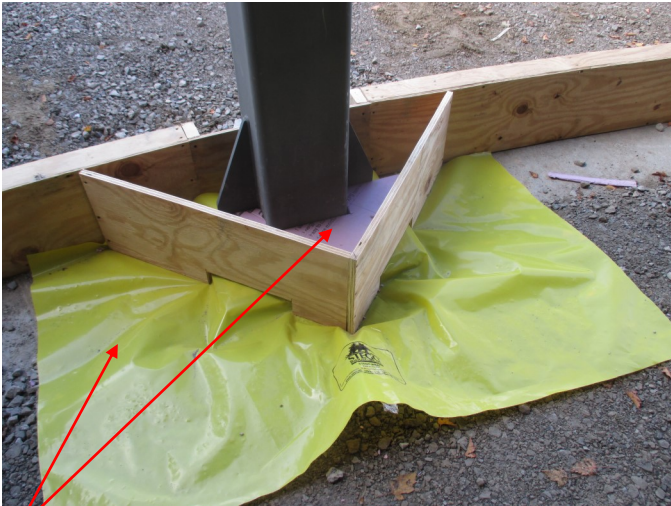
The top-left photo highlights some of the preparation work happening prior to the installation of the concrete floor slab next week. Here you can see some wood blocking that will allow the slab around the column and for the floor to be physically separated and therefore allowed to act independently to avoid unnecessary cracking. The yellow film shown is the vapor barrier which will help block moisture from infiltrating the addition through the floor slab. There is also rigid insulation being installed along the perimeter of the addition to assist in the heating of the space.

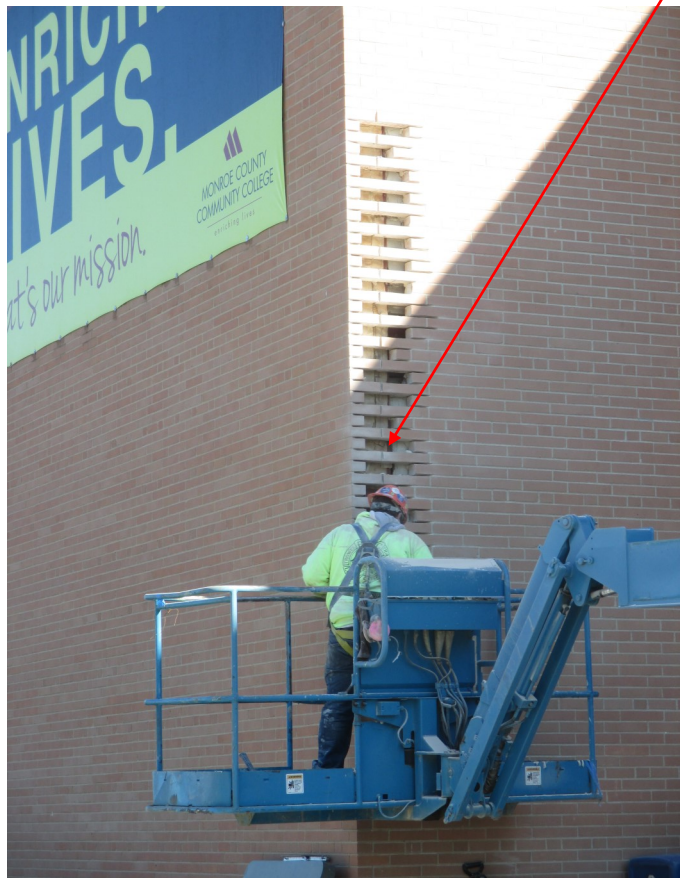
The bottom-right photo shows some of the additional brick veneer masonry repair work happening as part of the project. Here the cracked brick is being replaced with new brick to match.
