**MONROE COUNTY COMMUNITY COLLEGE  
FACILITIES ASSESSMENT AND DEFERRED MAINTENANCE  
CAPITAL PLANNING REPORT  
2011 UPDATE**

**SHWGROUP**  
ARCHITECTS | ENGINEERS | PLANNERS

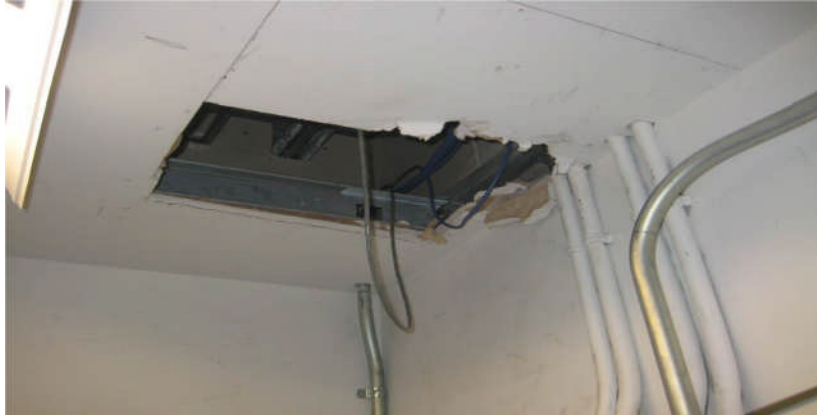
**Whitman Center** – breach in fire-rated ceiling assembly.

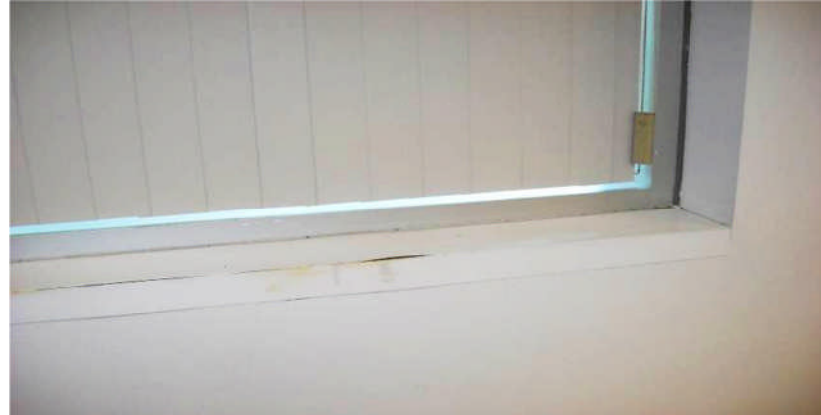
**Whitman Center** – water infiltration along exterior wall has caused deterioration of the plastic-laminated windowsills.

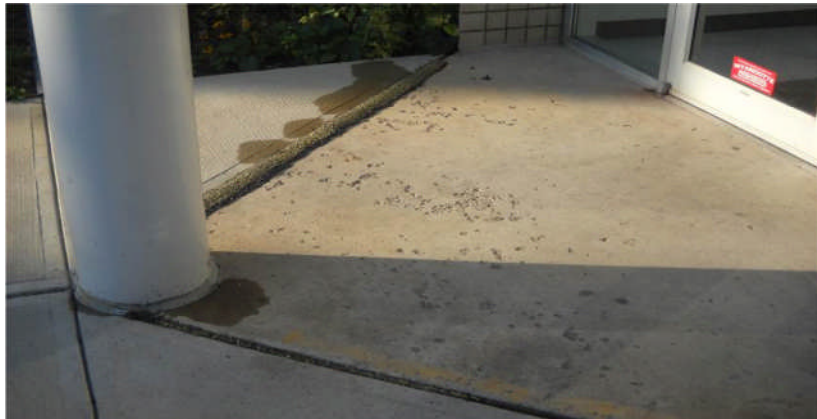
**Whitman Center** – settlement/heaving of exterior concrete slab (at main entrance) presents a tripping hazard.

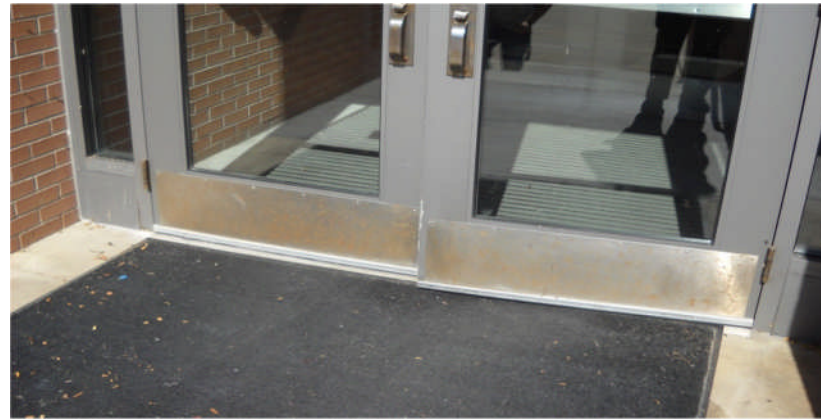
**Student Services/Administration** – Aluminum entrance doors and hardware at end of life.

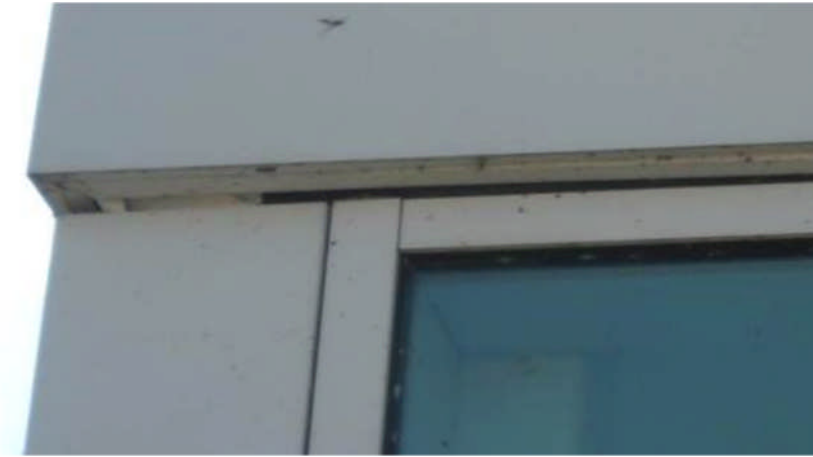
**La-Z-Boy Center** – It appears there is a void within the exterior aluminum, curtain wall assembly allowing the environment to enter the interior.

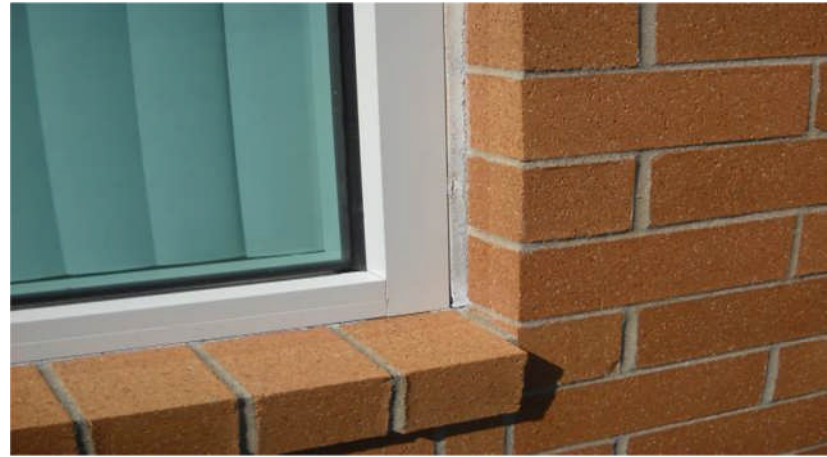
**Health Education Building** – Typical sealant joint is at end of life.

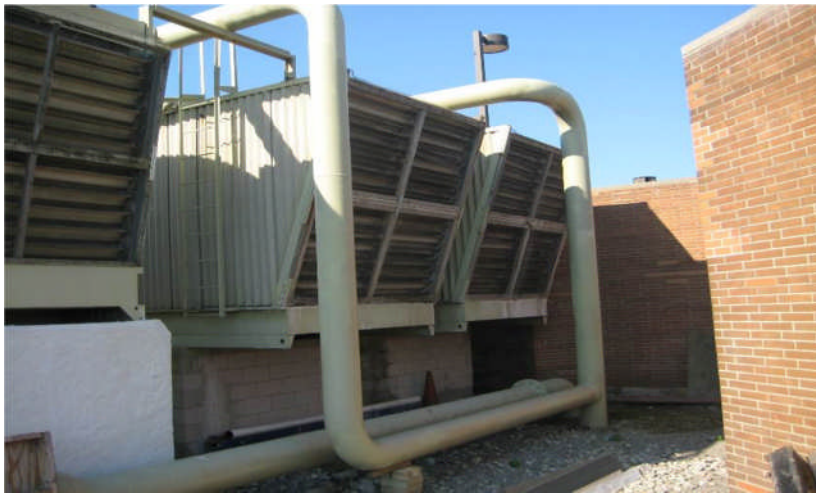
**Physical Plant** – Cooling tower and basins are near end of life.

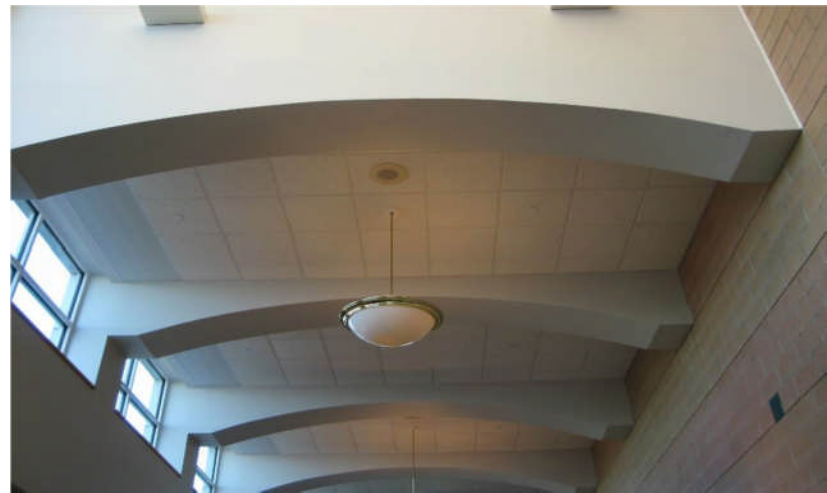
**Health Education Building** – Daylighting controls for the Atrium would save energy.

- Daylighting control of the Atrium fluorescent fixtures should be considered for energy savings.
- Wireless equipment is at end of life and requires replacement.
