Building Report | CLRC Renovations and Additions Project

01.21.22

The following are pictures from the week ending in 01.21.22 in regards to the CLRC Renovations and Additions Project. Similar to last week's report there was more to report concerning the first floor so I have included photos for that floor on the first two pages. Due to some more needed coordination between the electricians and the engineers prior to the placement of the floor slab for the southeast addition it was postponed until next week. Work on replacing the curtain wall around the perimeter of the first floor stopped this week, however since the materials were in the glazing contractor started on the north face of the second floor, and finished all but one set. Like on the first floor plan I have highlighted the completed windows in red for your reference. More wallboard was hung on the second floor with the total percentage complete surpassing the 75% mark. In the next few weeks the new electrical panels will be installed on the first floor and old infrastructure removed which will require the second of many either partial or total building systems shutdowns.

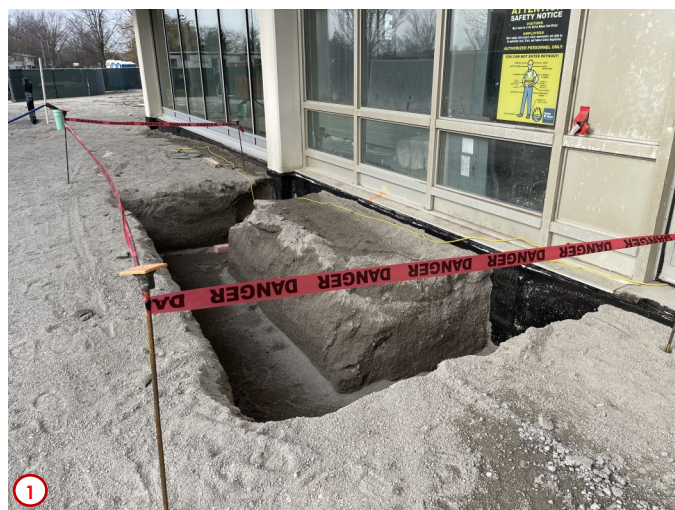
Photo #1 shows the excavation for the foundation system for the future screen wall that will enclose the area for the condensing units for the mini-split cooling systems in the main server in the basement. The foundation wall for this area will be placed next week along with several other miscellaneous areas around the south and west sides of the building.

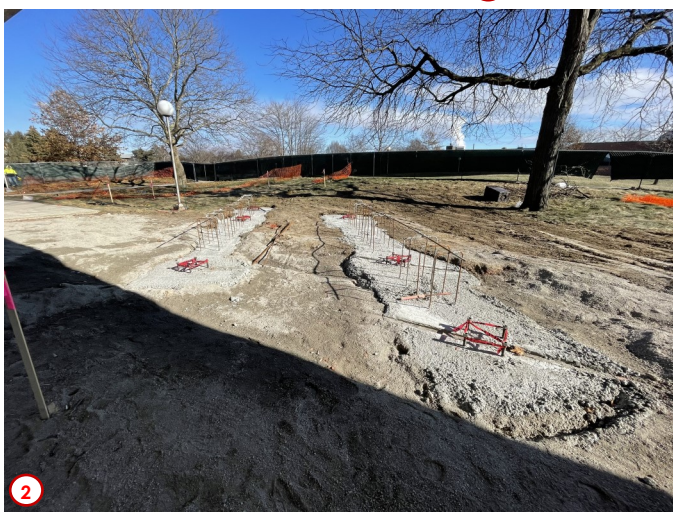
Photo #2 shows the foundations for the future entrance canopy on the east side of the building. You can also see the connecting reinforcing steel that will help connect the future partial height seating walls sticking up out of the concrete. Additionally, the anchor bolts (wrapped in the red tape) are in and these will help anchor the steel support columns for the canopy.

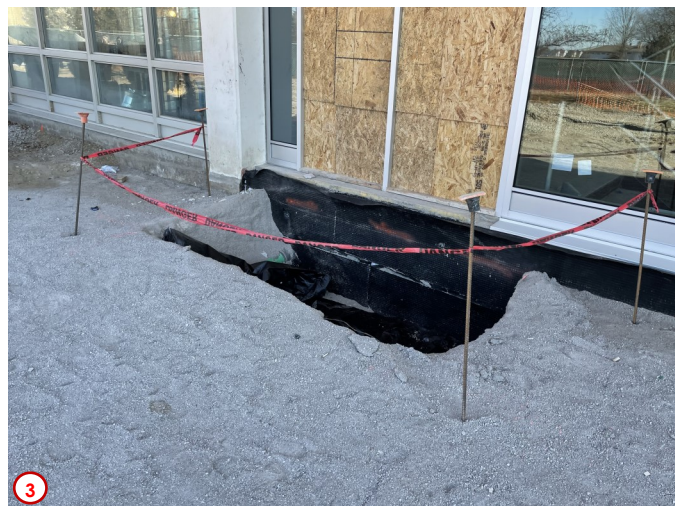
Photo #3 was taken on the east side of the building and shows the excavation needed for the future frost-proof entry stoop for the doors at the base of the west stair tower. This is a building requirement as it helps to prevent frost in the wintertime from possibly heaving the slab up that would prevent the doors from swinging out completely and therefore possibly obstructing building occupants who may be trying to leave the building in case of an emergency such as a fire event.

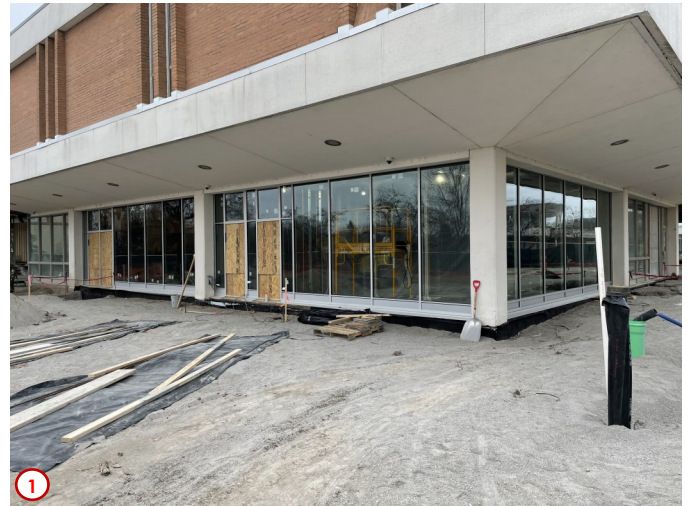
Photo #1 shows the progress of the installation of the new curtain wall system on the first floor. This past week an additional bay was completed and as seen in the photo is the left most bay which is near the west stair tower.

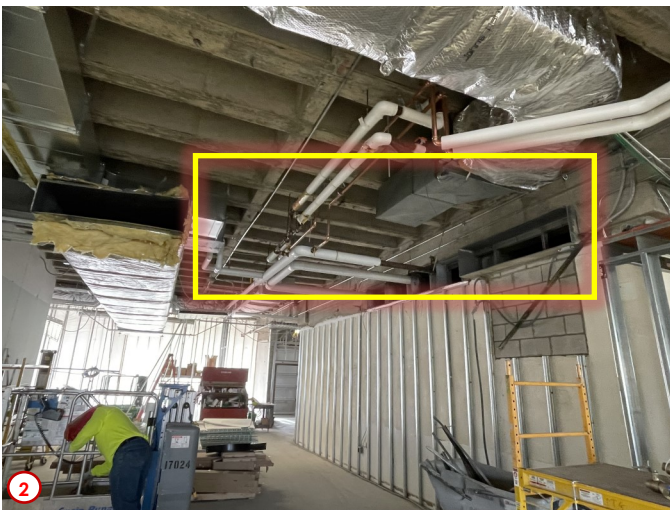
Photo #2 was taken on the first floor near the area that will be the future Entrance/Gallery into the Library. Here an existing section of HVAC ductwork was found to be not structurally sound and therefore is being replaced by a new section with a heavier gauge metal which will help it not only better convey heated or cooled air to the first floor, but will also help it be quieter while in operation which will be an added bonus for this space. The section of reference has been highlighted in yellow.

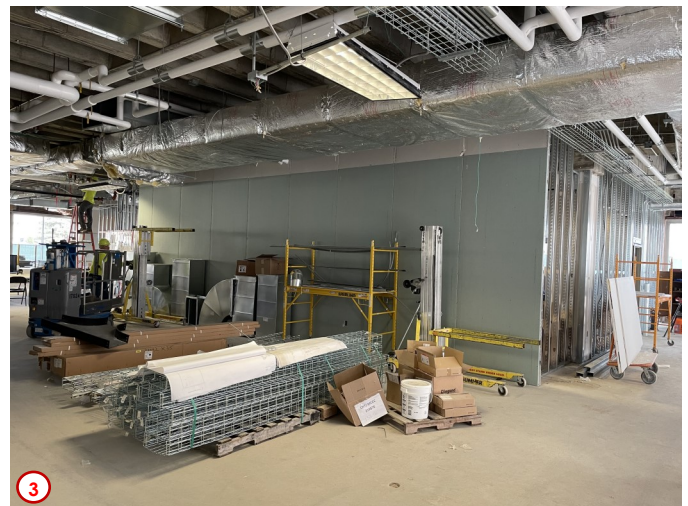
Photo #3 highlights the first area of wallboard that was installed on the first floor. This is the east wall of the future Entry/Gallery of the Library.

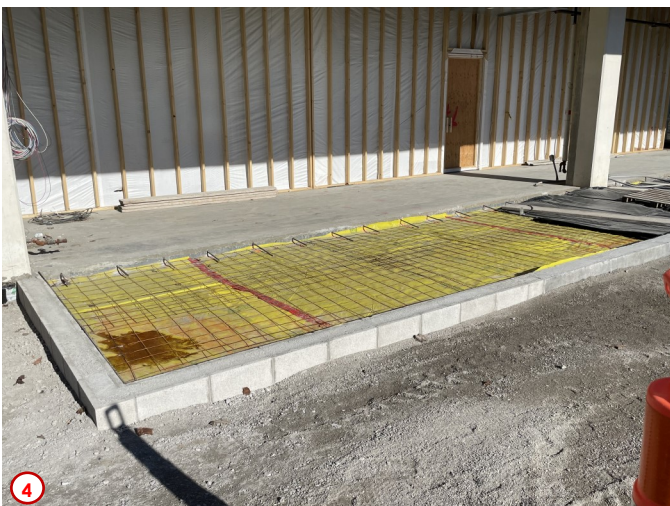
Photo #4 shows the area of the future addition to the southeast corner of the building. Looking at the photo you can see the wire-mesh reinforcing in place and the dowel rods that will help support the floor slab and connect it to the existing slab respectively. Next week this concrete will be placed along with the foundations for the screen enclosure, west entrance canopy, and the new door stop at the base of the west stair tower.

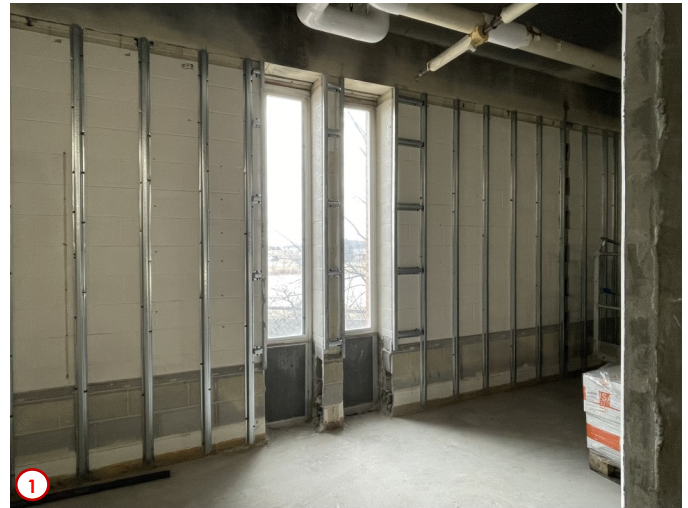
Photo #1 shows some additional demolition that happened this past week. Here the block wall from the window sill down to the floor slab was removed so that the entirety of the window frame is exposed. This was done because the new windows in the 2nd floor commons area only will be floor to ceiling which will allow for even more natural light into the interior of the building.

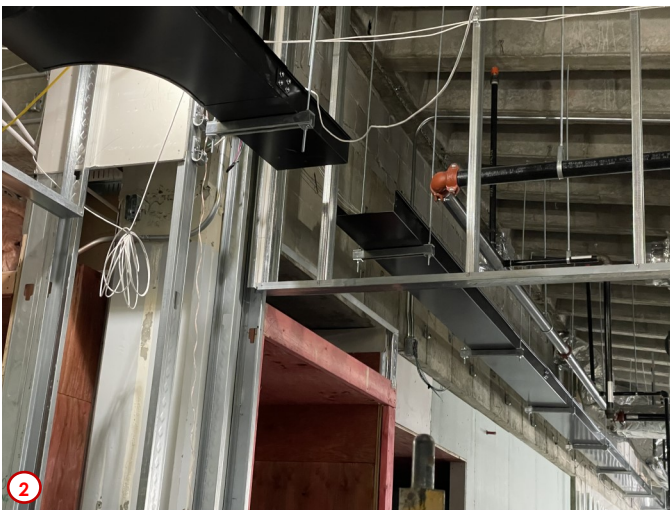
Photo #2 shows some more the cable tray being installed on 2nd floor. However unlike the basket style in other areas this tray solid as it will be partially exposed due to some of the ceiling systems that will be installed later. This will help the overall aesthetics of the area by hiding the numerous bundles of low-voltage and data cabling that will be housed in the trays.

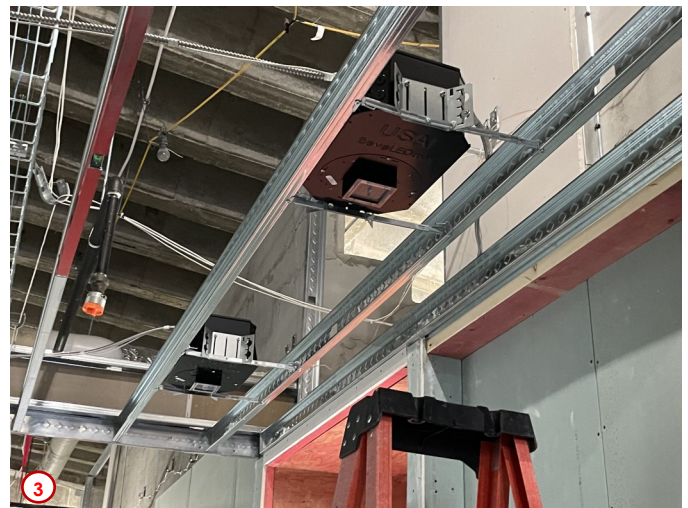
Photo #3 shows some of the first light fixtures installed on the 2nd floor. The featured fixtures are accent/general lighting in the area of the elevator lobby.

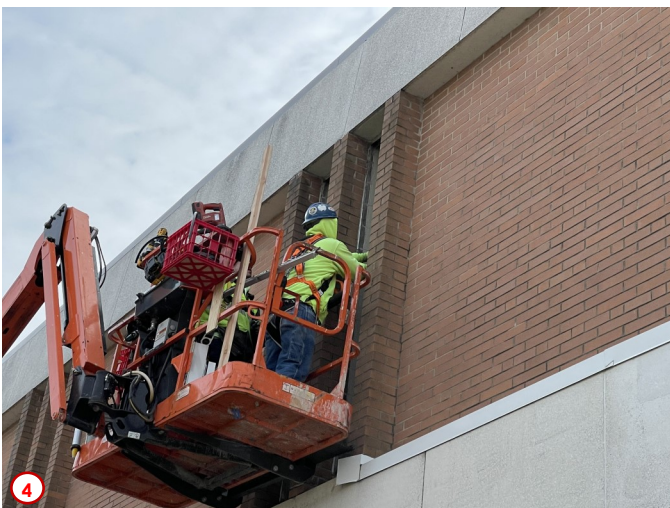
Photo #4 shows the glazing contractors on their lift working on installing the some of the new window units on the north side of the 2nd floor. These windows are outside of the future H/SS Office Suite, and like the new curtain wall systems on the first floor much more energy efficient with their thermally-broken frames and glass with a low 'e' film applied.
