# Building Report | CLRC Renovations and Additions Project

## 02.11.22

The following are pictures from the week ending in 02.11.22 in regards to the CLRC Renovations and Additions Project. This project is now somewhere between 50-60% complete which is where it should be according to the overall proposed schedule that was agreed upon prior to the start of construction. A very key element was installed this week as the concrete floor slab for the southeast addition was finally able to be placed thankfully due to a mid-week warmup temperature wise. Having this done will allow for other key building elements to be installed like the curtain wall on the first floor which will aid in the goal to get the building exterior envelope finished and therefore protecting the interior from the weather. Construction on the future east canopy will begin next week which is another major milestone for the project. Also, the painters will be on site mobilizing next week as they will begin applying the primer in some areas of the basement and possibly second floor. As of right now we are still on track to take occupancy of the building in June as planned.

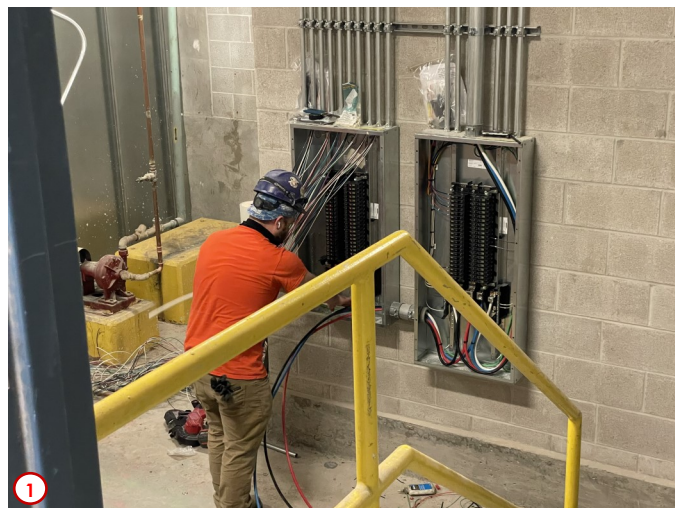
Photo #1 shows the electricians wiring the new panels that replaced the units that were removed last week from the north corridor in the basement. Again these panels were removed the corridor and moved into the inside of the mechanical as part of the overall effort to make the interior of the building safer for building occupants. Plus, this allowed the building to be essentially rewired and provide extra capacity in the panels for future work or equipment.

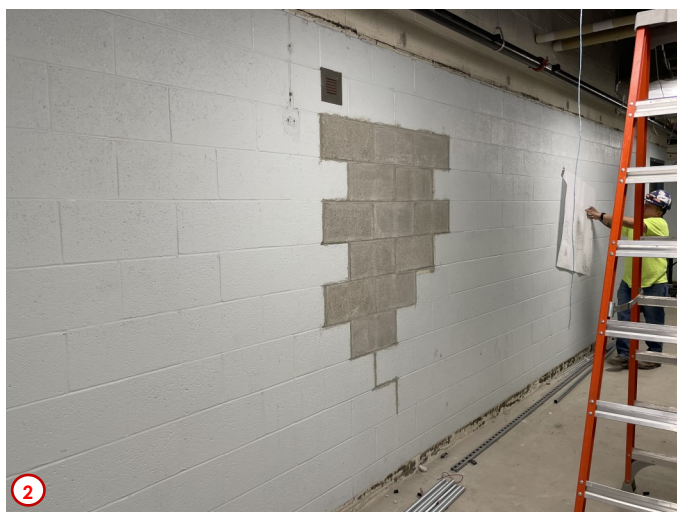
Photo #2 is a companion to Photo #1 and shows the walls filled in with new concrete block where the old electrical panels in the north corridor were removed. Once the walls are primed and painted one will not be able to distinguish between the existing and new block.

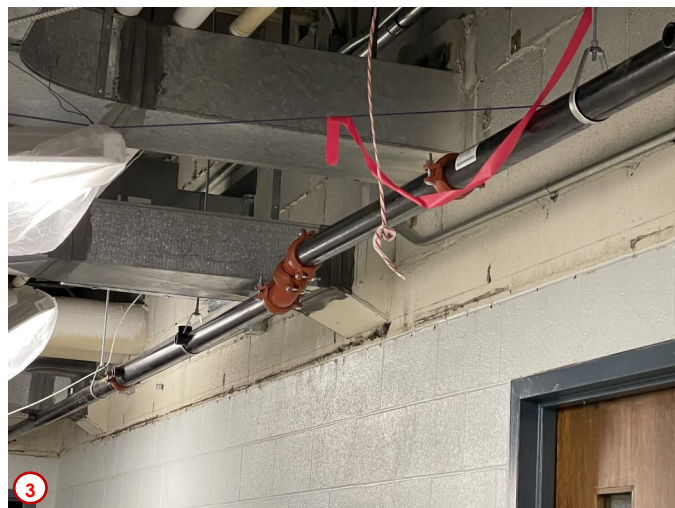
Photo #3 was taken in the east corridor and shows the progress of the installation of the new fire-sprinkler trunk lines. There is a significant amount of mechanical, plumbing, electrical, and teledata infrastructure above the ceilings in the corridor which means sometimes there are a lot of obstacles that these trunk lines have to work around. Once the finished ceilings are installed in the basement all of the aforementioned infrastructure will be nicely concealed and an aesthetically pleasing suspended will be installed giving the area a very nice environment for building occupants.

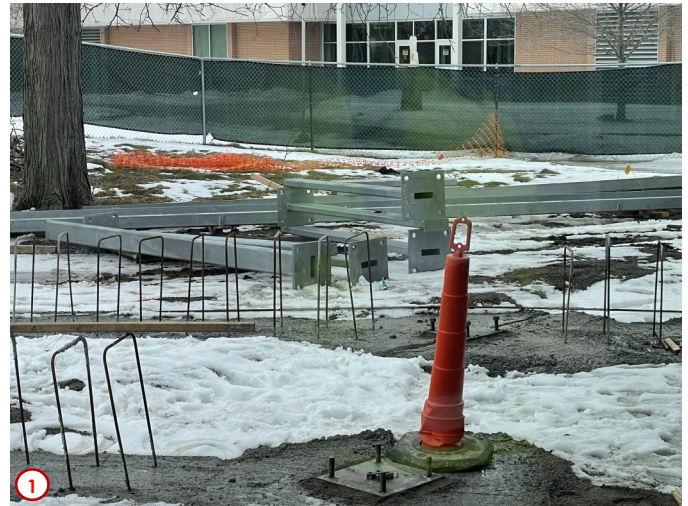
Photo #1 shows some of structural steel on site for the east canopy. Next week the contractors will focus on starting the process of erecting the frame for the east canopy, and once completed the finished canopy can begin.

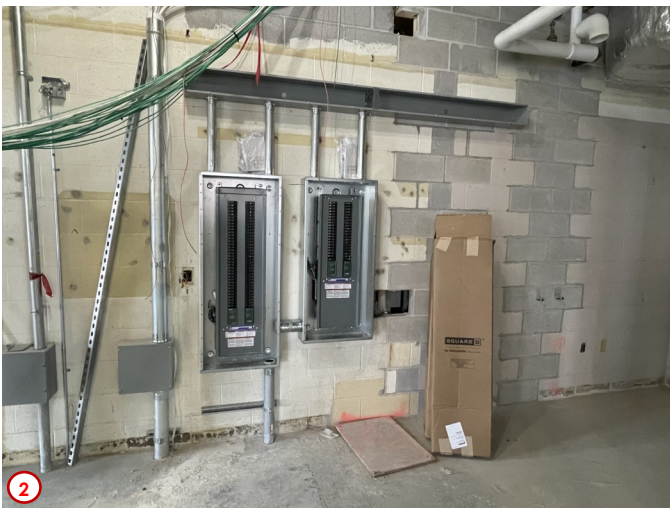
Photo #2 shows the installation of the new electrical panels in the janitorial closet on the first floor. Once these new panels are in the existing panel that currently sits outside of the existing elevator can be removed which will be one of the last items to be cleared out of the way of the new east/west corridor that will connect the entry vestibules. This new corridor is key to our plan to ensure that the building will be 100% barrier free upon completion.

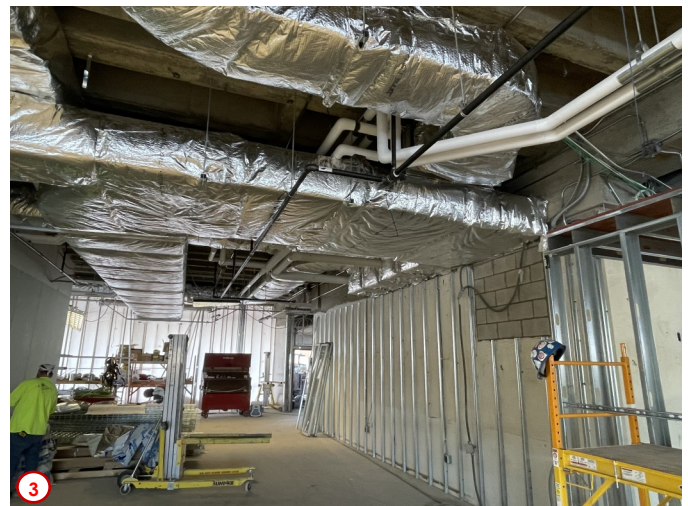
Photo #3 shows the missing section of main HVAC ductwork now in place in the Library and already insulated. Again the old section was damaged and removed. The new section is an upgrade as it is made out of heavier gauge metal and will last the college many years to come.

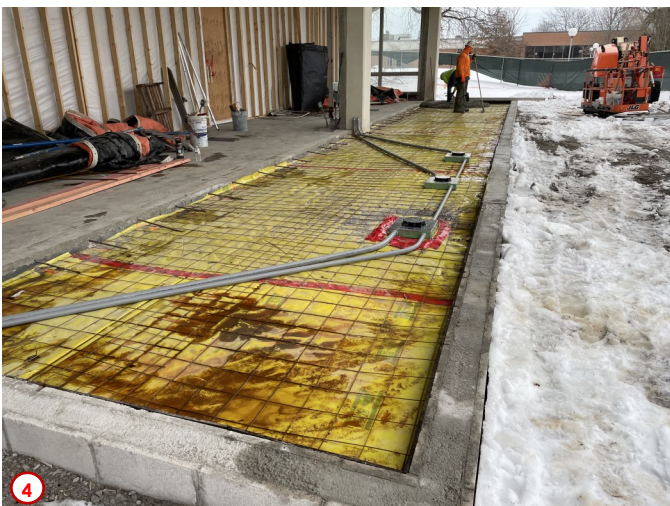
Photo #4 shows the very beginning stages of placing the concrete for the floor slab at the southeast addition. You can also see the underfloor electrical that was installed which will provide electricity and data to the future computer desks that will sit in the new lab that will be located in this corner of the building.

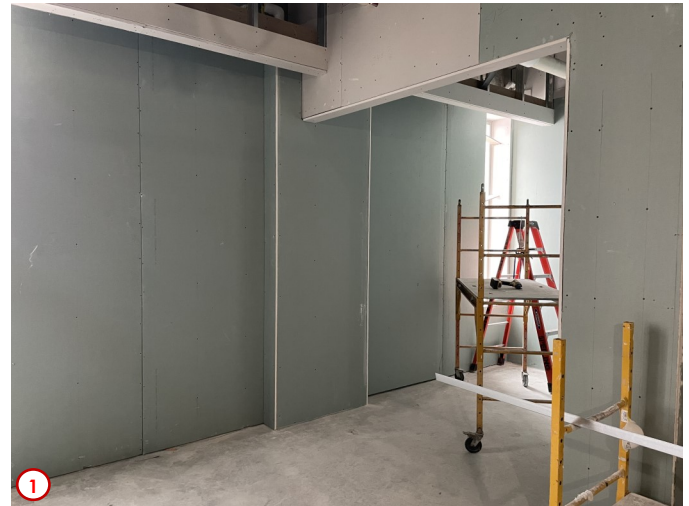
Photo #1 highlights some of the work happening in the future Writing Center on the second floor. The bump out in the background is where some framing and wallboard are now concealing some new hydronic piping that was installed that will support some radiant heating panels that will line the perimeter of the building and provide supplemental heating to ensure building occupant comfort.

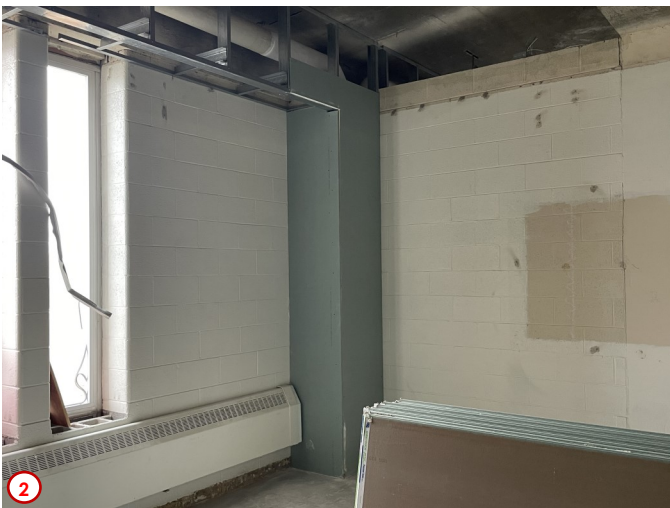
Photo #2 is another example of some of the finer finishing happening on the second floor. Here you can see a new shaft being enclosed around a roof conductor that is running down the corner of this future classroom. This will help make for a more finished look for this space once completed.

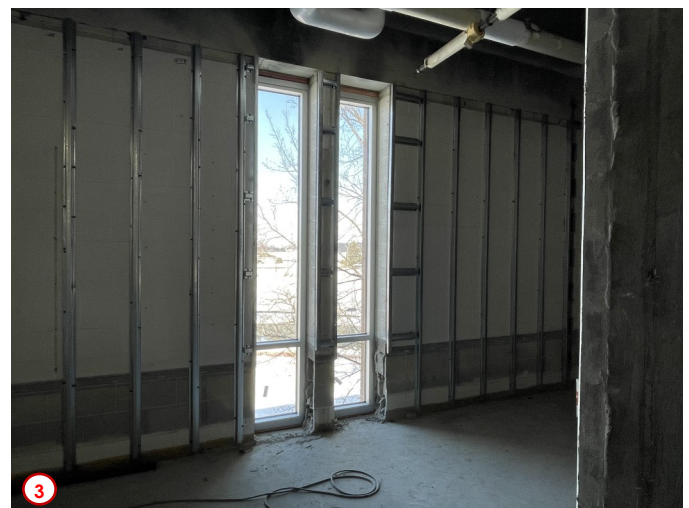
Photo #3 shows the new windows in place in the commons area at the top of the stairs. Again the existing wall was removed at the bottom of these windows to allow more light to infiltrate the interior of the building. By providing these floor-to-ceiling windows it opens up more scenic views of the neighboring Little Pond adjacent to the La-Z-Boy Center.

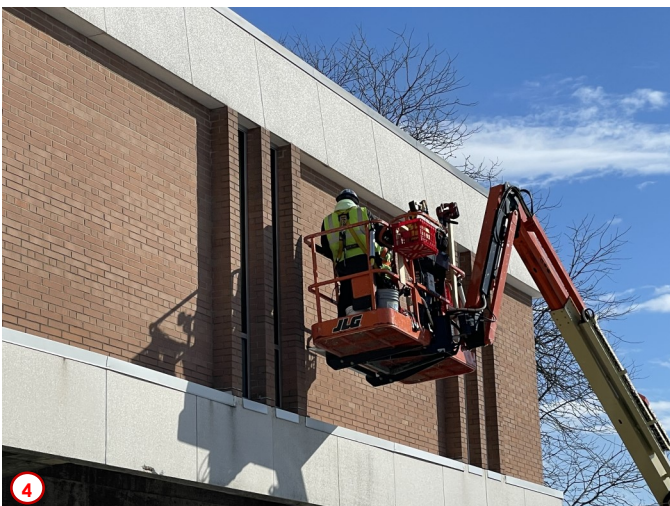
Photo #4 highlights the contractors working on replacing more of the existing window units along the southern face of the second floor. There are only three remaining sections to replace and then the entire second floor will be finished, and then the glazers will move back to the first floor and work towards finishing all of the remaining sections of curtain wall.
