Building Report | CLRC Renovations and Additions Project

06.10.22

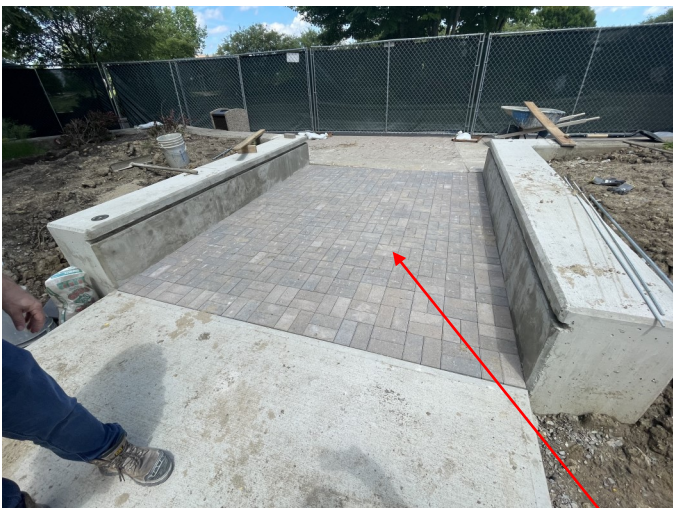
The top-left photo shows the new brick pavers now in place where the new connecting sidewalk intercepts the circular landscaped area in the center of the campus mall.

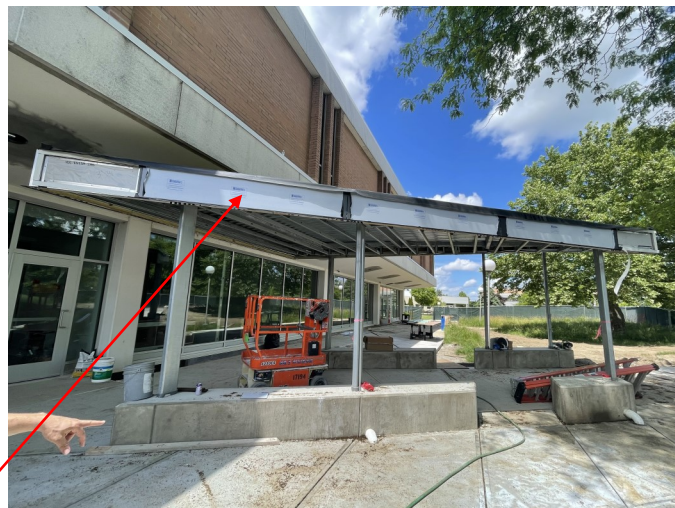
The top-right photo highlights the progress of the finishing of the new east entrance canopy. Here the new fascia cladding is being installed around the perimeter of the structure.

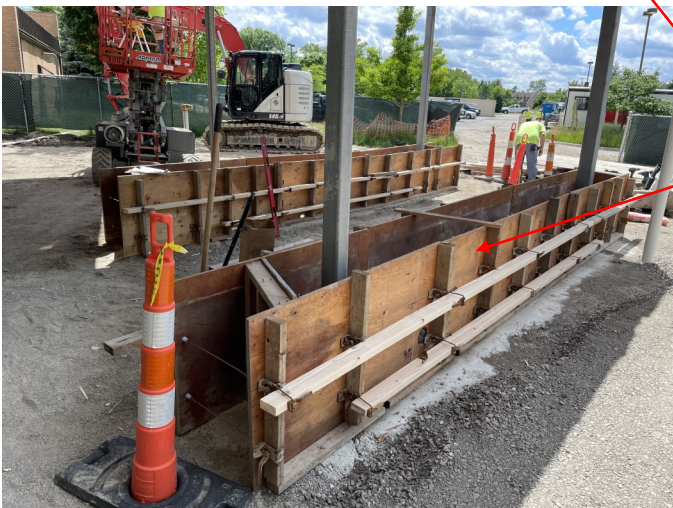
The bottom-left photo features the work happening to form and place the concrete for the seating walls at the west entry. The next step for this area will be to form and place concrete for the new sidewalk that will connect to the edge walk of Parking Lot 7. This work is slightly behind schedule due to unfavorable weather conditions the past few weeks.

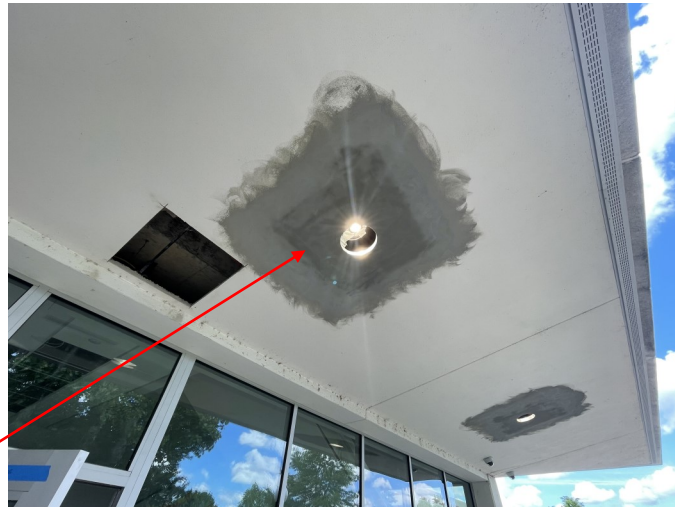
The bottom-right photo is an example of one of the many instances where the new soffit lighting is now installed and the surrounding area being patched to match the existing stucco. The entirety of the soffit under the second floor will be painted so that the patches and existing stucco blend together and appear unified. This new LED soffit lighting will not only be more energy efficient, but also be more effective in providing adequate light levels for the sidewalks below. Once the soffit is painted the trim package for each light will be installed so as to not only weather proof the light fixture, but also to keep pests from taking up residence in the surrounding cavity.

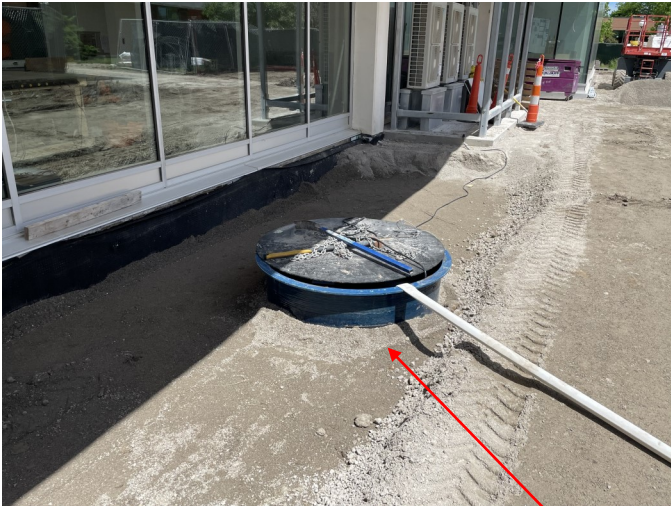
The top-left photo shows the area around the new storm water structure now backfilled which will allow the concrete collar to be installed. Afterwards the new sidewalks in this area will be formed and installed as the contractors strive towards finishing the remaining sitework.

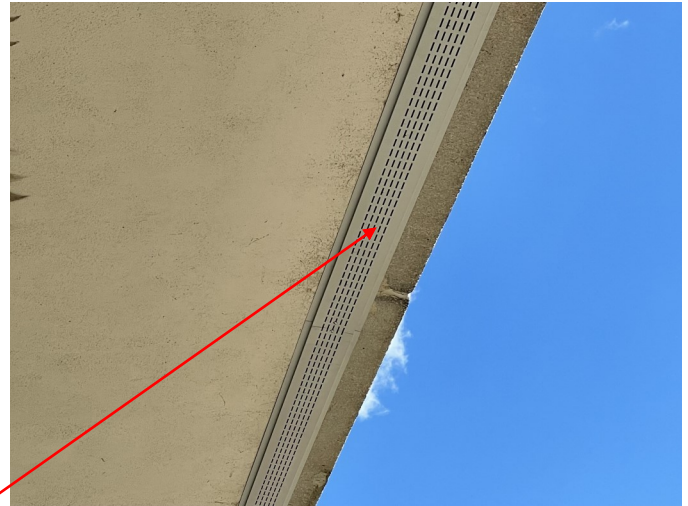
The top-right photos shows an area where the new metal soffit vents have been installed. This venting will form a continuous loop around the perimeter of the second floor and allows for air-flow in and out of the soffit cavity.

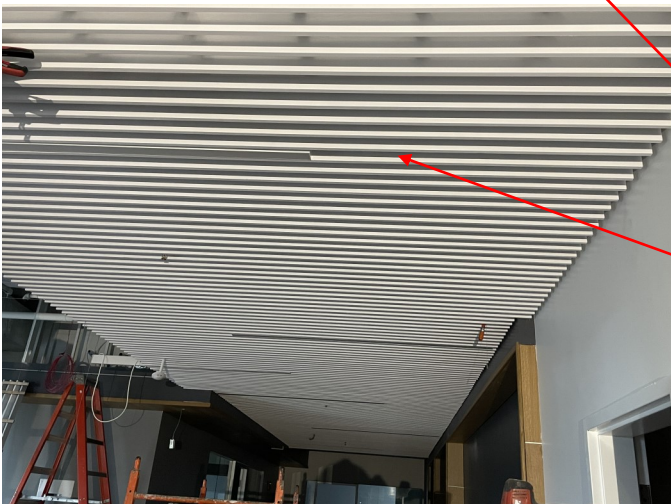
The middle-left photo highlights the progress of the installation of the new accent wood slatted ceiling being installed on the 2nd floor near the open west stair tower.

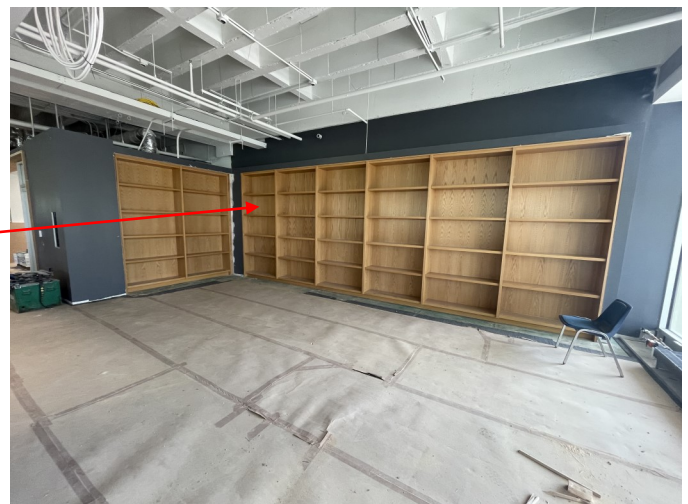
The bottom-right photo features one of the two areas in the library where there are built-in bookshelves that will house some of the college's collection.

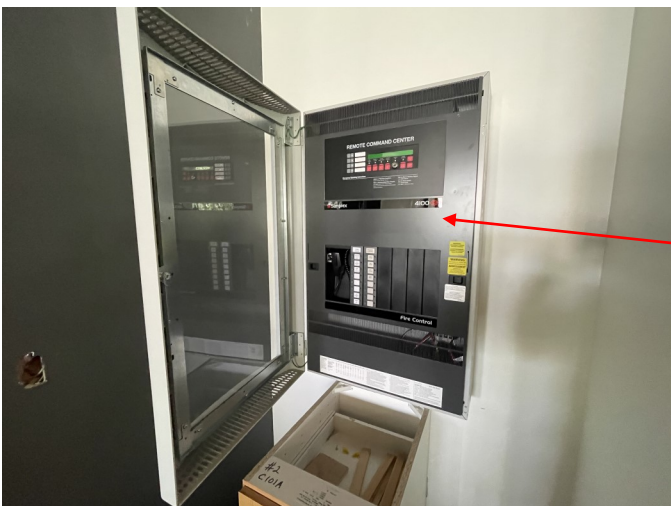
The bottom-left photo shows some of the new safety systems that have been installed. Featured in this photo is one of the new code required fire-alarm systems control panels now installed, wired, and programmed. This panel is housed in an alcove near the future circulation and reference desk in the library, and will assist both college personnel and first responders, if necessary, with vital system information and control.
