# Building Report | CLRC Renovations and Additions Project

## 10.15.21

The following are pictures from the week ending in 10.15.21 in regards to the CLRC Renovations and Additions Project. A lot of rough framing happened this past week all of which was on the second floor. Rough framing on the first floor will start next week along with the process to waterproof targeted areas of the basement. There was little work done in the basement this past week however next week more will start happening as the beginnings of the building-wide fire sprinkler system start to be installed. Overall the project is on track despite some setbacks to the exterior work due to unfavorable weather conditions. However despite the delays outside the additions should still be on track to be weather tight before winter conditions settle into the area. A bulletin has been issued for some changes required by the state fire marshal's office in regards to the western stairs, and so construction manager is working the subcontractors to revise their schedules, scopes of work, estimates, etc. in order to facilitate the necessary life safety requirements.

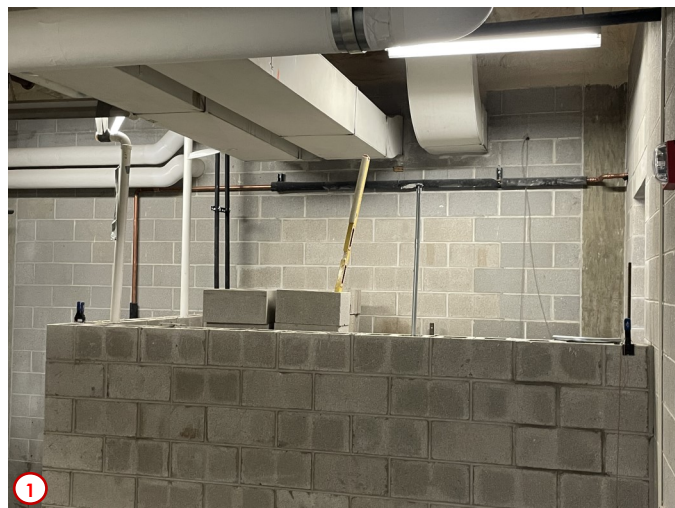
Photo #1 was taken earlier in the week and shows the block walls nearly complete. In the background you can see some of the plumbing infrastructure in place for the future mop sink that will be placed in the Janitor's Closet.

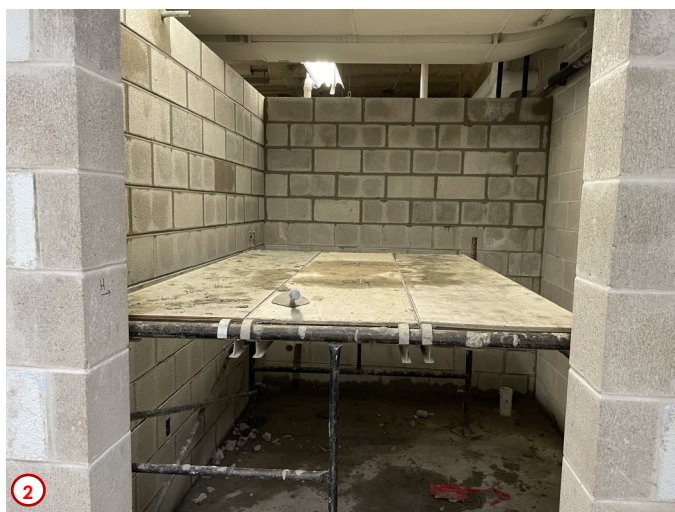
Photo #2 is of the future Janitor's Closet, but later in the week. However in this photo you can see the walls are now complete. Next up the contractors will install the metal framing in order support the hard ceiling for this space. That way the closet will be totally enclosed and the framing will not interfere with the existing mechanical systems in the area. In the photo you can see the plumbing infrastructure for the mop sink and the oil separator that will be installed later.

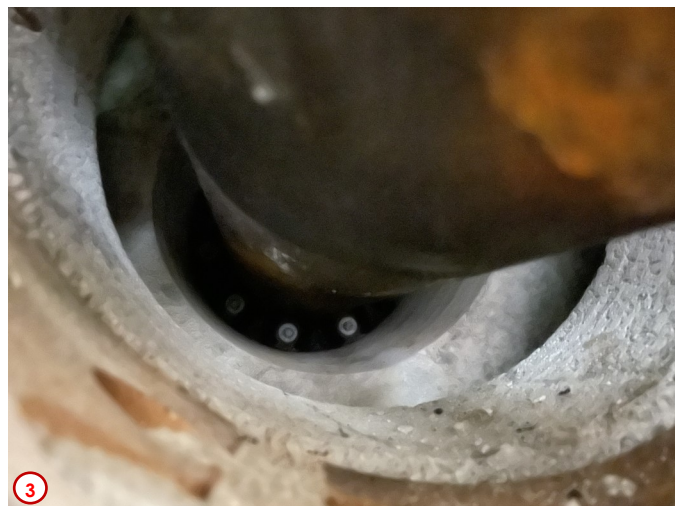
Photo #3 shows a small but very significant part of the installation of the fire sprinkler riser penetration through the west basement wall. Here you can see a device that was installed to help seal the hole around the pipe. On the exterior of the basement wall this pipe penetration was sealed and covered in a waterproofing compound as another means of protection. All this was done in preparation for excavation next week when the start of the targeted basement waterproofing takes place.

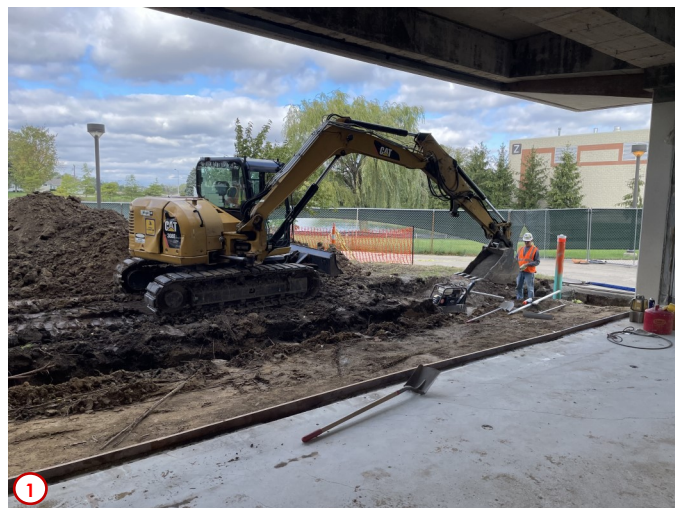
Photo #1 is of the excavation contractors backfilling after removing the old storm sewer line that was in this area. The previous line was located in the area of the foundation system for the planned addition on the northwest corner of the building and had to be removed. As mentioned in last week's report the new rerouted line is already in place and functioning well.

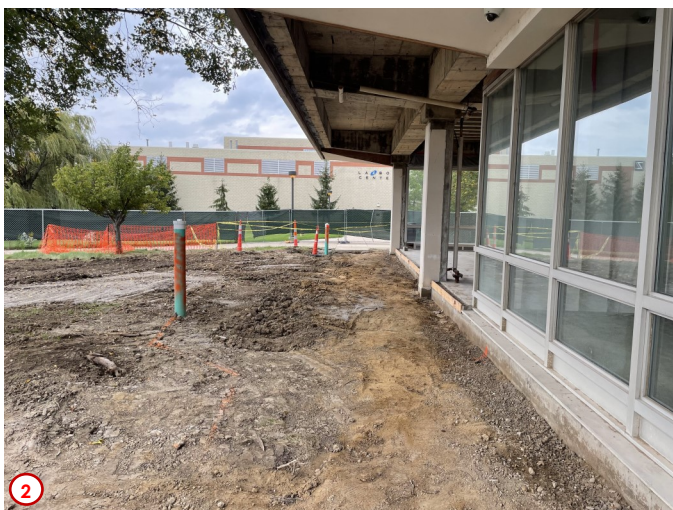
Photo #2 was taken later in the week in same area as Photo #1 and shows the site prepped and ready for excavation as next week the targeted waterproofing of the basement walls will take place. All the waterproofing needs to be completed before any of the forms for the foundations can be constructed.

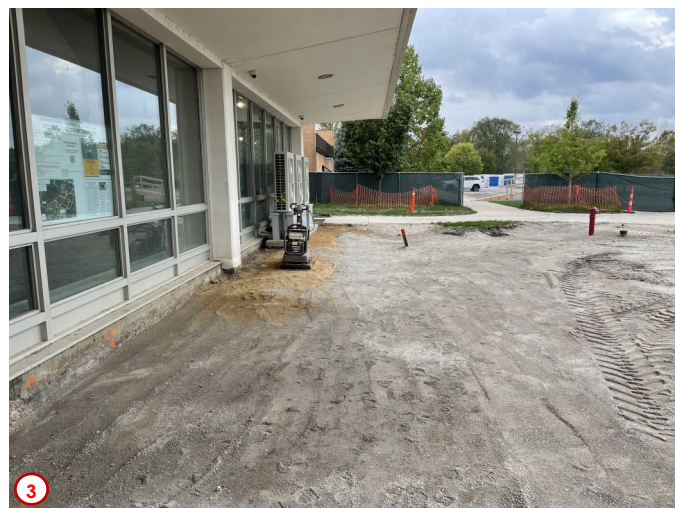
Photo #3 was taken in the same area as Photos #1 and #2 and shows more of the completed backfilling and site prep finished. This area will be where the future main west entrance to the building will be located and the associated canopy.

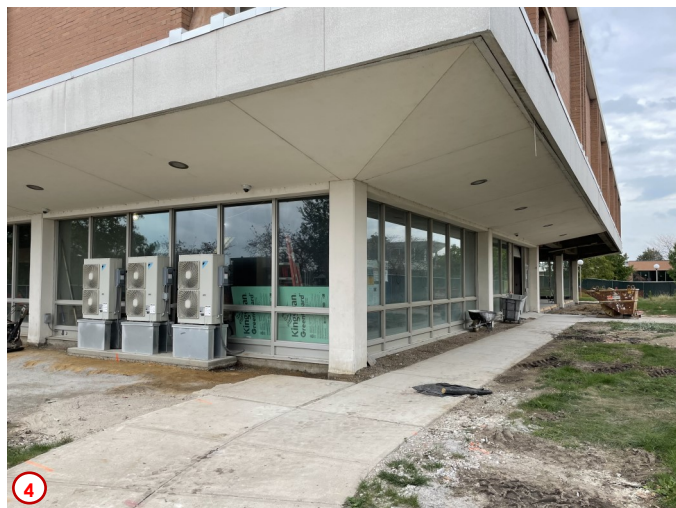
Photo #4 was taken at the southwest corner of the building and shows some site cleanup that was necessary for the targeted basement waterproofing to take place next week. The temporary scaffolding that was erected to convey building materials to the second floor has been taken down as well for now.

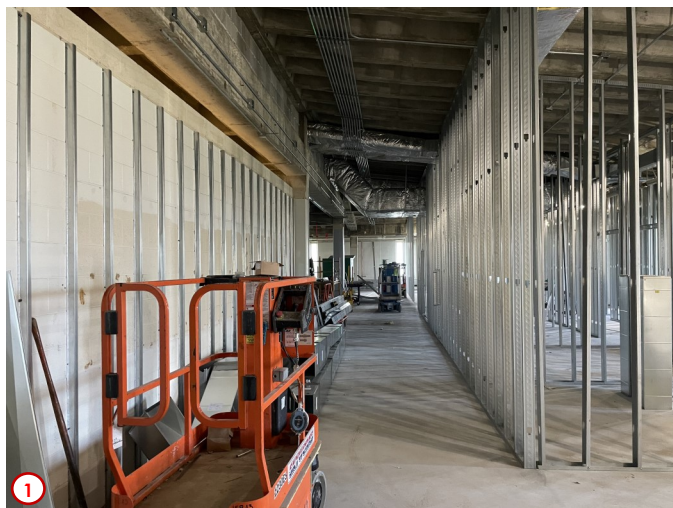
Photo #1 shows more the completed rough wall framing completed for the Humanities/Social Sciences Division Office Suite. There is still quite a bit of smaller areas that need to be addressed, but for now the contractors have moved onto other areas of the second floor to rough framing.

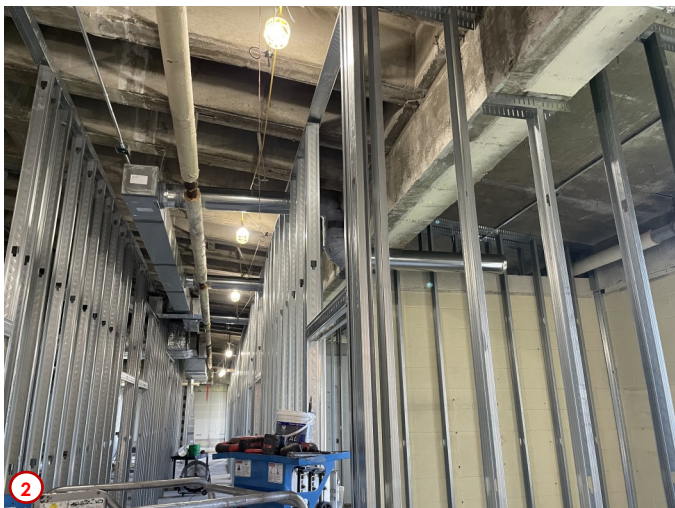
Photo #2 highlights some of the mechanical infrastructure that can be installed now that the rough framing for the H/SS Office Suite is complete. Here you can see the new ductwork running the length of the future corridor and even some of the branch lines that will provide heated or cooled air to the faculty offices. Next week the electricians will move into this area to start installing the in-wall electrical infrastructure.

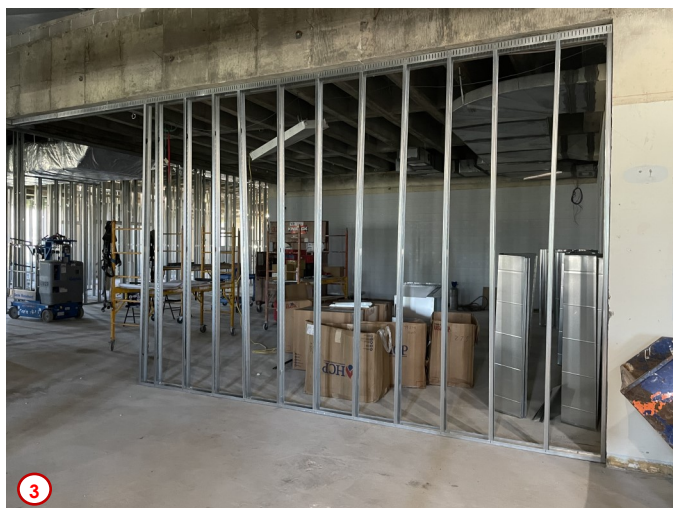
Photo #3 shows some of the rough framing going in for the future classroom that will occupy part of the space that formerly housed the LAL/ Disability Services and the Writing Center.

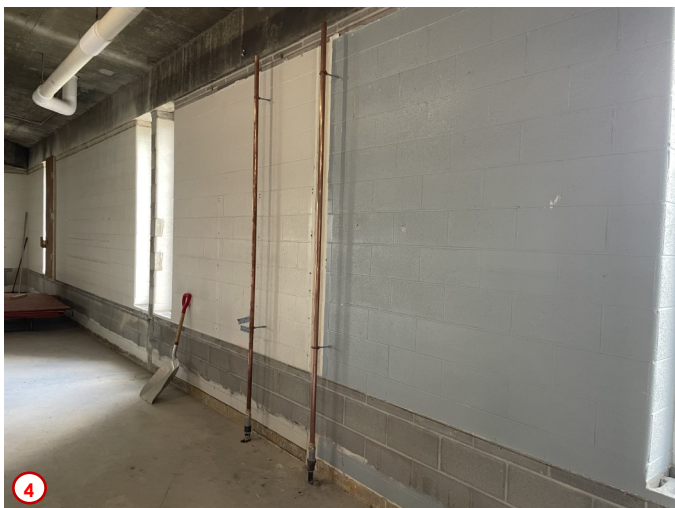
Photo #4 was taken along the west wall of the second floor near the west stairs and shows the very beginnings of the installation of the hydronic piping that will feed hot water to radiant panels that will line west wall and installed in the ceiling grid. These ceiling mount panels will replace the old units that used to line the base of the wall. The purpose of these panels is to help make up for heating or cooling loss from all the fenestration in the wall. This same scenario is happening in multiple places around the perimeter of the second floor.
