# Building Report | CLRC Renovations and Additions Project

10.22.21

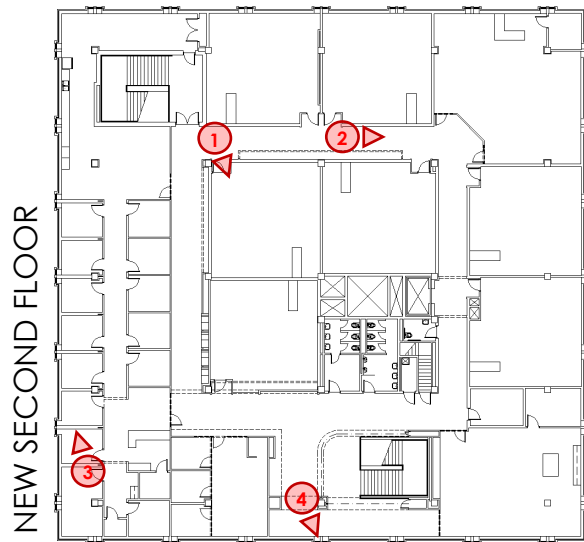
Photo #1 was taken near one of the classrooms on the second floor and shows some of the typical work being done there. At each of the classroom entrances the old entries were removed and new framing being installed to help further advance the efforts of making the building completely barrier-free and ADA compliant.
