# Building Report | CLRC Renovations and Additions Project

11.12.21

The following are pictures from the week ending in 11.12.21 in regards to the CLRC Renovations and Additions Project. There was a lot of activity this week as the targeted waterproofing for the basement began, new framing for some of the walls on the first floor was installed, and more of the in-wall infrastructure was finished on the second floor. There will be a concentrated effort to finish the waterproofing around the south face of the basement so that it can be backfilled so that the foundation system for the addition at the south-east corner of the building can be installed along with the pads for the existing condensers for the server room A/C units can be relocated to their new locations. A lot of coordination is happening with the architects, engineers, and college representatives as we all collaborate on finalizing numerous items such as furniture, security camera and access control locations, the library patron counting system, A/V integration throughout the building, etc. All of these need to be set prior to finishes being installed.

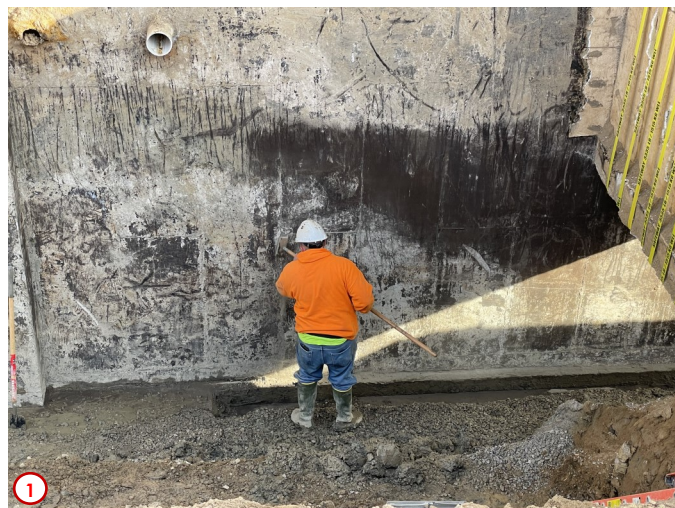
Photo #1 highlights the rather manually intensive process to prepare the surface of the basement walls to receive the waterproofing materials. The existing waterproofing materials have to be scraped off, and then the surface scrubbed so that it is clean in order to allow the new sealcoat and mastic for the drainage board to be properly secured.

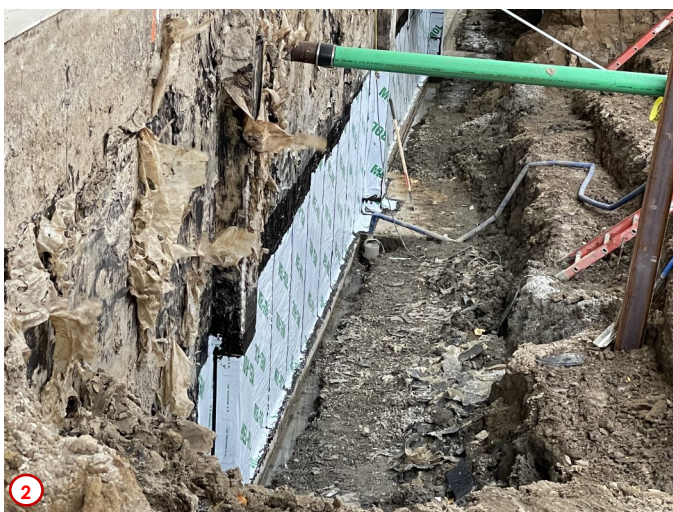
Photo #2 shows the first area of targeted waterproofing in place. For proper construction sequencing purposes once the new drain tile is in place adjacent to the existing footing this area will start to be backfilled in layers (or lifts). This is necessary so that the new fill can be properly compacted so that is capable of bearing the future loads from either the building addition or mechanical pads that will be located in this area in the future. This is extremely important because the new backfill needs to meet or exceed the bearing capacity of the in situ (or existing soil) as it has been tested and what the structural engineer for the project used as guidelines when designing the foundation systems for the project.

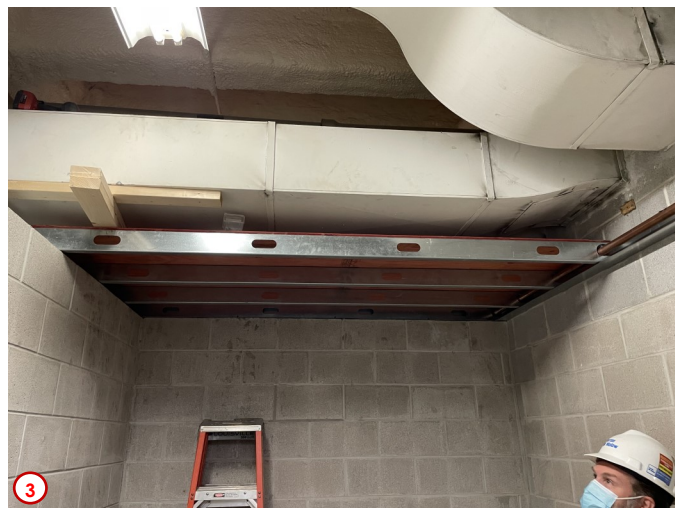
Photo #3 shows the beginnings of the framing for the ceiling system in the new janitor's closet in the basement. This room will receive a "hard lid" or gypsum board ceiling rather than a suspended system of grid and tile. Additionally, the framing is covered in fire-treated wood sheathing to protect the ceiling from anything falling through and to allow proper support for anyone wishing to access the mechanical systems in the area for maintenance reasons.
