# Building Report | CLRC Renovations and Additions Project

## 11.5.21

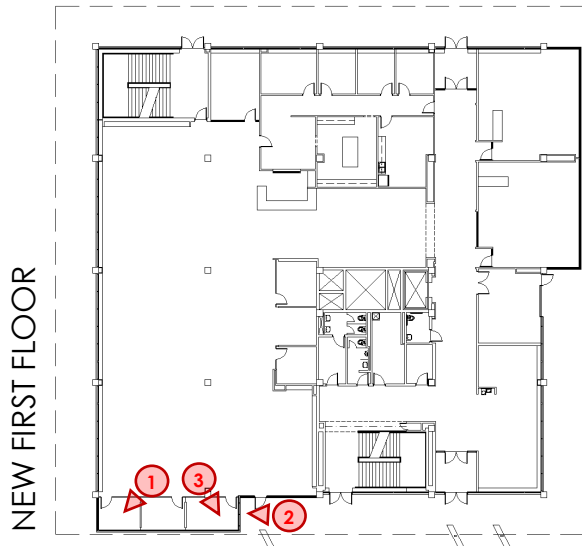
Photo #1 was taken earlier in the week and highlights the area of the addition to the northwest corner of the building and the now compacted fill in place. This fill will provide a solid base for the future concrete slab which will be installed in this area. In the foreground you can see the welded wire mesh reinforcing ready to be placed that will be imbedded in the future floor slab.

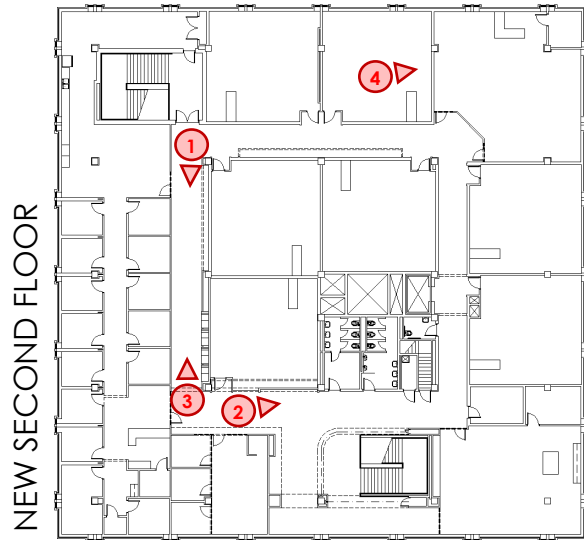
Photo #1 was taken in the new north corridor and shows a small portion of overall set of cable trays being installed that will be above the future suspended ceiling system. These cable trays will house the data cabling that will feed all of the future technology for the building.

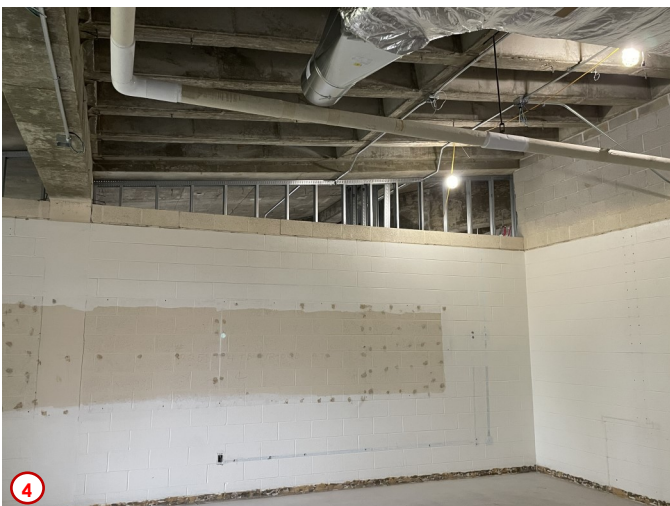
Photo #4 was taken in one of the existing classrooms adjacent to the future active learning classroom. Here some metal stud framing was added to the existing masonry wall that will be covered with board to help create a separation between the two classrooms for acoustical and heating/cooling reasons.
