Building Report | CLRC Renovations and Additions Project

12.23.21

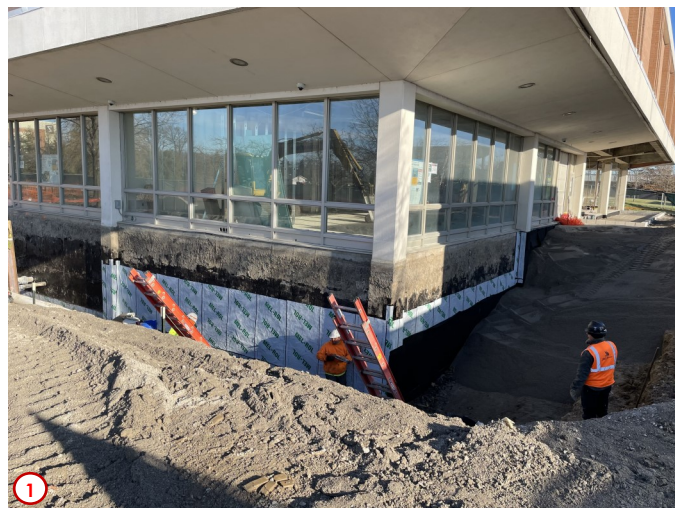
Photo #1 was taken earlier in the week as the contractors were finishing the targeted waterproofing on the west face of the basement wall. Here they are on the other side of the wall from Room C-17 which is where the main server room is for the campus. This waterproofing will help to provide yet another layer of protection to keep excess moisture out of that room and away from the very costly and sensitive equipment housed in that space.

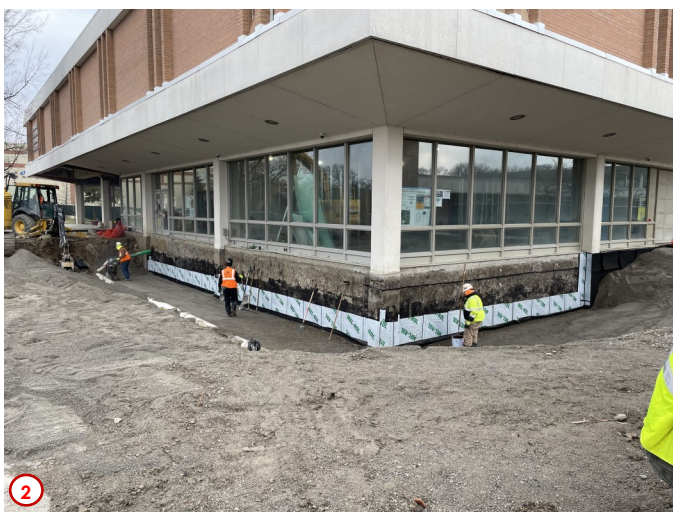
Photo #2 was taken later in the week and shows the process nearly completed. As of the day of this report that area has been backfilled which will allow remaining items that need to be completed in this area to begin. Some of these items include the installation of the entrance canopy that will angle out from the new entrance vestibule towards Parking Lot 7.

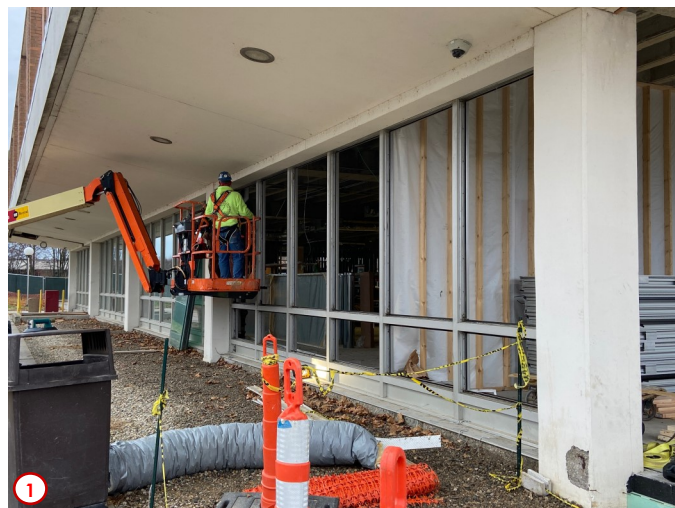
Photo #1 was taken earlier in the week and shows the glazing contractors installing some of the new curtain wall frames on the north side of the building. These new frame systems are thermally broken which means the exterior and interior faces are connected by an insulating gasket that helps prevent heat or cold transmitting via conduction. The old system was one piece which was not energy efficient.

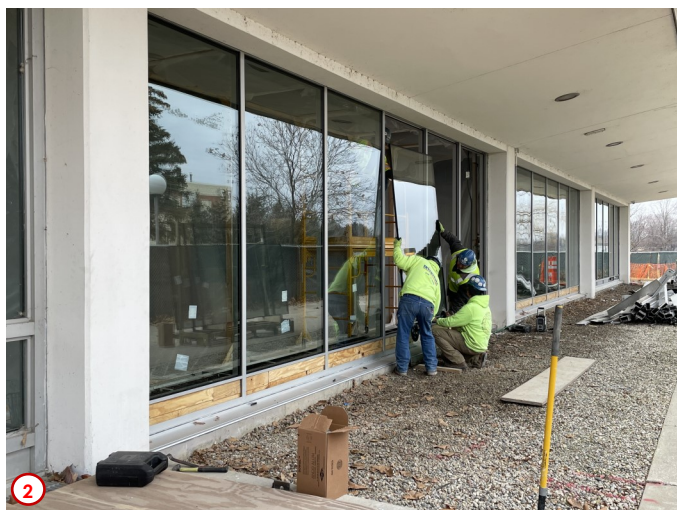
Photo #2 was taken later in the week and shows the glazing contractors installing a section of the double-paned glazing being installed into the new frames. This new glazing is not only much more energy efficient but also a "low-e" coating on it that protects the building interior from the harmful effects of UV rays. The old glazing did not have this coating, and this will help protect the books housed in the library stacks in this area from being faded by the sun.

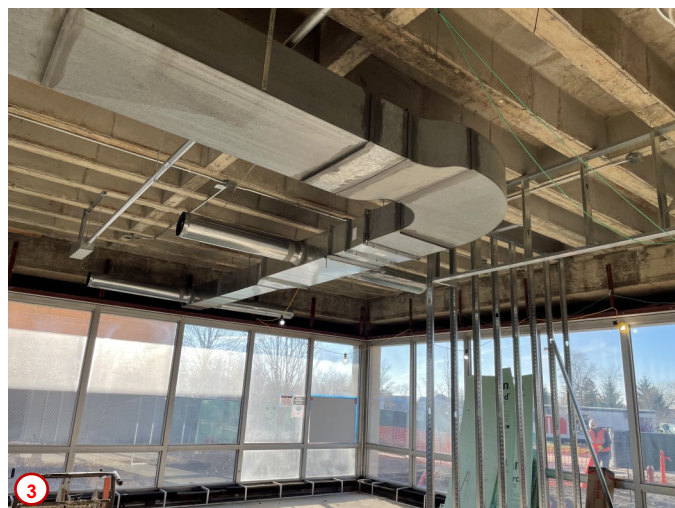
Photo #3 highlights the progress of the installation of more of the mechanical infrastructure on the first floor. This area is the future student commons area near the west entrance (nearest Lot 7), and prior to the renovations was the quiet study area of the Library.

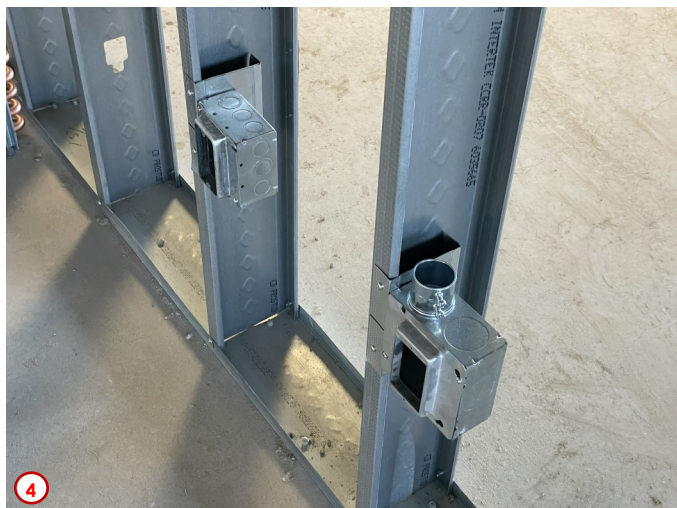
Photo #4 shows the very beginnings of the installation of the in-wall electrical infrastructure on the first floor. This means that the majority of the above ceiling electrical work is now complete. Once all the in-wall work is completed and inspected, then the acoustical insulation can be inserted before the wallboard is installed.

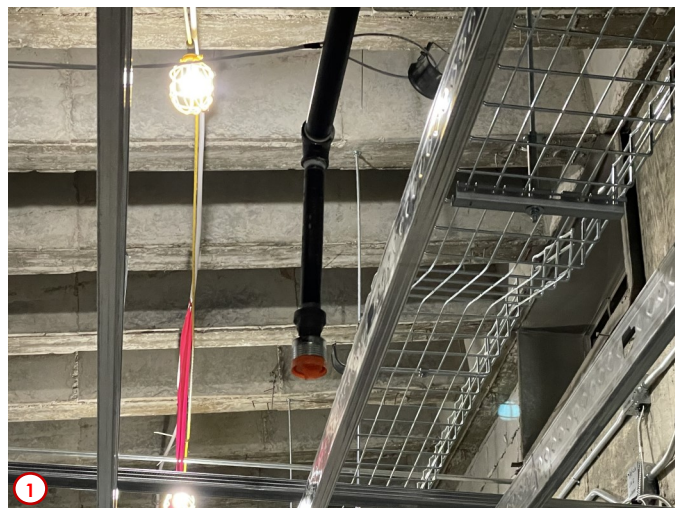
Photo #1 shows the continuing work to finish the fire-sprinkler systems on the second floor. With all the trunk and branch lines installed now the focus is on placing all the drops and the heads. In fact, they were completed this week and so next week the contractors will move to the first floor to start the installation of the fire-sprinkler system on that floor which will mark another milestone for the project.

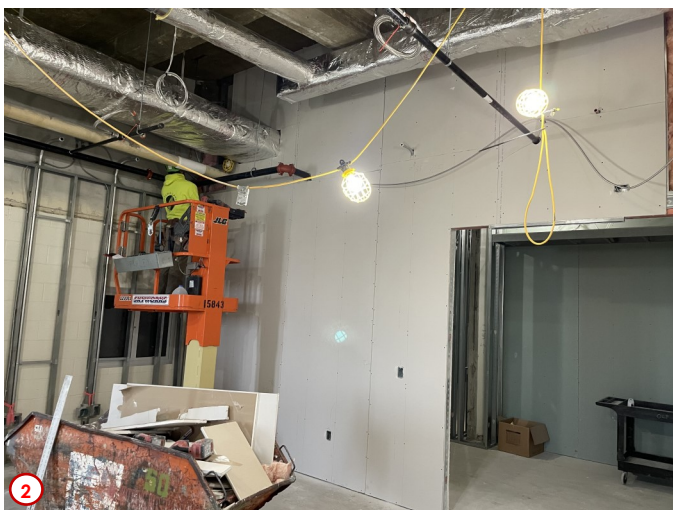
Photo #2 shows the work being done to install more of the wallboard on the second floor. This area happens to be in the new H/SS Office Suite, specifically the area which will serve the adjunct faculty. This area used to be part of the old north corridor on the second floor, but is now part of the secured office suite for the faculty.

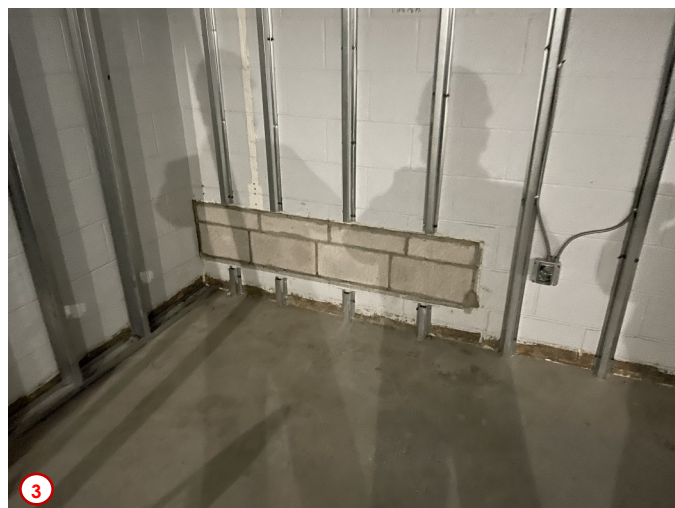
Photo #3 shows another area where an old HVAC return air-grille has been filled in. While this may seem rather insignificant it is rather important as more of the second floor's new mechanical infrastructure is now complete. Now the majority of the heated or cooled air will be supplied and returned through the ceilings for the majority of the floor.

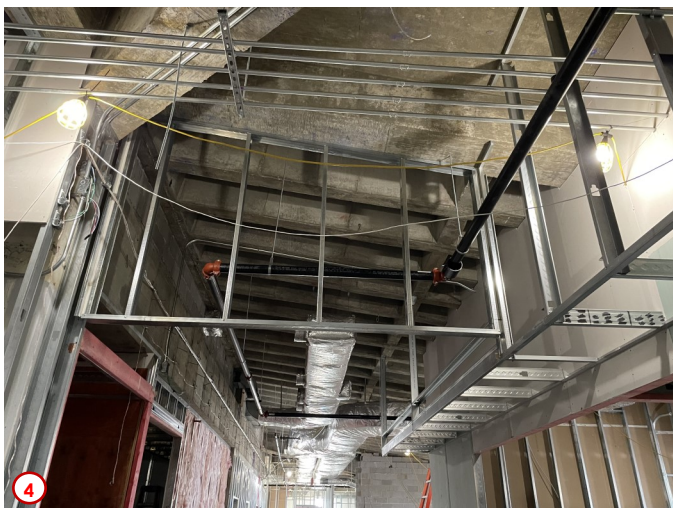
Photo #4 highlights more of the rough framing being installed on the second floor. This area is a bulkhead on the second floor near the future Writing Center, and will serve as a transition for the wood-slatted ceiling in the student commons area and the suspended acoustical ceiling in the north corridor that runs between the interior classrooms and the H/SS Office Suite.
