Building Report | CLRC Renovations and Additions Project

8.20.21

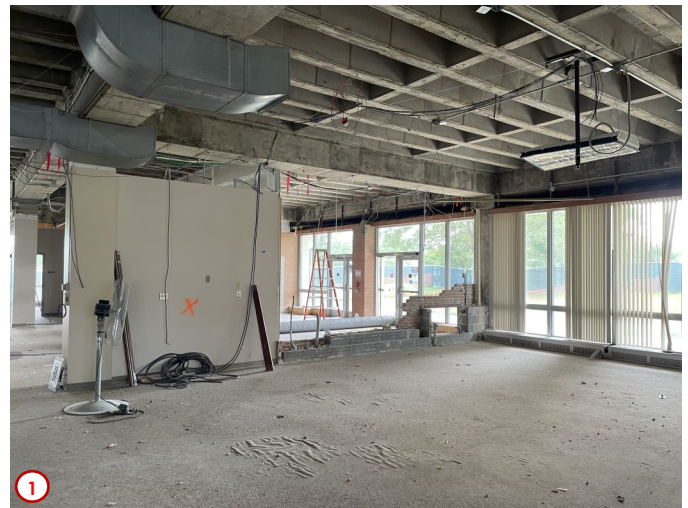
Photo #1 was taken over near the soon to be demoed library circulation desk looking towards the old entrance. As you can see the walls in that area have started coming down to make way for the new framing for the staff office suite and student conference room that will reside in that space.

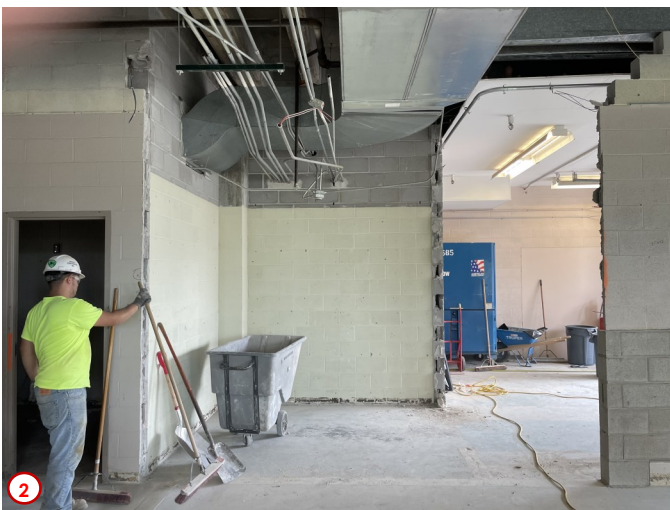
Photo #2 shows the progress of demolition that is happening near the area of the elevator. This work is very symbolic as these walls are the last remaining barriers that stand and soon will be gone so that this building will finally be barrier free and therefore ADA compliant. After all of the walls surrounding the existing elevator shaft are gone the contractors can start erecting the new framing that will become the new first floor corridor that will connect the new east and west entrances as well as allow free access to the vertical circulation routes.

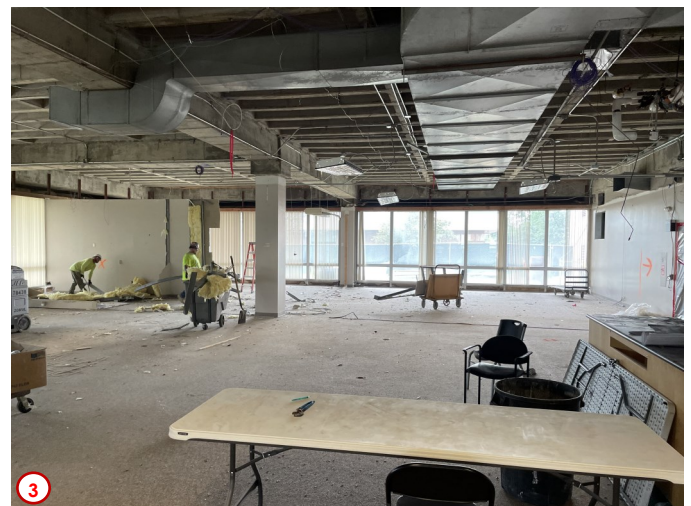
Photo #3 provides a glimpse into the demolition work being done to remove all the old walls that were part of the library staff offices, and reference collection area. One of the new additions will be connected onto that area which will house a classroom and computer lab. Additionally, part of that area will be the new main circulation corridor, the library main entrance, and part of the staff office suite. After all the walls are down the remaining carpeting will be pulled up, and then any existing mechanical and electrical infrastructure that needs to be removed to allow new construction to happen will be demoed as well.

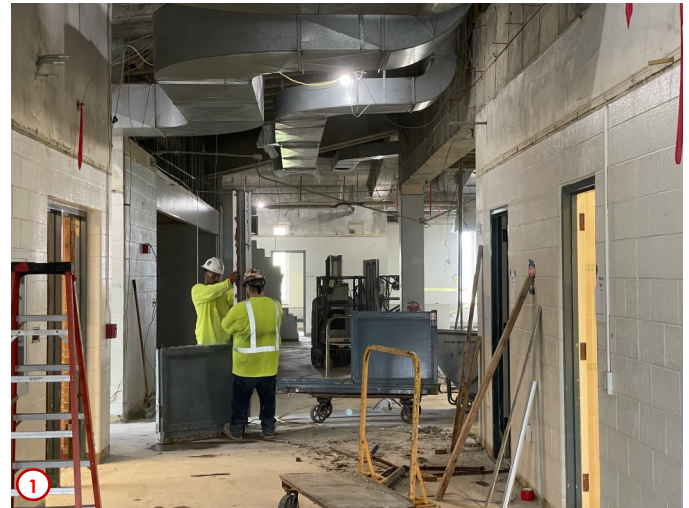
Photo #1 was taken last week when the remnants of the entrance and west walls of the LAL were being taken down. That area is now clear and part of it will become a new corridor, the rest will be part of the new Writing Center, and a classroom.

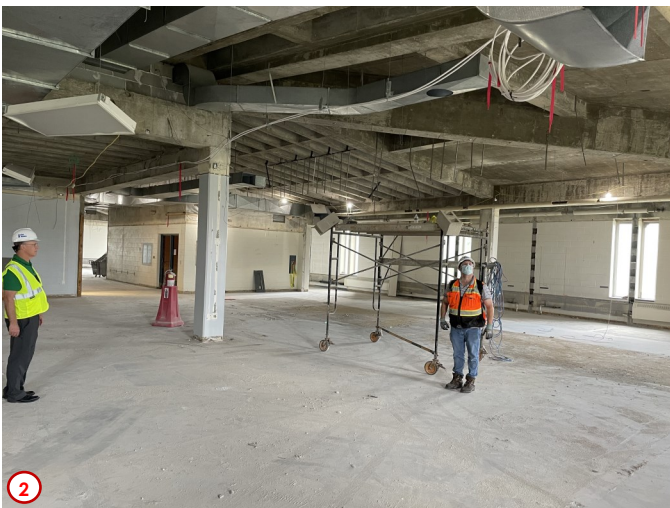
Photo #2 is a photo of the old LAL but taken this week and shows that the remainder of the walls are now gone along with those of the faculty offices lining the west wall of the second floor. In the background one can see where the western stair tower ends at the second floor. This stairwell will be opened up so that the space is even more welcoming. In order to ensure building occupant safety new fire protection systems will be installed. The final version of these systems are being worked on by both the architect and construction manager so that they are in compliance with state fire bureau mandates.

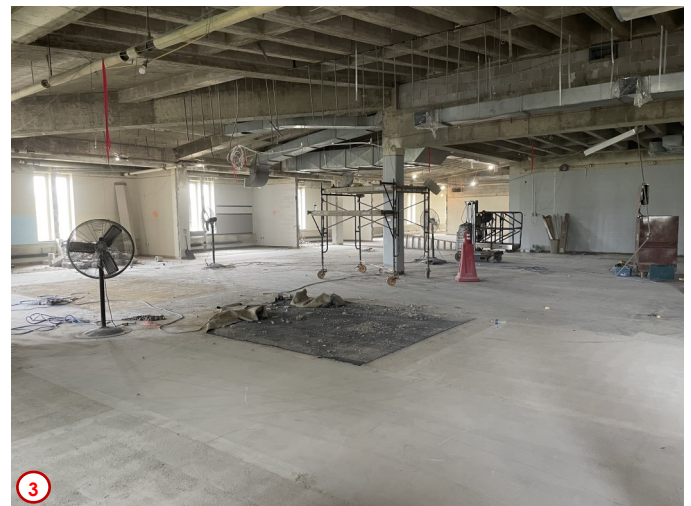
Photo #3 was taken this past week in the old LAL area, and looking northeast towards the now demolished faculty offices lining the north wall of the second floor. Again in this area there will be a new faculty office suite, circulation corridor, and classroom built.

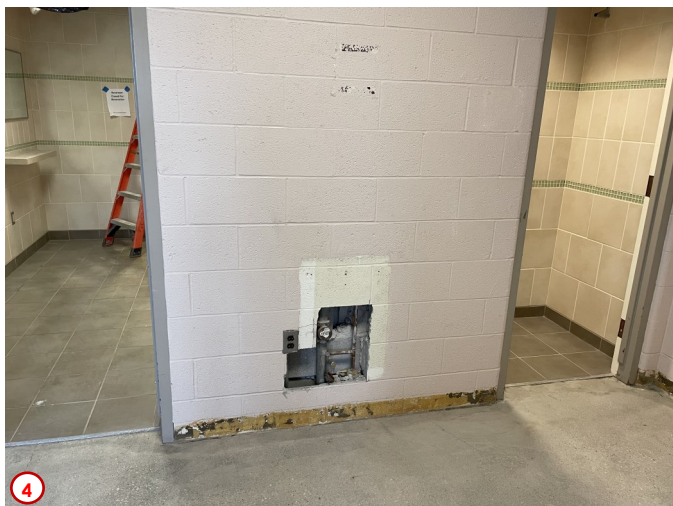
Photo #4 shows the progress of the demolition of the existing plumbing fixtures on all three floors of the building. The old electric water coolers are being removed and replaced with new ADA compliant units. These new units will also have water filling stations incorporated into them as per our new campus-wide standards.

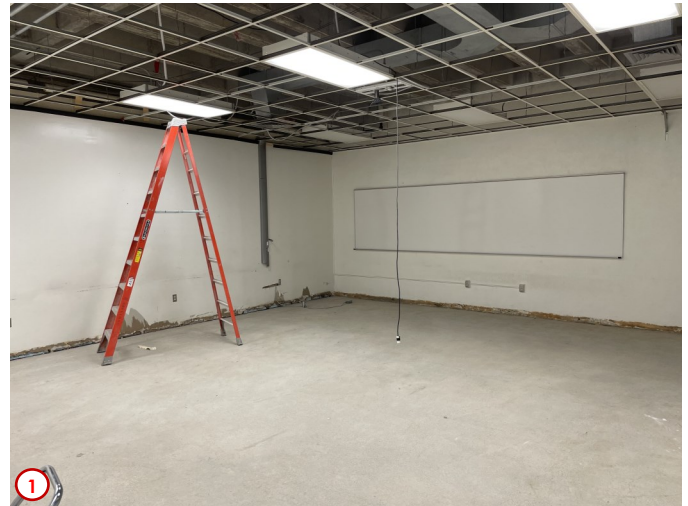
Photo #1 shows the progress of the typical demolition happening in all of the existing basement classrooms. You can see that all of the old tile has been abated and the mastic removed as well leaving a clean floor slab for the new carpet squares to be glued down at a later time. The existing ceiling tile and grid will be removed along with the lighting so that the new fire sprinkler lines can be installed along with the new ceiling and LED lighting.

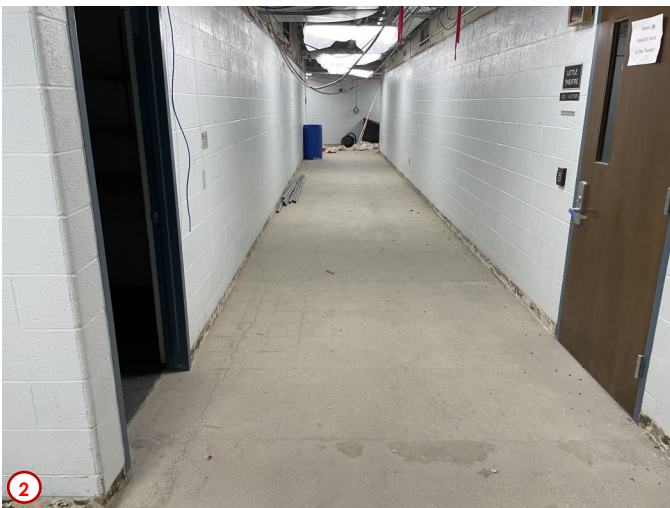
Photo #2 highlights the eastern corridor outside of the Little Theater. Similar to the classrooms the old floor tile has been abated and removed along with the old wall base. This area will receive new paint, ceiling and lighting, and flooring with associated wall base.

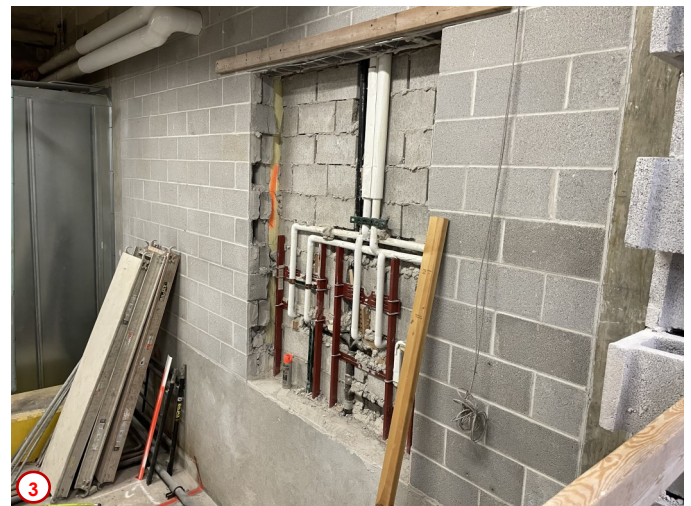
Photo #3 highlights the progress of re-plumbing the existing basement restrooms. Here one can see the backside of the plumbing chase wall has been opened exposing the existing galvanized steel piping. This piping will be replaced with new copper hot and cold water domestic water lines which will greatly improve the water quality in the building.

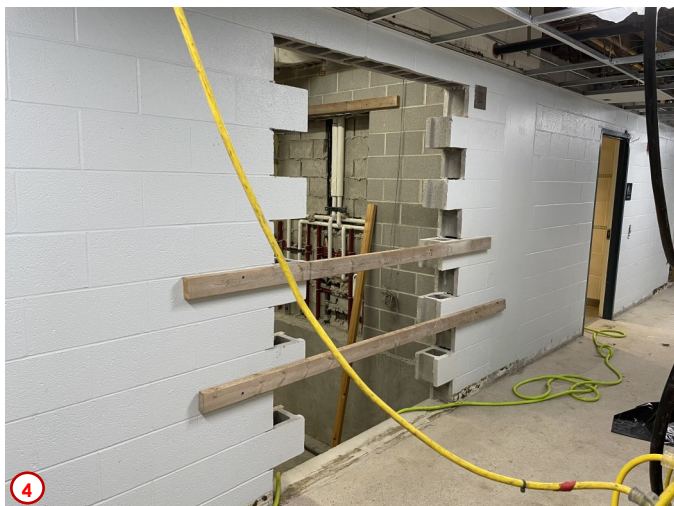
Photo #4 shows the progress of the construction for the new janitor's closet in the basement. Here one can see the new rough opening for the door into that space. The next phase will be for the contractors to tooth in new concrete block and install the new door and frame. However, this will not be finished until the new walls and floor slab are in for the closet.
