# Building Report | CLRC Renovations and Additions Project

9.17.21

The following are pictures from the week ending in 9.17.21 in regards to the CLRC Renovations and Additions Project. Excavation work has started so that buried utilities can be reworked and/or new installed in preparation for the additions on the south and west side of the building. Additionally, major demolition is entering into its last phase as the west stairwell will soon be entirely exposed. Some minor areas of additional demolition started this week on the second floor. Due to some concerns over some structural integrity and original construction practices all the entrances to the existing classrooms have been removed to make way for new construction. The added benefit to this is that it will allow us to better guarantee that all the entrances to the classrooms will be ADA (Americans with Disabilities Act) compliant where previously they were not. A lot of materials are set to arrive in the next few weeks and so there will be walls, bulkheads, etc. being installed as the both the interior and exterior start to take shape and match the architect's plans for the building.

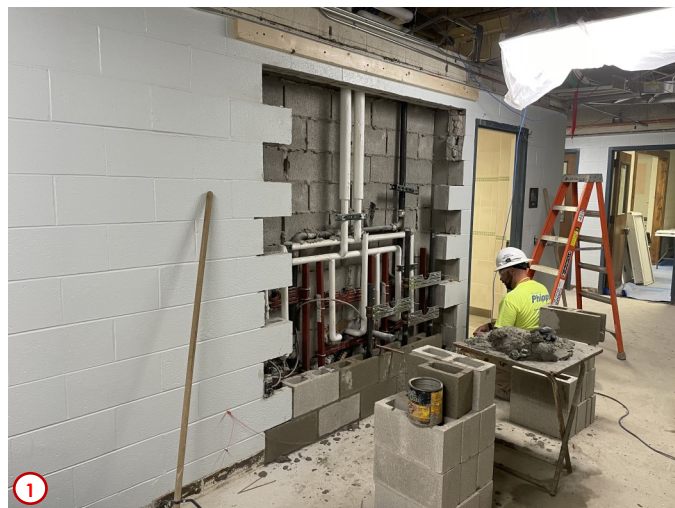
Photo #1 shows the masonry contractor starting to fill in the opening that was created near the plumbing wall for the Men's Restroom in the basement of the CLRC. This area was opened up so that the old problematic galvanized steel domestic hot and cold water lines could be replaced. The new copper piping has been installed, insulated, and passed its code required pressure test which means the new masonry could be installed.

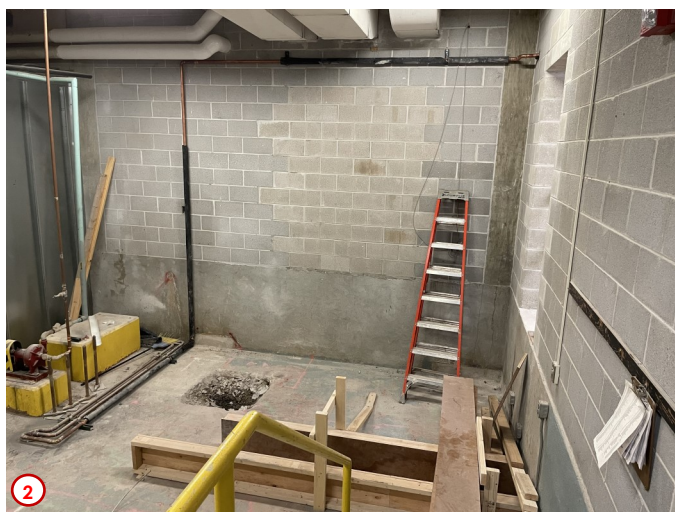
Photo #2 shows the beginnings of the placement of the forms for the new custodial closet that will take over the corner of the Mechanical Room in the basement of the CLRC. Originally the floor slab was to be cut open so that the new footings could be installed, however after the area was scanned by radar the number of utilities running through this area caused a change to be made. So the structural engineer came up with an alternative solution for the foundation design which the contractors will use to construct the room. Additionally in the photo one can see the re-routed drainage line along the wall in the back which helps drain the mini-split cooling systems in the main server room across the hall, and the slab being opened up to install the code required oil separator for the new janitor's closet drainage line.

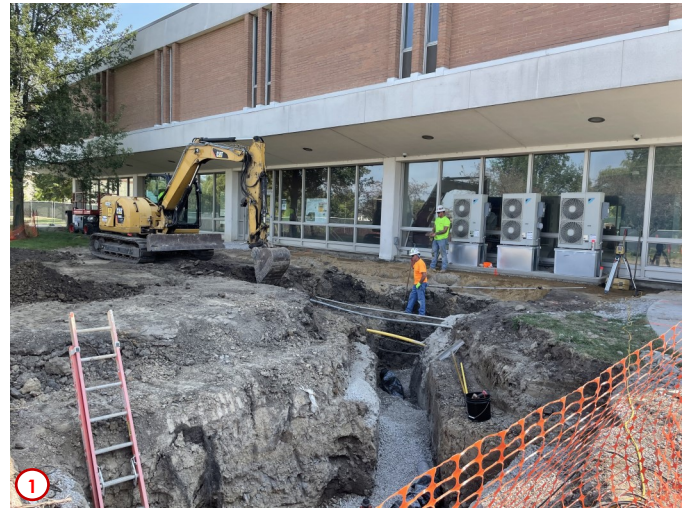
Photo #1 was taken outside the southwest corner of the building and shows the efforts of the excavation contractors to expose some of the existing utilities in the area and to prepare the site for new utilities that will help support the equipment and activities planned for the building interior.

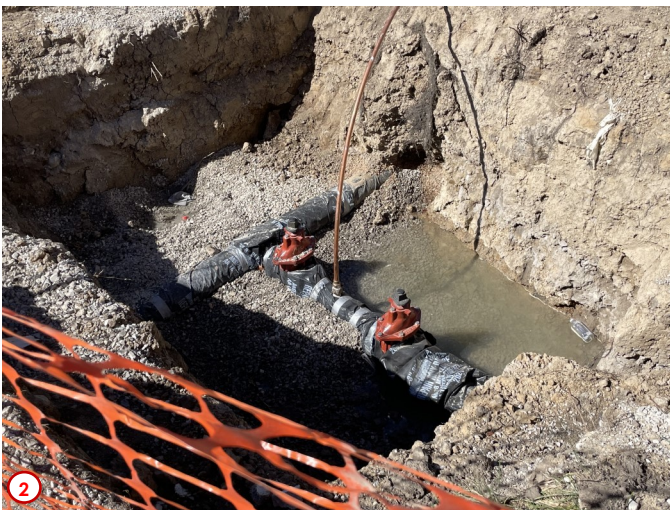
Photo #2 is located in the same area as Photo #1 and is a close up showing the new connection needed to the existing domestic water loop on campus that will eventually supply the water for the new building-wide fire sprinkler system. This particular connection will eventually lead into the new basement fire riser room.

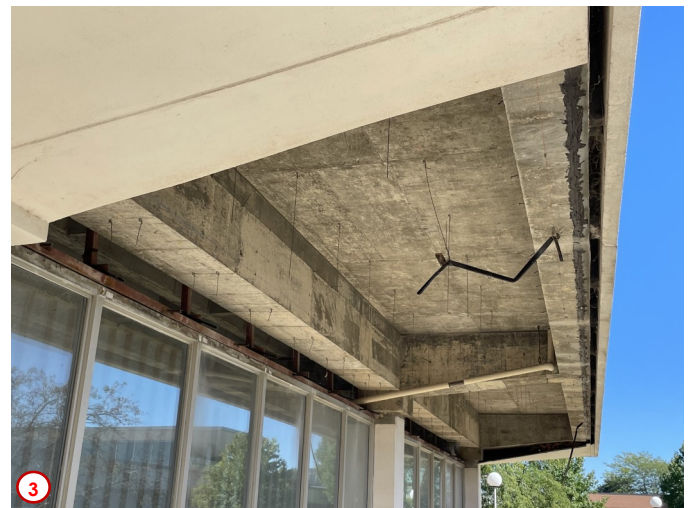
Photo #3 shows the existing soffit on the southeast corner of the building to be removed to help prepare the area where the addition will later be constructed. This addition will consist of a new classroom and computer lab that will support a number of divisions and groups across campus.

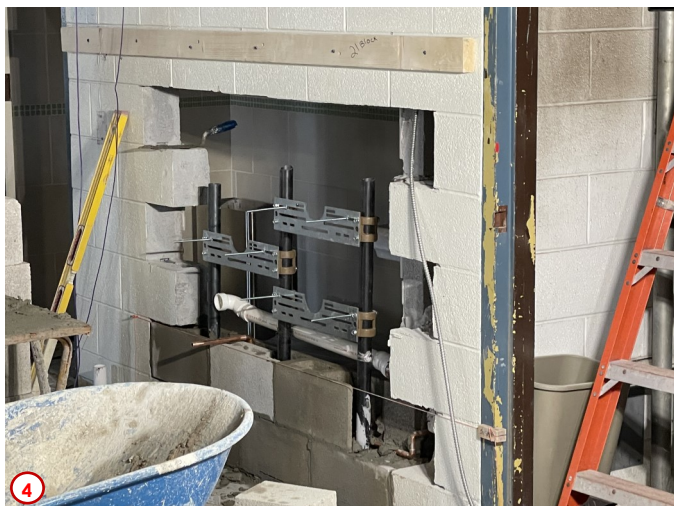
Similar to Photo #1 that was taken in the basement Photo #4 shows the work of the masons as they close up the openings in the existing concrete block walls on the first floor near the restrooms. This area will be the location of the new electric water coolers that will serve the first floor. There will be two with one being mounted lower to meet ADA compliance and will also feature a bottle filling station as per our new campus-wide standards.

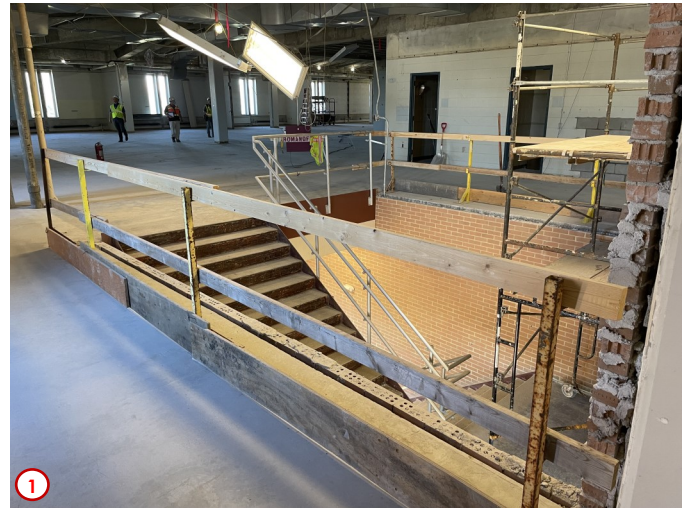
Photo #1 was taken in the area of the former office of the Dean of the Business Division and shows the now opened west stairwell on the second floor of the CLRC. Later this area will be where the contractors will be framing in the pocket where the fire curtain will be housed until needed.

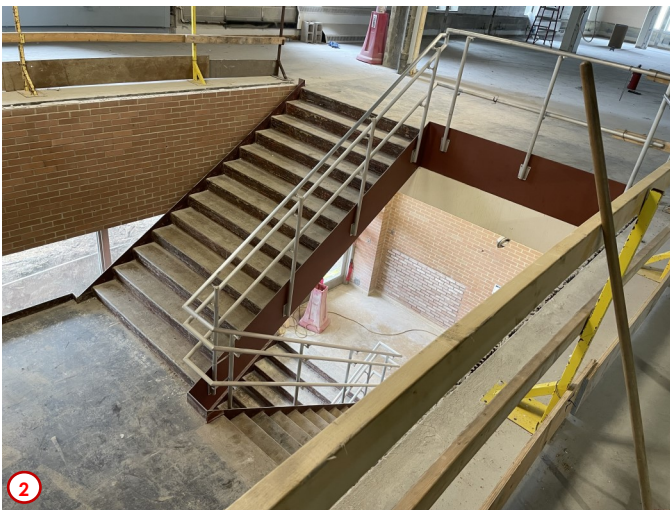
Photo #2 is of the same west stairwell but looking from the opposite side. You can see just how well removing the enclosing walls opens up the area as intended by the architects, allows in much more natural light into the area, and creates a stronger vertical connection between the first and second floors.

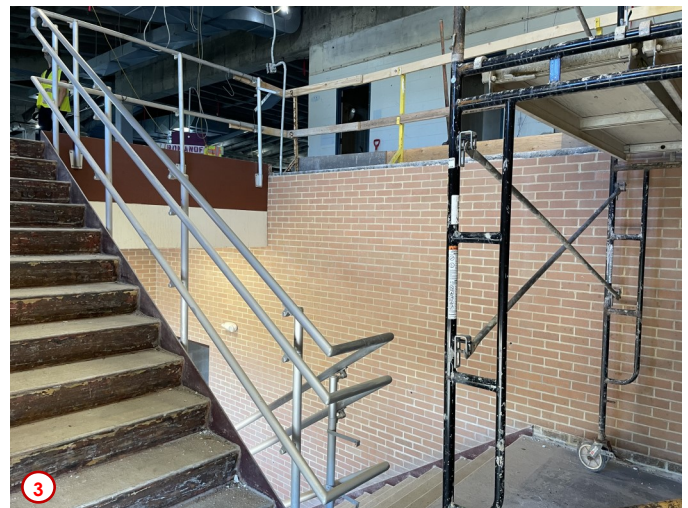
Photo #3 is again of the same stairwell, but was taken from the intermediate landing. Soon the wall in the background will be removed as well and building occupants will be able to see both floors at the same time while navigating the stairs.

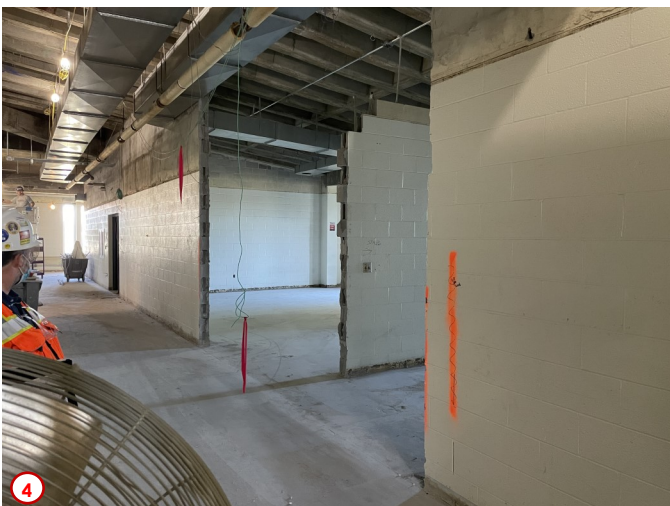
Photo #4 highlights one of the areas of additional demolition that was mentioned in the summary at the beginning of this report. This area was where two existing walls were removed due to some concerns about their long term viability. Now the contractors will be able to frame in new entries into these classrooms that will be both secure and ADA compliant.
