Building Report | CLRC Renovations and Additions Project

9.24.21

The following are pictures from the week ending in 9.24.21 in regards to the CLRC Renovations and Additions Project. This project is progressing very well and soon will shift from primarily demolition to a lot more new construction. In response to this this report will be the last to show the former building plans, and then starting next week proposed building plans will be featured. This way we can focus less on "what was" to "what will be!" Demolition will start to wind down on this project as the contractor estimates they are somewhere between 95-98% complete with removing what needs to go to facilitate new construction. Some planned and unplanned site work will start next week that is required before the foundations for the additions on both the south and west side of the building can take place. Along with the foundations for the additions starting soon those for the two new canopies that will be erected on the east and west side of the buildings will start soon as well.

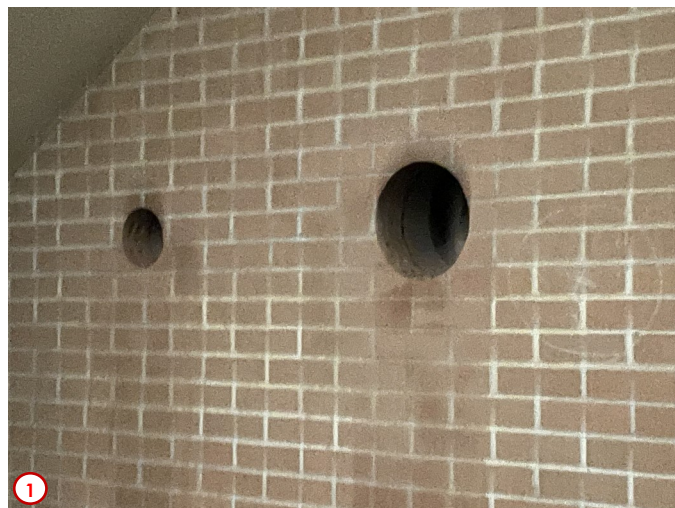
Photo #1 shows the completed bores for the new fire riser supply line and fire department connection in the new fire riser room in the basement under the west stair tower. The larger hole will be for the connection from the fire riser to the existing domestic water service loop on the west side of the building. The smaller hole will house the line feeding off the new fire riser to the fire department connection outside the building which allows them to hook up a truck to supplement the water in the building-wide fire sprinkler system.

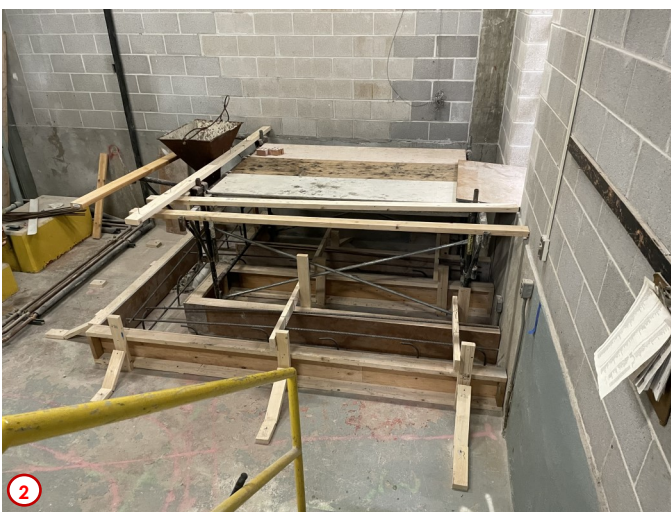
Photo #2 highlights the finished formwork for the foundations for the new Janitor's Closet in the basement. The reinforcing steel bars have been placed, and next week the contractors will be placing and finishing the concrete so this portion of the project can move ahead as planned.

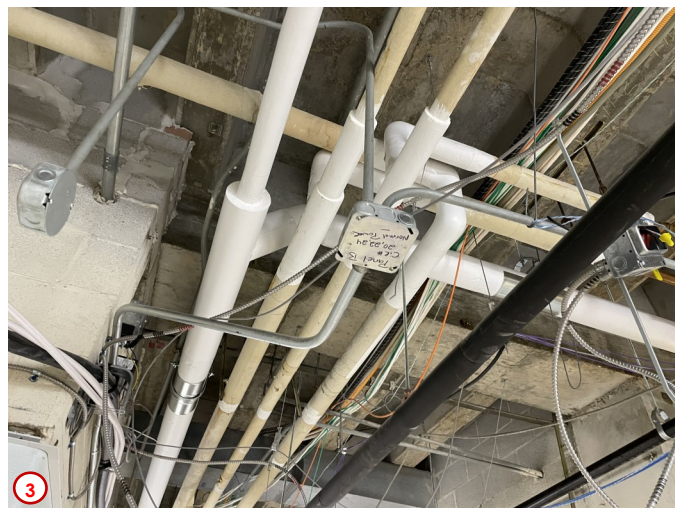
Photo #3 was taken in the southwest corner of the corridor system in the basement. The newly installed pipe insulation, which is the brighter white segments in the photo, was recently completed. This insulation is necessary to help prevent loss of heat or cooling in both the domestic and hydronic piping systems, and also prevent the pipes from "sweating" and ruining the future acoustical ceiling tiles that will conceal of the infrastructure featured in this photo.

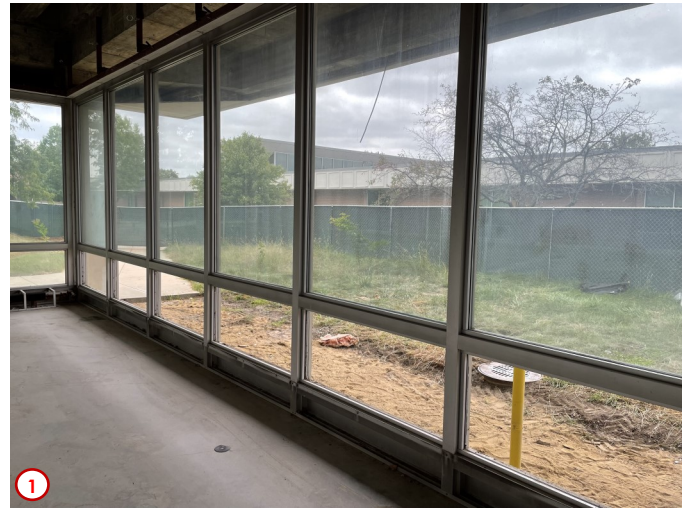
Photo #1 was taken just inside the southeast corner of the first floor of where the library offices were located. Here you can see that the contractors have started removing the glazing sections from the existing curtain wall system in preparation for removing the frames as work on the classroom and computer lab addition progresses.

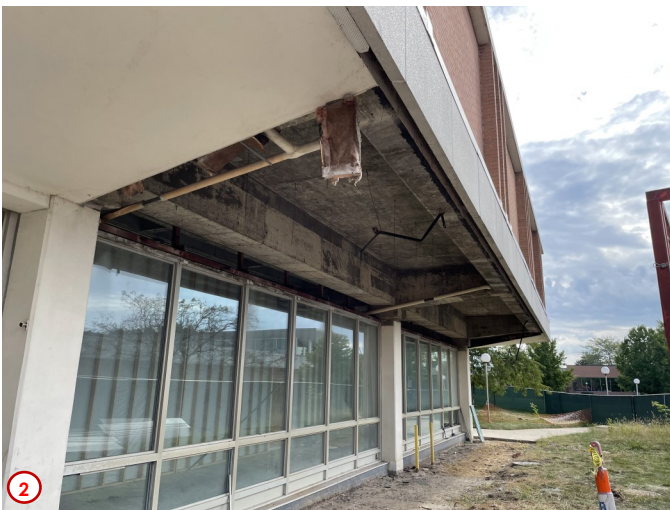
Photo #2 was taken just outside the building in proximity to Photo #1 and shows that the remaining portion of the existing soffit that needed to be demoed in preparation for the addition has been removed. Next week the contractors will conduct some abatement and demolition work on some existing site drainage structures in this location in preparation for the construction of the foundation system for the addition can begin.

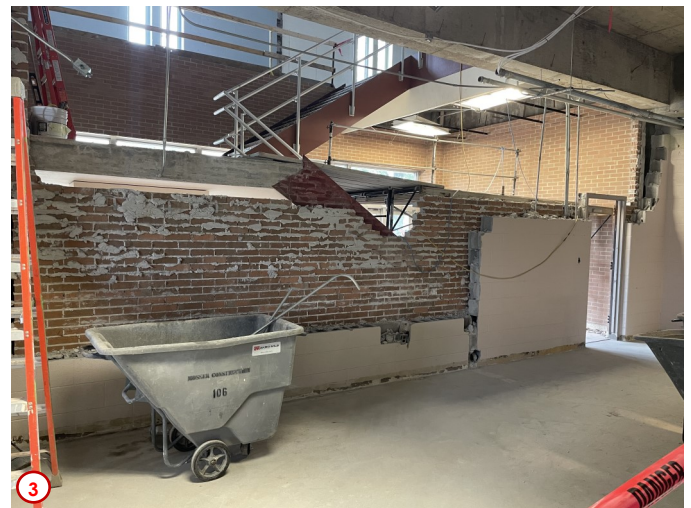
Photo #3 show the progress of the continuing demolition of the remaining brick and block walls surrounding the west stair tower. This demolition work should wrap up next week as the project starts to transition from demolition to new construction.

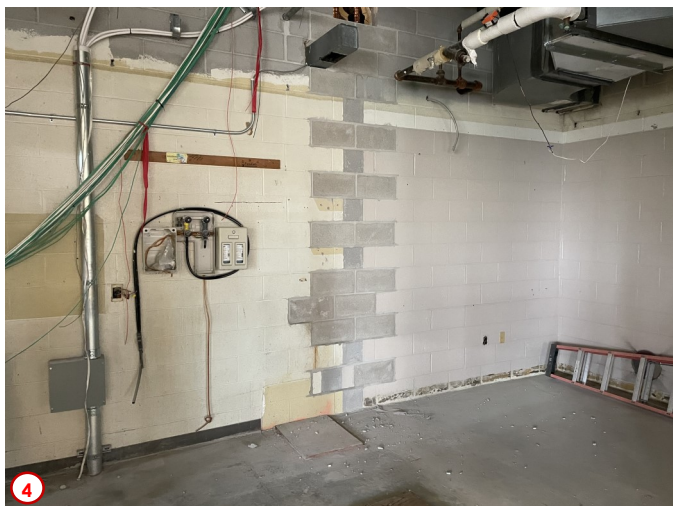
Photo #4 shows some additional infilling of the existing concrete block wall that used to separate the old janitor's closet and staff lounge. The new block were tuck-pointed in and new framing and finishes can be installed in accordance with the architect's plans for the new layout of spaces in this area.

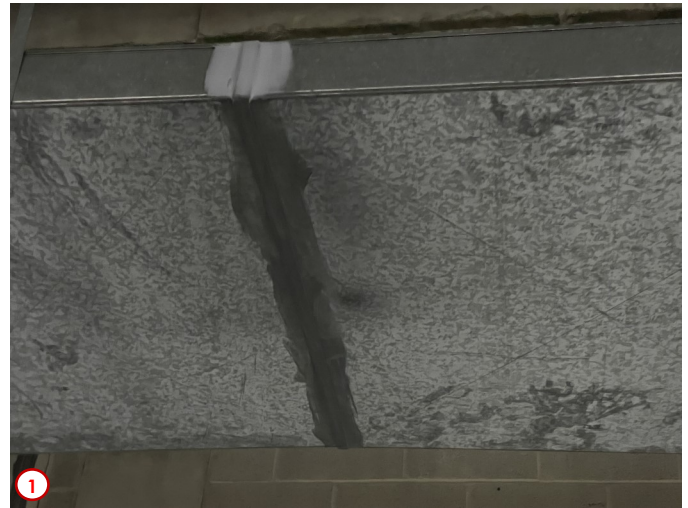
Photo #1 was taken in the area that used to be the LAL on the second floor. Here you can see the existing ductwork that will remain has been sealed at the joints and soon will be insulated. All this is in an effort to bring the existing mechanical infrastructure up to the current building code's energy conservation standards similar to what any new ductwork will be like after it is installed.

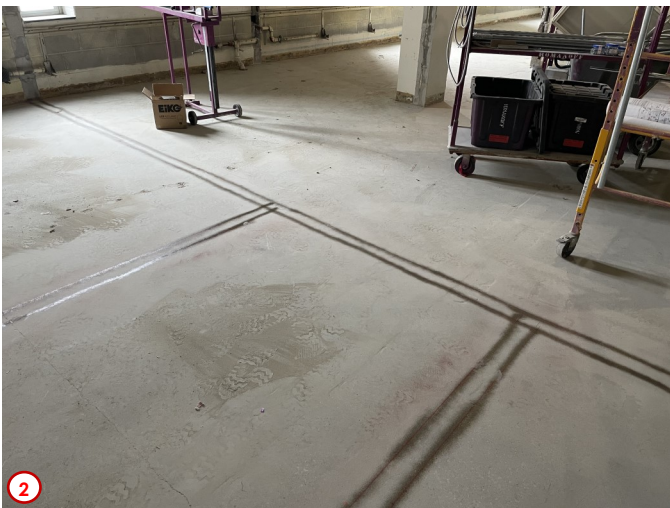
Photo #2 shows the floors being marked with the layout of the new walls that will soon makeup the new H/SS Division Office Suite. The metal floor track and studs will start to be placed next week as more new construction starts to happen on all three floors.

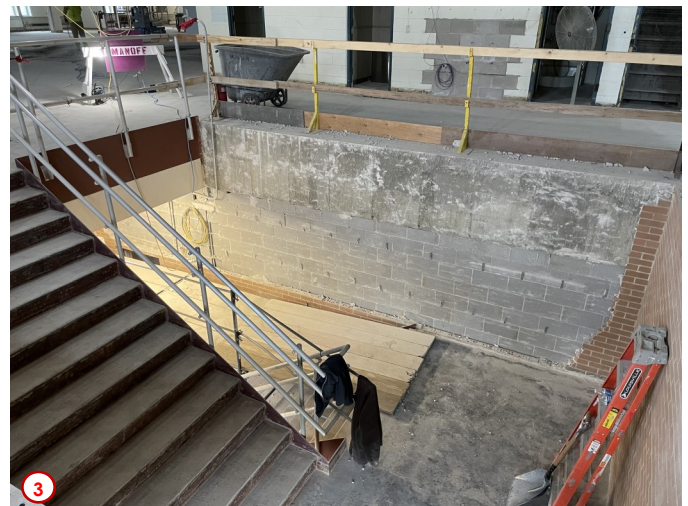
Photo #3 is similar to one taken last week, and was included to give an update on the continuing demolition of the old stair tower enclosure at the west stairs. One can see in the background the existing concrete floor framing that is now exposed.

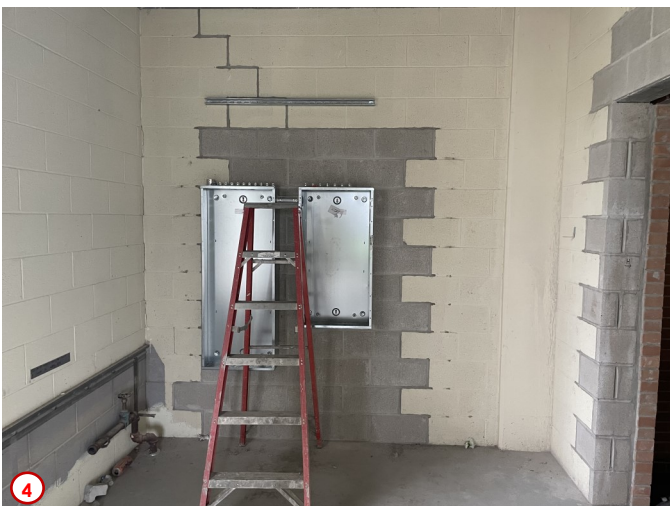
Photo #4 was taken in the area of where the new staff lounge will be located on the second floor in the H/SS Division Office Suite. Here you can see some of the new electrical panels were installed in what will be the future electrical closet in the south end of the space. This is all part of an effort to move the electrical panels from the public corridors into secured locations, and also to essentially help rewire the building so that the infrastructure can better support the proposed layout and future instructional equipment to be installed at a later time.
