Building Report | CLRC Renovations and Additions Project

01.14.22

The following are pictures from the week ending in 01.14.22 in regards to the CLRC Renovations and Additions Project. For this report there was little to no work completed in the basement, however there was on the first floor so I have included photos for that level on both the first and second page of this report. A lot in-wall or above ceiling mechanical, plumbing, and electrical infrastructure was completed so that wallboard can start in the next few weeks. The contractors started to tape and mud the joints in the wallboard on the second floor as that area is further along in the construction process. The foundations for the canopy on the east side were excavated, received the necessary reinforcing bars, and then received concrete. Next week the slab for the addition at the southeast corner of the building will be placed as well as the foundation for the future canopy on the west side of the building. Three more bays of new curtain wall were completed at the southwest corner of the building.

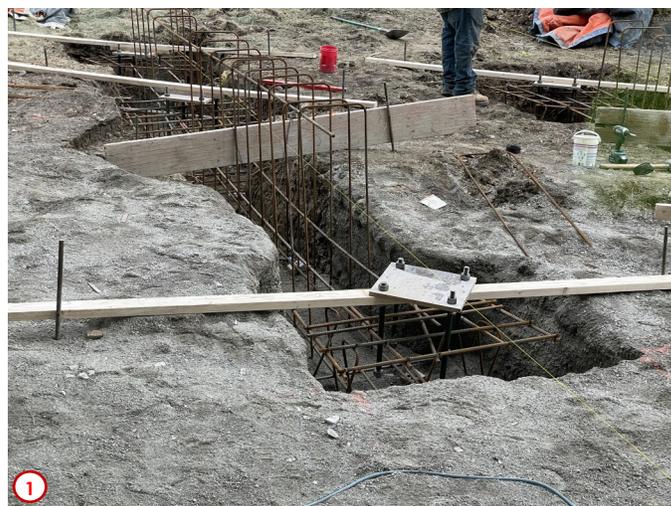
Photo #1 was taken outside the future east entrance on the first floor, and shows the trench excavated for the foundation system for the new canopy that will be installed in this area. You can also see the steel reinforcing bars and location for the anchor bolts will allow the structural steel to anchor to the foundation.

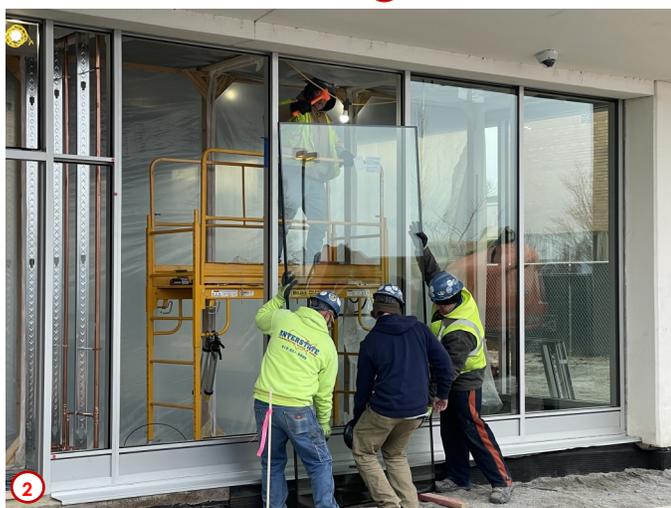
Photo #2 one can see the glazing contractors installing one of the many sections at the southwest corner of the building. Each of these sections of glazing weighs nearly 500 pounds. This area is where the future student lounge will be located. The contractors skipped other areas to install the frames and glazing in this area as it is directly above the main server room in the basement below. This was due to the favorable weather conditions on that day that was free of any precipitation.

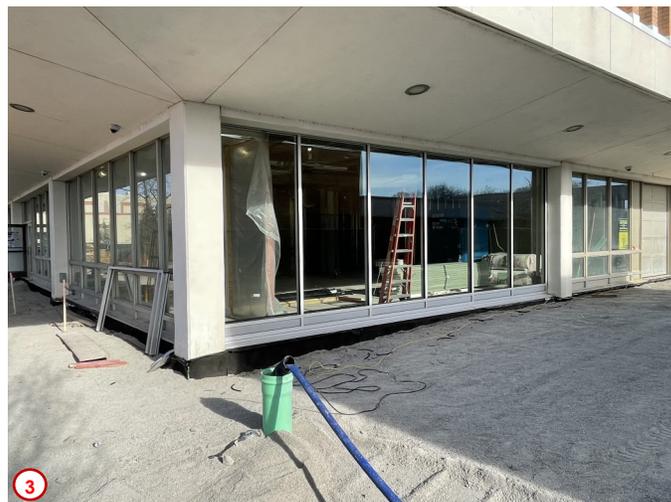
Photo #3 shows the completed southwest bay on the south face around the corner from the area featured in Photo #2. With this bay receiving its new curtain wall system this area is now completely enclosed and therefore weatherproof.

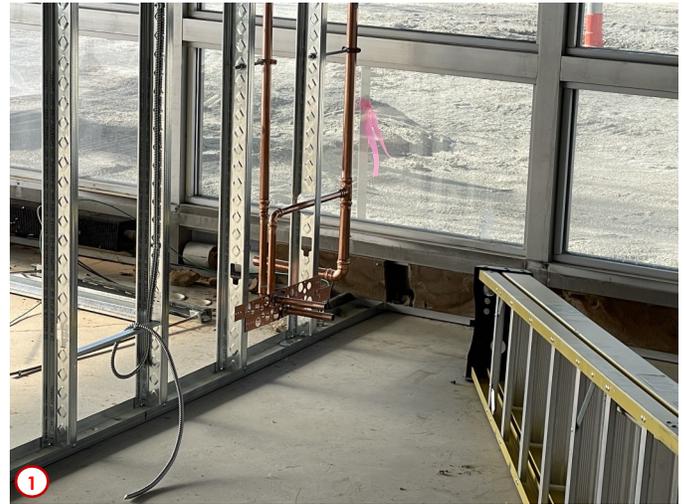
Photo #1 was taken in the area that will become the new east vestibule in the main corridor on the first floor. Here you can see more of the mechanical infrastructure now installed. Featured is the in-wall hydronic piping that will supply the unit cabinet heater that will provide supplemental heat.

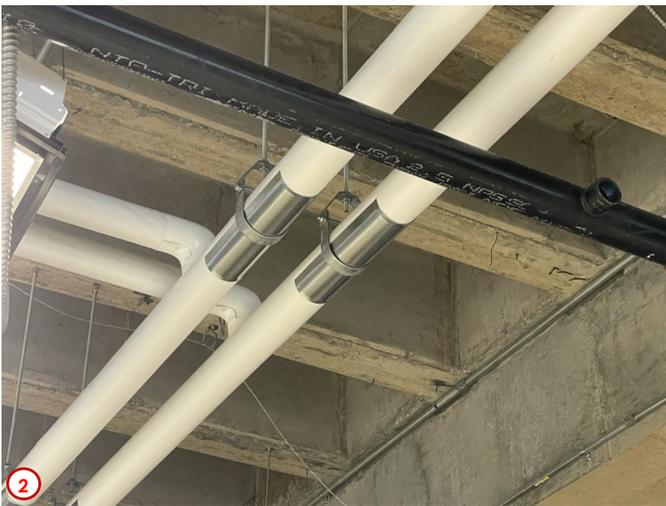
Photo #2 some of the many areas where the above-ceiling hydronic piping has been insulated on the first floor. This piping is above what will become the gallery area of the future Library space. The contractors are over 75% finished with their pipe insulating on the first floor.

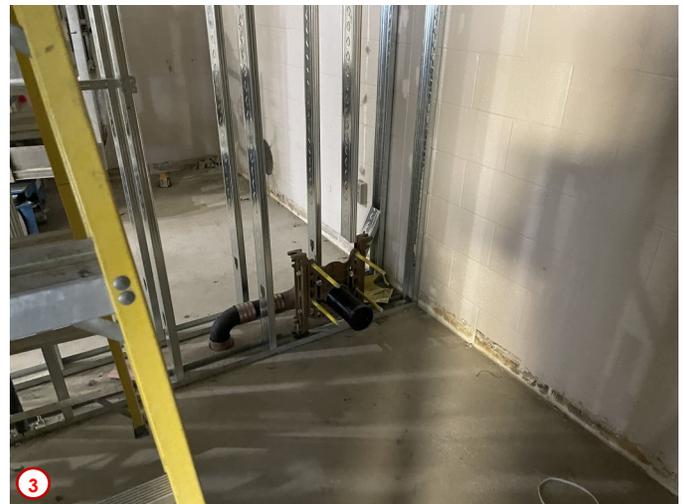
Photo #3 highlights the installation of some of the in-wall plumbing infrastructure needed. Featured in this photo is the carrier and waste line installed for the wall-mounted toilet in what will be the unisex restroom on the first floor.

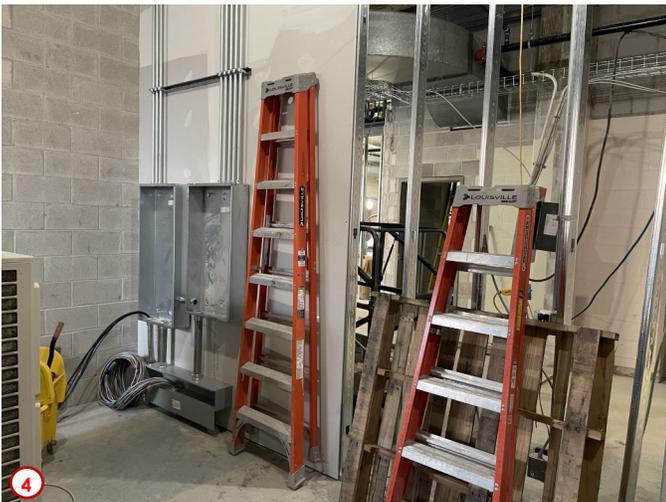
Photo #4 shows some of the new electrical panel tubs now installed in the area of the receiving area on the first floor. Much of the feeds needed coming from the basement electrical room have been pulled to this location. The electrical contractors will now begin to populate the tub with the panel and circuit breakers. When these are finished they can be energized and the existing panels set to be removed can be demoed.

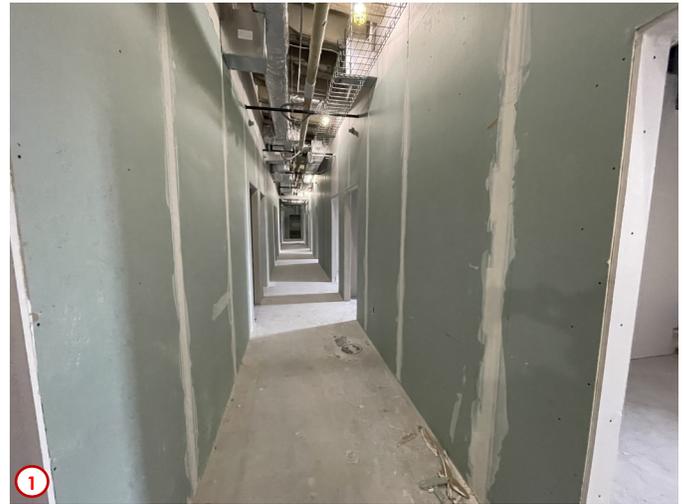
Photo #1 highlights the progress of the finishing of the wallboard on the second floor. The area featured in this photo is the corridor in the new H/SS Division Office Suite. Here you can see the joints for the wallboard being taped and mudded. Next week the contractors will start to sand the joints so that later the wallboard can receive its coats of primer and paint.

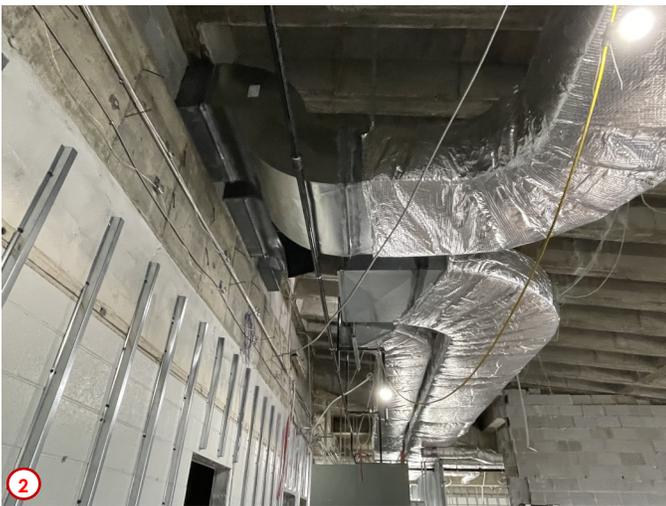
Photo #2 shows the aforementioned area of existing ductwork that had to be raised so as to allow the installation of the fire protection trunk line. Now the connections between the ductwork and the feeds coming out of the main shaft are being completed.

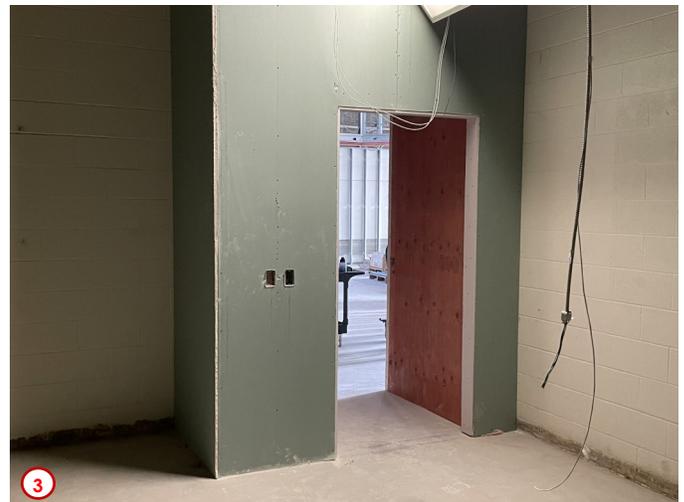
Photo #3 shows one of the many instances where the new ADA compliant entries into the classrooms have received their wallboard, and soon will be finished.

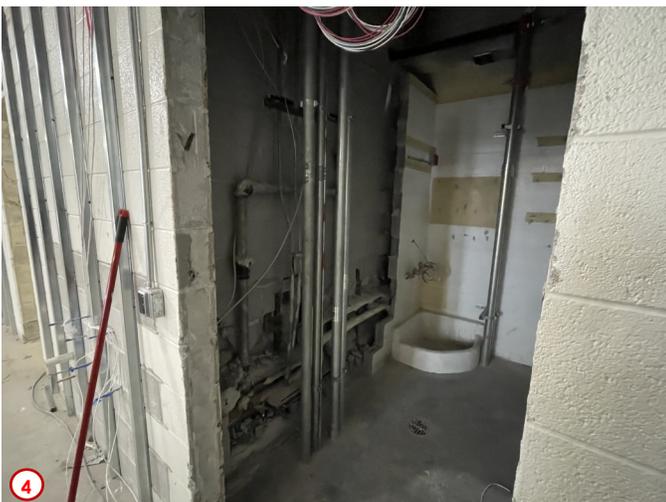
Photo #4 shows an area on the second floor in the existing janitor's closet where some additional demolition work was recently completed. Here the wall was opened so some conduit can be run from the mechanical penthouse above down through and eventually into the basement. These conduits will house everything from new electrical wiring to communication cabling. A new wall will be built out which will also enclose the recently installed conduit in the foreground.
