Building Report | CLRC Renovations and Additions Project

02.18.22

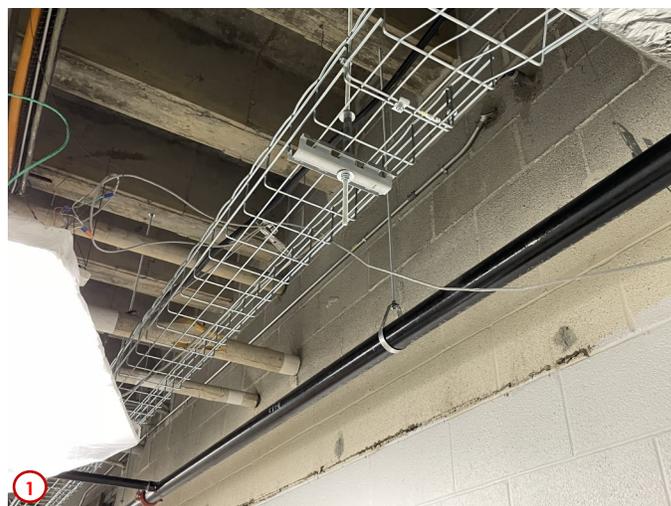
Like the 2nd and 1st floors the basement is now having a lot of its above ceiling infrastructure being installed. For example, in Photo #1 one can see not only the aforementioned fire sprinkler main trunk lines now in place, but now next to the cable tray is in that will hold all of the new data cabling that will feed all the classrooms, offices, etc. in the area with network connections stemming from the main server in the southwest corner of the basement.

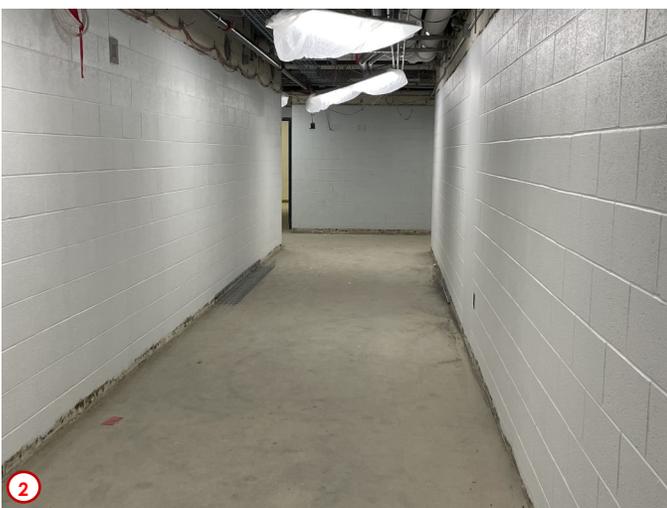
Photo #2 shows the existing concrete block walls now primed and ready for the painters to start applying the two coats of finished color. The walls shown in this photo used to be a light blue which differed from the other floors, however now all three floors will have the same wall colors to create continuity throughout the building.

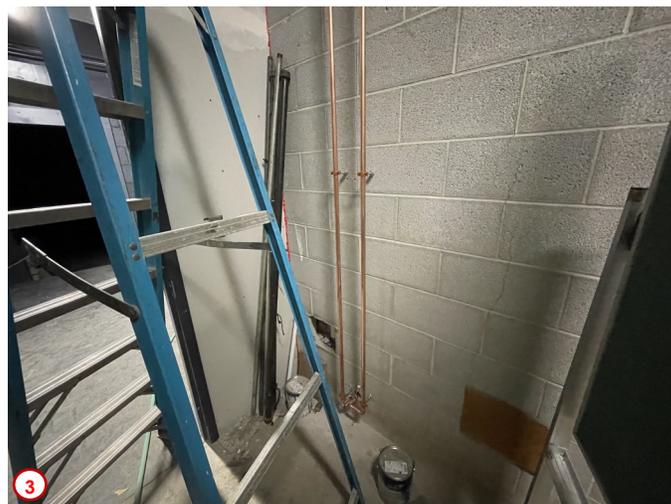
Photo #3 highlights the installation of the new copper hydronic lines that will feed the new unit heater in the east stair well on the other side of the wall. Both stair wells will receive new cabinet unit heaters as part of the overall building renovation project. These unit heaters supplement the overall heating for the building as the stairwells with their exterior doors can suffer heat loss during colder weather, and therefore help to maintain proper thermal comfort for the building occupants.

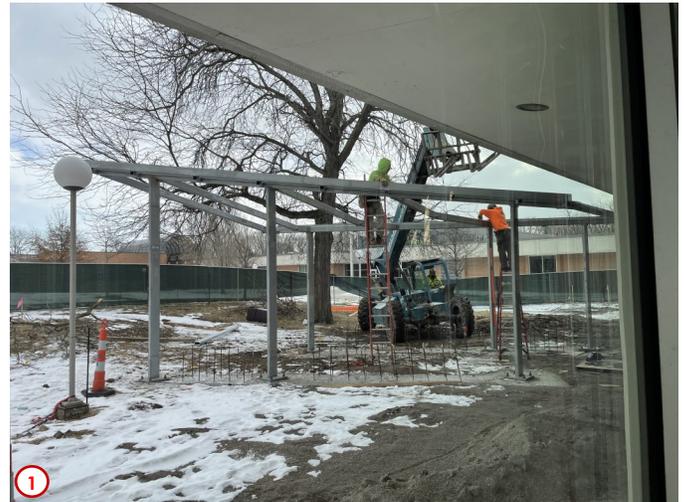
Photo #1 was taken earlier in the week and shows the contractors erecting the steel structure for the new east entrance canopy. At ground level you can see the reinforcing stirrup bars coming up out of the footing that will both support the concrete seat wall that will be placed and also structurally reinforce it. The concrete for the seat wall will be placed when the weather improves.

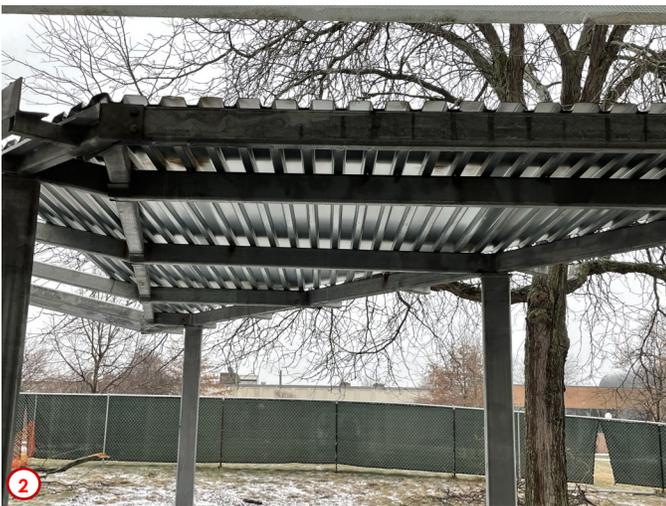
Photo #2 was taken later in the week and shows the first few panels of the corrugated metal roofing deck being installed on top of the canopy structure. Parts of this decking will be covered in rigid insulation while other areas will receive wood sheathing. All of the roof will be covered by a single-ply roofing membrane.

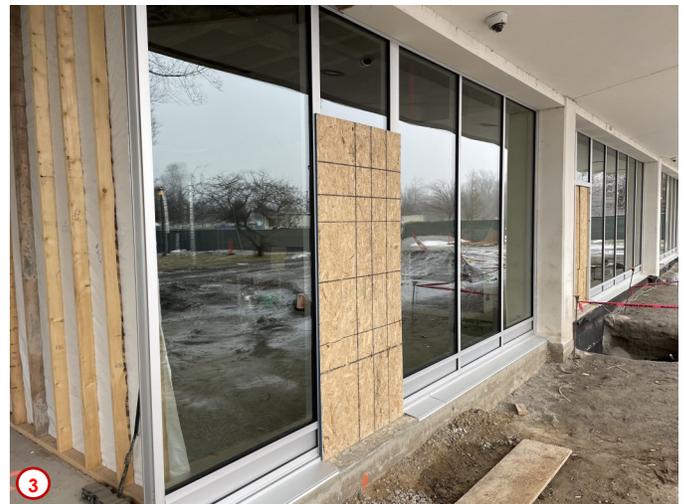
Photo #3 shows another bay along the west façade of the first floor that has received its new curtain wall system. Next week the contractors will start the installation of the areas that line the perimeter of the additions at the northwest and southeast corners of the building.

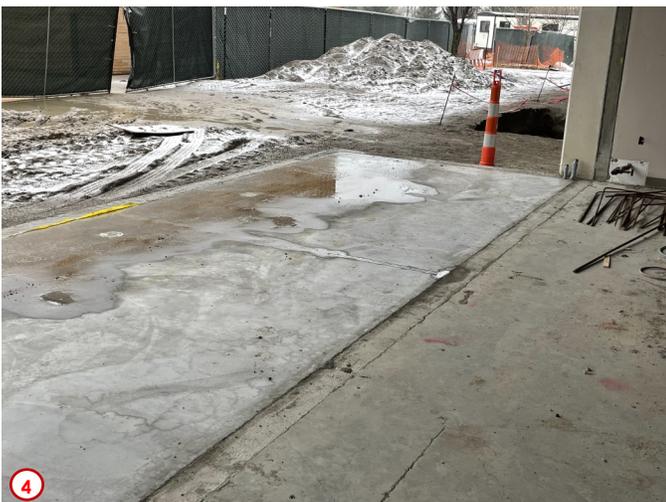
Photo #4 shows the now cured concrete floor slab for the southeast addition. With both floor slabs ready to receive the new curtain wall systems. When all these are installed the total perimeter of the first floor will then be complete and weathertight which then aids with the interiors of the building being able to be installed.

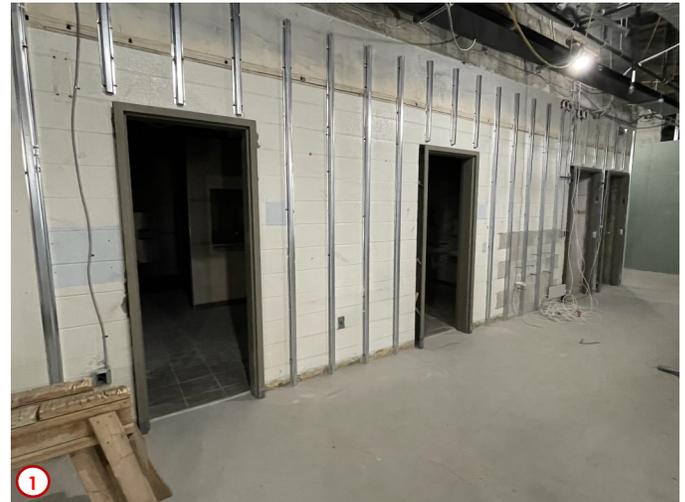
Photo #1 shows some new door frames that were installed this past week. Here there were four different existing door frame scenarios that had to be dealt with, so in order to make everything work correctly and look cohesive new frames were installed that will properly receive the new wallboard planned for this area.

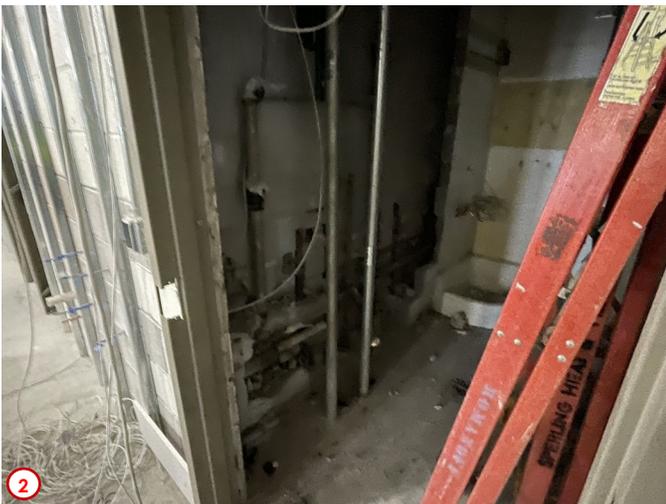
Photo #2 shows the progress of the work happening in the second floor janitorial closet. Here the existing wall was opened up, asbestos properly abated, and some old piping removed. Now new pipes that will connect the penthouse fire sprinkler trunk lines to the new fire riser in the basement will be installed in this area. Once complete the new wall will be installed and finished. This area is especially difficult to run new piping through from floor to floor as it is directly over some major structural components support the second floor and penthouse above.

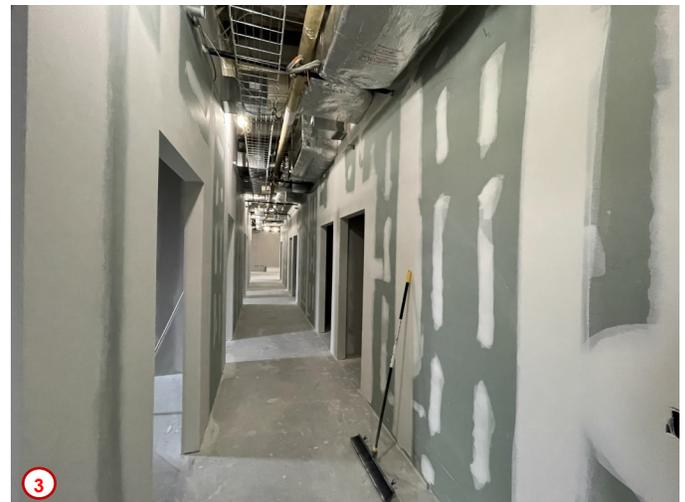
Photo #3 was taken in the new H/SS Division Office Suite and shows the wallboard prepped and ready for primer and paint. Next week the painters will start in this area which marks a pretty significant marker in the overall project timeline as they project (at least on the 2nd floor) moves from framing to finishing.

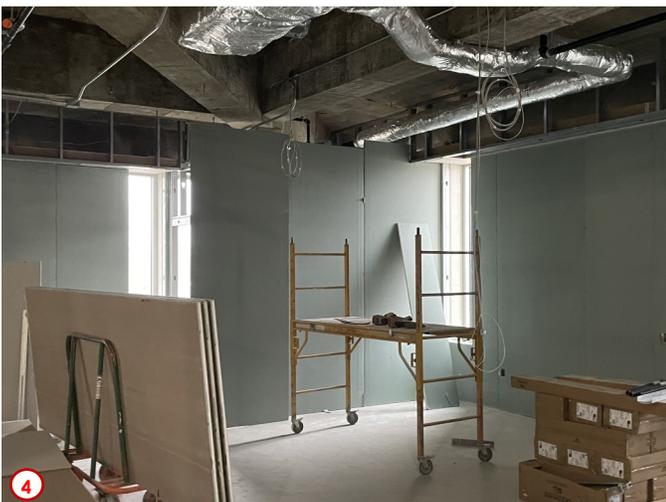
Photo #4 shows more wallboard being installed in the southeast corner of the 2nd floor, specifically in the future active learning classroom. This one of the last areas to receive the wallboard. This work times out nicely as soon as it can be taped, mudded, and sanded the painters, who are now on site, can come prime and paint this room.
