# Building Report | CLRC Renovations and Additions Project

## 03.11.22

The following are pictures from the week ending in 03.11.22 in regards to the CLRC Renovations and Additions Project. Another major milestone was reached this week with this project, and that is the completion of the new curtain wall system with not only the replacement sections but the new as well around the additions. This means the exterior of the building is now weather-proofed which will greatly aid in the efforts to finish the interior of the first floor. Also happening this past week as the flush test for the fire sprinkler system at the new fire department connection. The test was successful and received approval by the local fire marshal. This means the new fire riser can be constructed as the contractors push towards wrapping up that portion of the project. In the next few weeks will see the roofing contractors arrive on site so that they can begin the process of replacing the existing built-up roof with a new hybrid system. Additionally more site work will commence in the few weeks as the site work on the east side of the building will get underway.

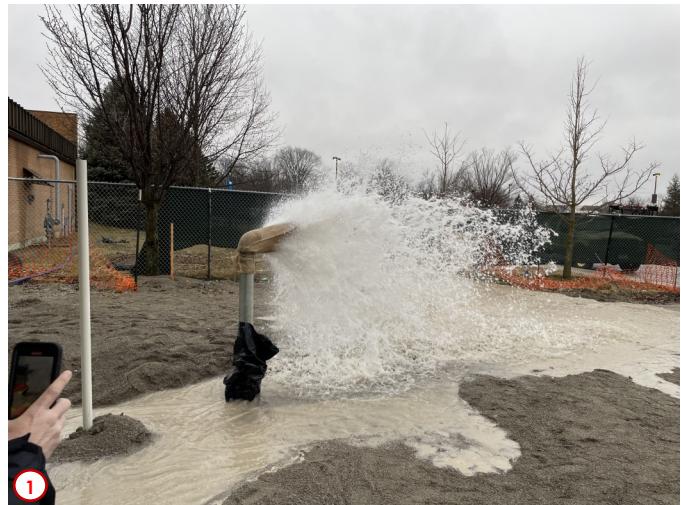
Photo #1 shows the flush test in progress for the new fire department connection. What happens is that the line is temporarily hooked up to the domestic water supply so that any particulates can be flushed out of the system so that in the future in the case of an actual event when the fire department connects their trucks to the fire riser to supplement the building's sprinkler lines that the heads won't get clogged. Once the water was shut off the burlap bagged was visually inspected by the local fire marshal, and when acceptable received his approval.

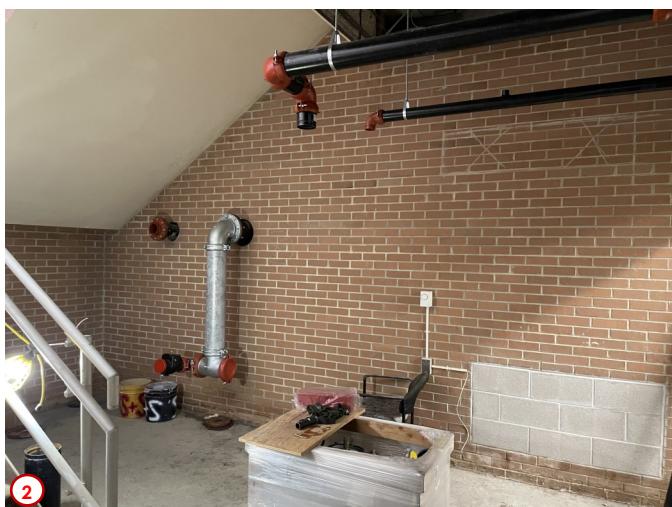
Photo #2 was taken a few days after the flush test and shows the beginning of the first segments of the new fire riser being installed. The fire riser will eventually be connected to trunk lines seen towards the top of photo.

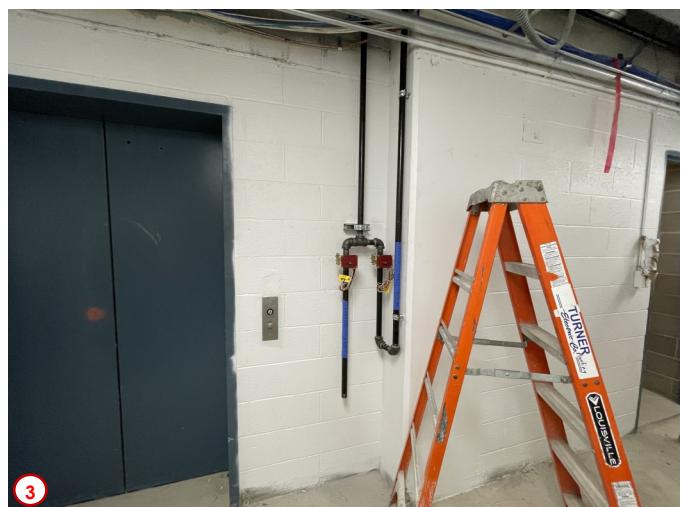
Photo #3 shows some more components of the building fire sprinkler system being installed in the basement near the elevator shaft and equipment room. These lines have check valves in them all which will be concealed behind metal framing and wallboard, however will have an access door to allow for monitoring and adjustment by not only college maintenance staff, but the local fire department, and our fire sprinkler system monitoring vendor.

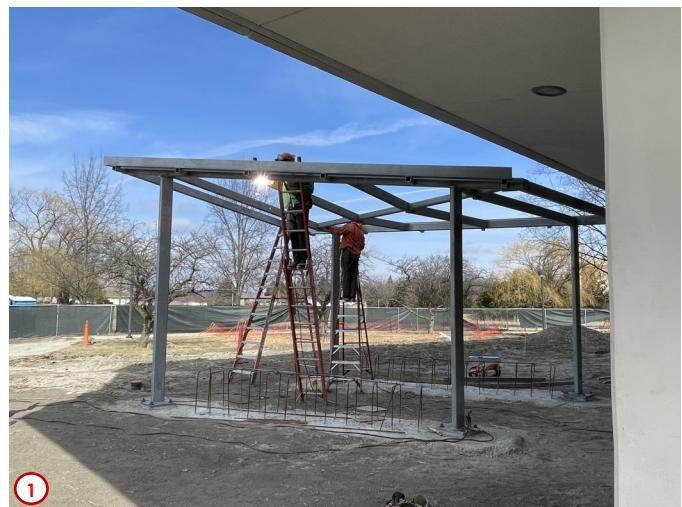
Photo #1 highlights the beginnings of the erection of the structural framing system for the new entrance canopy on the west side of the building. Here you can see the contractors welding some of the smaller cross members to each other to solidify the integrity of the entire structure.

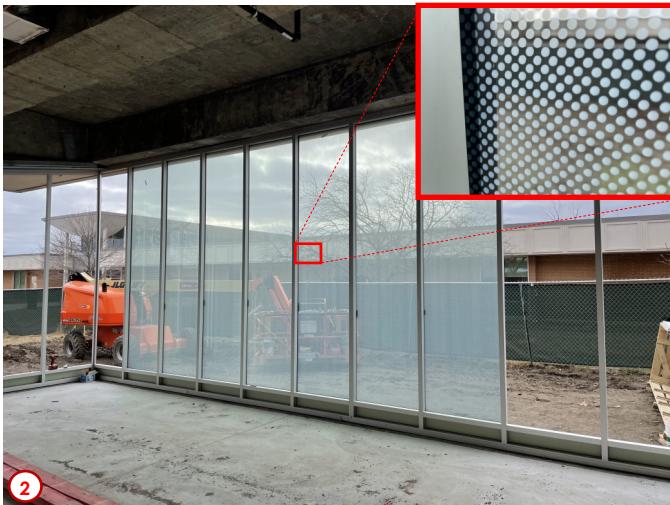
Photo #2 was taken earlier in the week and shows some of the first glazing panels being installed into their respective frames for the southeast addition. The glazing panels are made of sandwiched panels of fritted glass. What that means is that the glass has been acid etched with a dotted pattern which makes it less transparent. I have provided a detailed photo in the corner for further elaboration.
