# Building Report | CLRC Renovations and Additions Project

03.25.22

The following are pictures from the week ending in 03.25.22 in regards to the CLRC Renovations and Additions Project. The replacement of the existing roof started this week, and with that I have temporarily replaced the basement floor plan with that for the mechanical penthouse and roof for reference. Weather dependent the roof replacement will take roughly two weeks, and will consist of totally removing the old built-up roof system and replacing it with a new hybrid membrane system. Additionally a new roof access hatch and ladder will be installed which will greatly assist our maintenance crews when performing their duties. The new building-wide fire sprinkler system passed its pressurization test this week and was approved by both the state and local fire marshals. Now all of the controls will be installed and later connected to the building's fire monitoring systems. More finishing happened on the second floor with more painting, ceiling grid installation happening. A lot of new rough framing was completed this week on the first floor as well as wallboard installation.

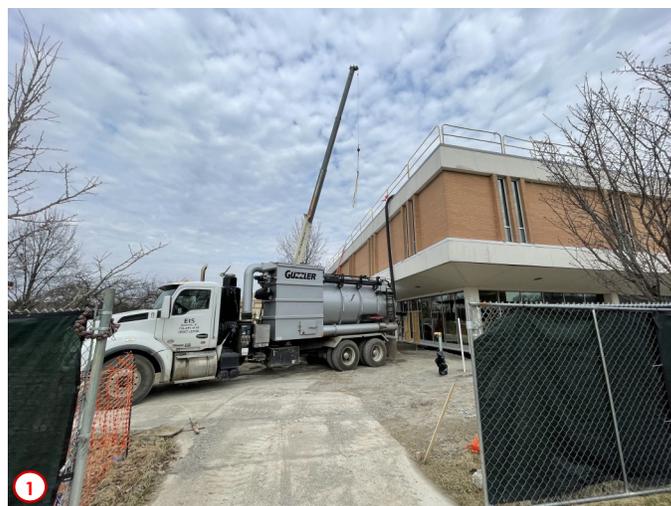
Photo #1 features the vacuum truck that was used to remove the existing stone ballast from the roof. In the background you can see the crane that has been set up to convey the new roof materials and needed installation equipment.

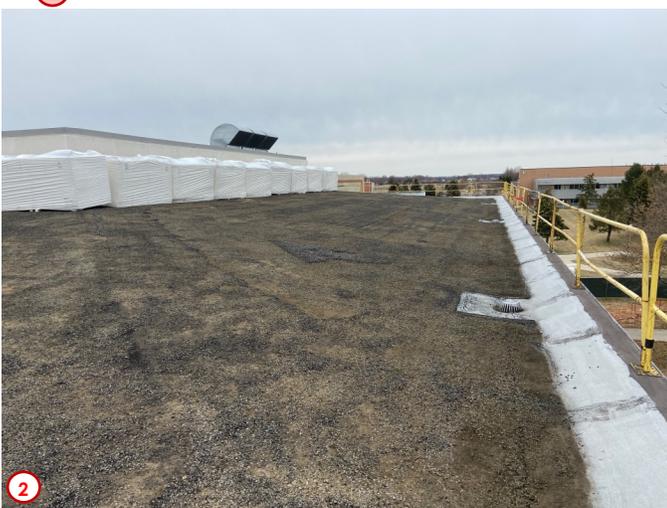
Photo #2 shows the existing roof now sans the stone ballast. With the ballast gone the many layers of bitumen asphalt and felt paper can be removed exposing the building structure underneath. Once totally removed the new hybrid system roof system which consists of rigid insulation, an extruded membrane, and chemically adhered protective stone layer will be installed. This new hybrid system has already been installed on the neighboring Founders Hall building, and will hopefully serve the building and College well for years to come.

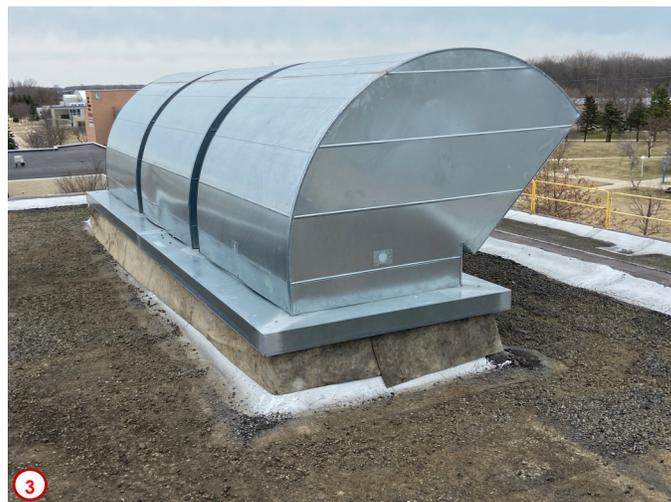
Photo #3 was taken on the upper portion of the roof and shows one set of the roof-mounted gooseneck mechanical louvers. Although these louvers were installed as part of the campus-wide geothermal HVAC system project the existing curb that they sit needed to be altered and reflashed to work with the new roofing system.

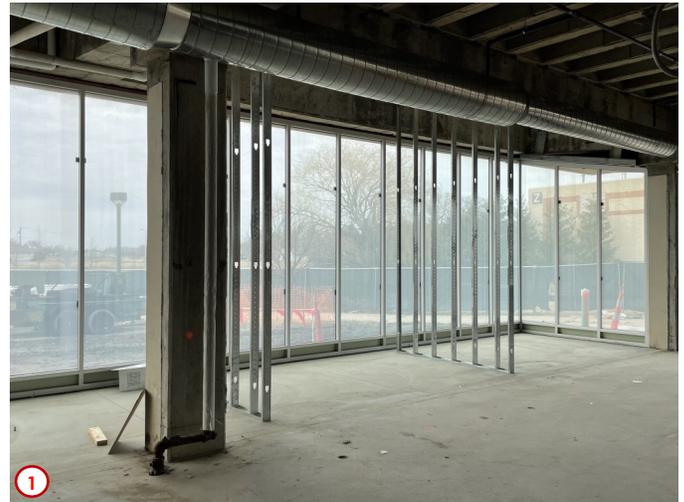
Photo #1 shows the progress of the installation of the rough framing in the northwest addition on the first floor. Here you can see the partition walls that will separate the future huddle rooms off of the Library being constructed.

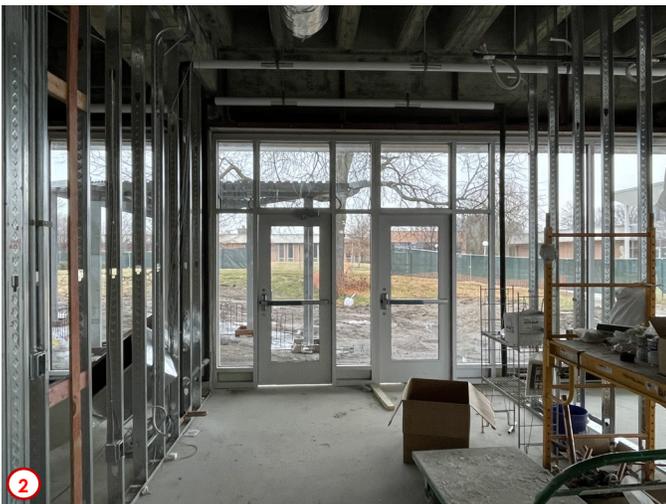
Photo #2 was taken looking at the new east entry vestibule off of the new main corridor. Featured in this photo are the new entry doors that were installed this week. Not only were this set of doors installed, but many others all the way around the perimeter of the first floor. The interior set of entry doors that will help complete the vestibule will be installed at a later time once the framing that area of the space has been completed.

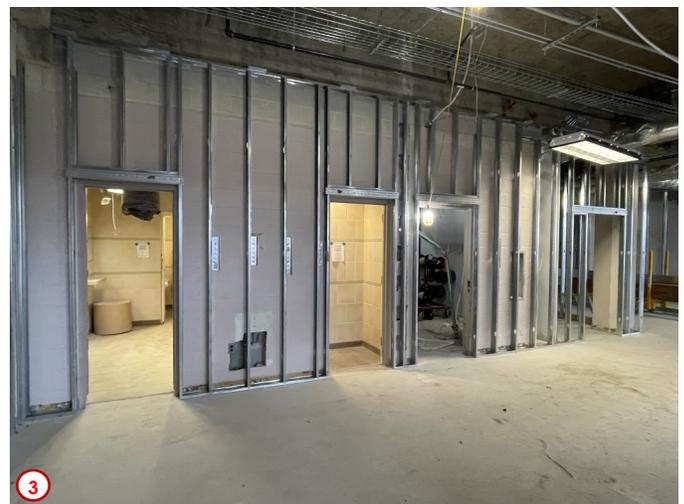
Photo #3 highlights the progress of more of the installation of some new rough framing being installed on the first floor. Here one can see some furring channels that have been installed over the existing masonry walls that will later receive a later of wallboard and be finished.

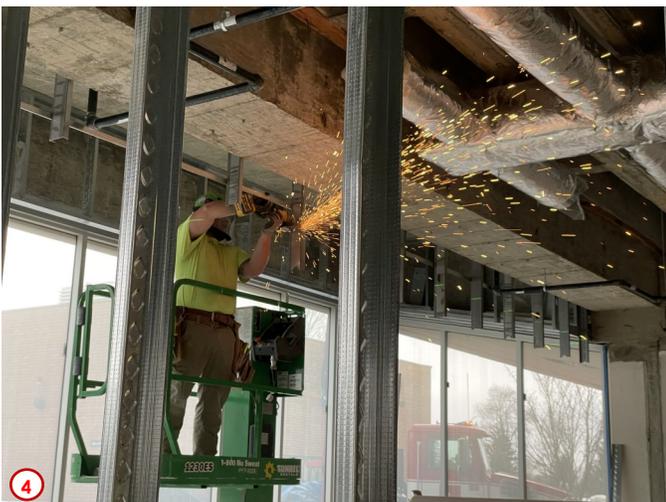
Photo #4 shows one of the many contractors at work on the first floor installing new light-gauge metal framing. Here the worker is trimming some newly installed metal studs that will provide the framework for the future bulkhead in the southeast addition that will provide a transition point for the suspended ceiling grid and the open ceiling that is part of the design aesthetics in the new computer lab and classroom in this area.

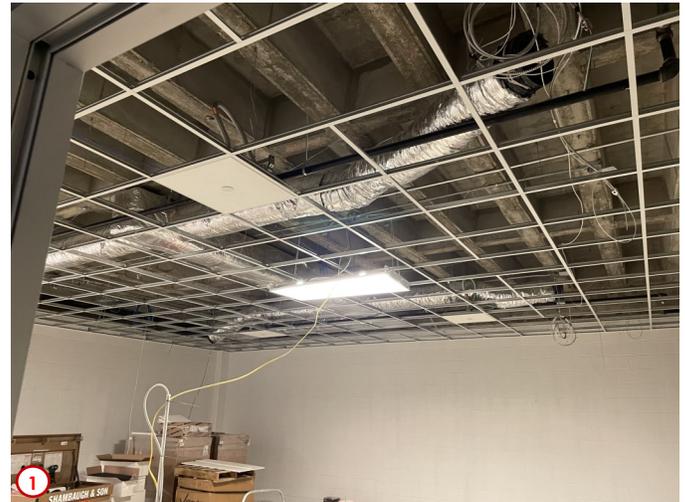
Photo #1 was taken inside one of the existing classrooms that are being refurbished as part of the overall project. Here you can see the new suspended ceiling grid system now in place and ready for the electricians to install the new LED light fixtures.

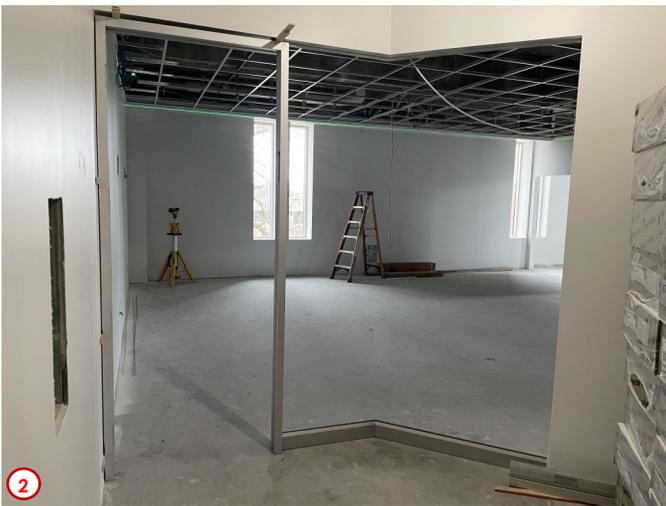
Photo #2 highlights the east entry into the future TEAL (technology enhanced active learning) classroom on the second floor. Featured in the photo is the new door frames being installed. In the background you can also see the ceiling grid for this room being completed.

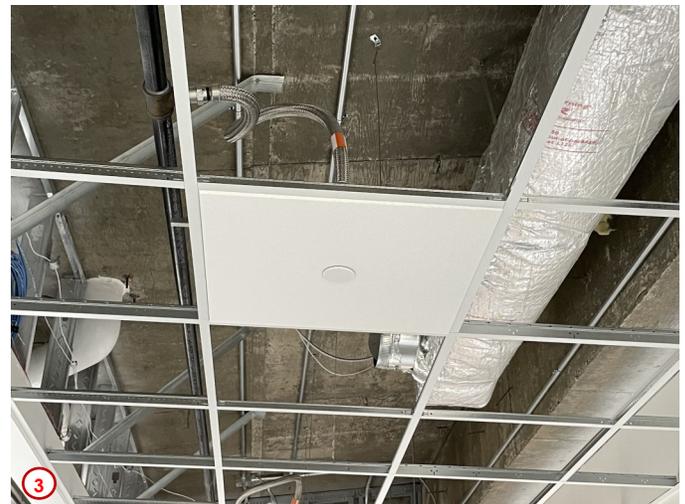
Photo #3 features some of the finish work for the new building-wide fire sprinkler system installation. Here you can see one of the countless new drop-down sprinkler heads w/ cover plate now properly terminated into a new ceiling tile.

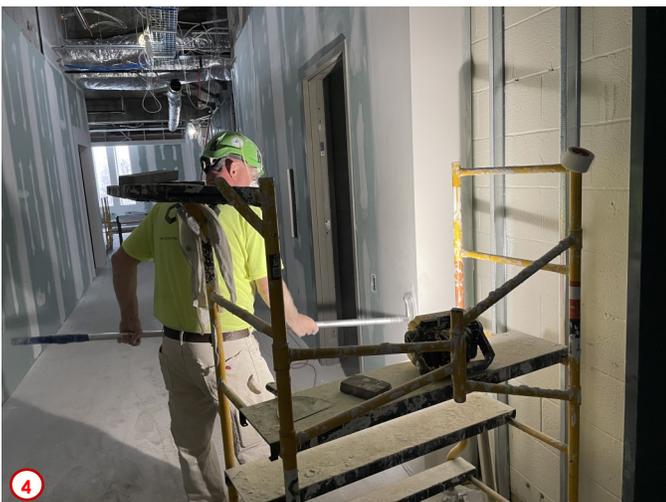
Photo #4 shows one of the many interior contractors sanding one of the new joints in the wallboard near the existing elevator door on the second floor. After all the seams, joints, corners, etc. are taped and mudded all that has to be properly sanded before the painters can come in and apply the multiple layers of primer and finish paint.
