# Building Report | CLRC Renovations and Additions Project

04.08.22

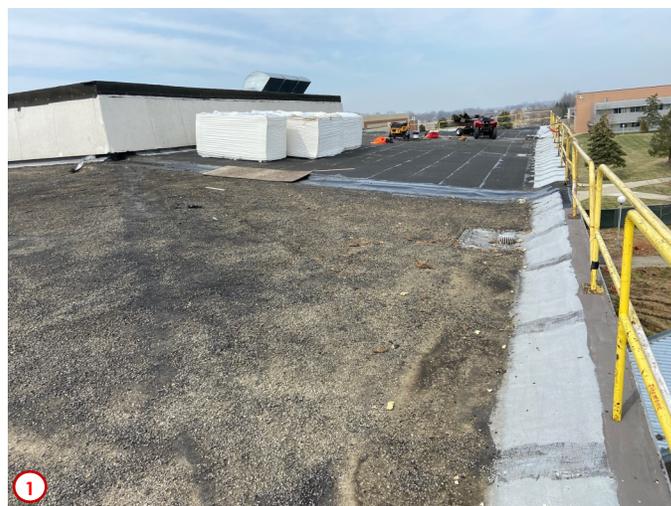
Photo #1 was taken along the east side of the lower portion of the roof. Here you can see an example of how the roofing contractors have been working in smaller sections. This way they can get the work accomplished even with the extra rainy weather we have been experiencing lately, and by doing this they are able to keep the interior of the building dry.

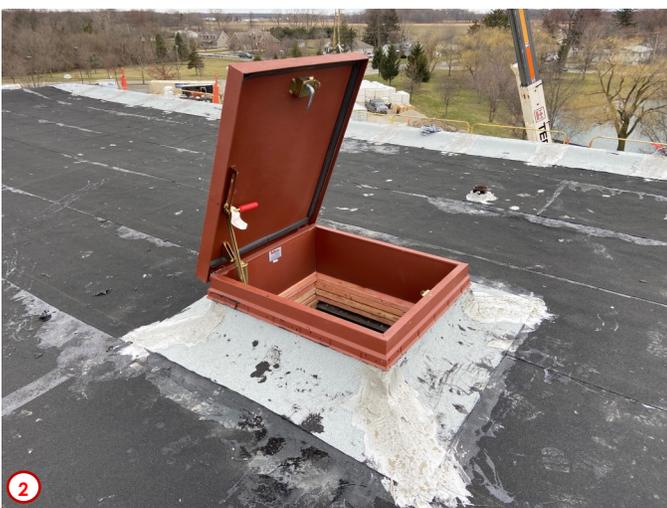
Photo #2 shows the roof access hatch now installed. This new hatch is seated higher than the previous version which will encourage water to flow away from the unit, therefore hopefully discourage any leaks from forming around the perimeter of the unit.

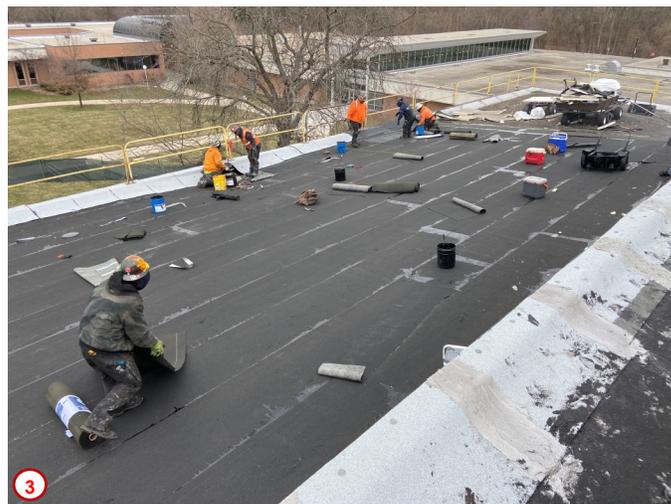
Photo #3 highlights the installation of the roofing membrane. The membrane is chemically bonded to the insulation layer underneath and then all the joints are sealed. Once the membrane is installed and covers the roof completely then adhesive is applied and then a layer of stone ballast will be installed which will protect the roofing in two ways: help protect it from the damaging effects of the sun's UV rays, and also protect from falling objects possibly penetrating the membrane which then would be most likely prone to become a leak.

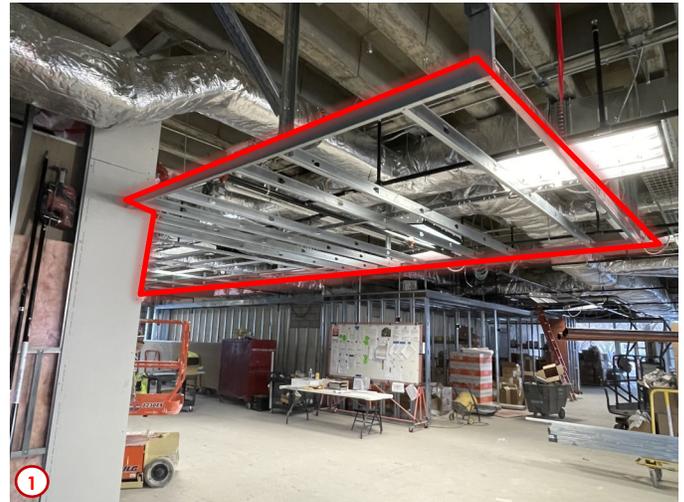
Photo #1 shows the light-gauge metal framing (highlighted for your reference) now installed for the bulkhead that will be above the reference desk area in the library space. This framing will eventually be clad in a panelized wood veneer system.

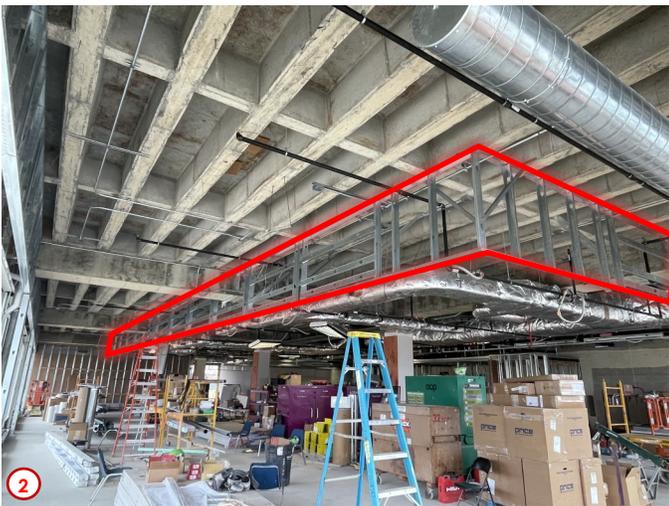
Photo #2 was taken in the northwest corner of the future library space looking towards the southeast and highlights the framing for the bulkhead which will help separate the exposed framing for the second floor above and where the ceiling cloud above the stack area ends. This framing has been highlighted in red for your reference.

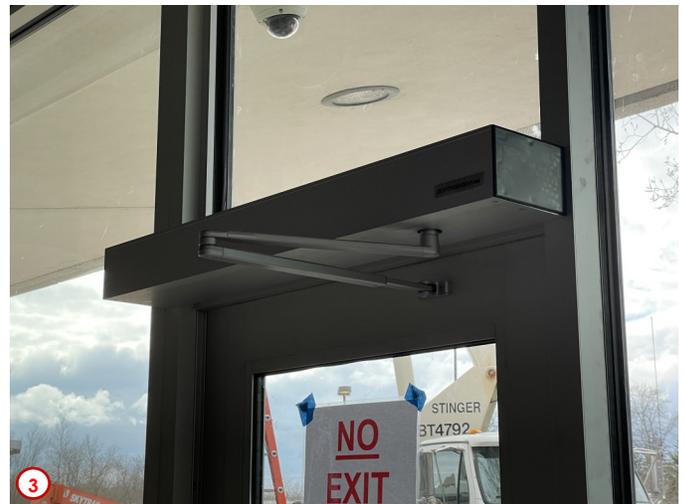
Photo #3 is just one example of many throughout the first floor where the needed door hardware was installed. Here you can see one of many exit doors with the needed closer now installed at the top of the door frame.

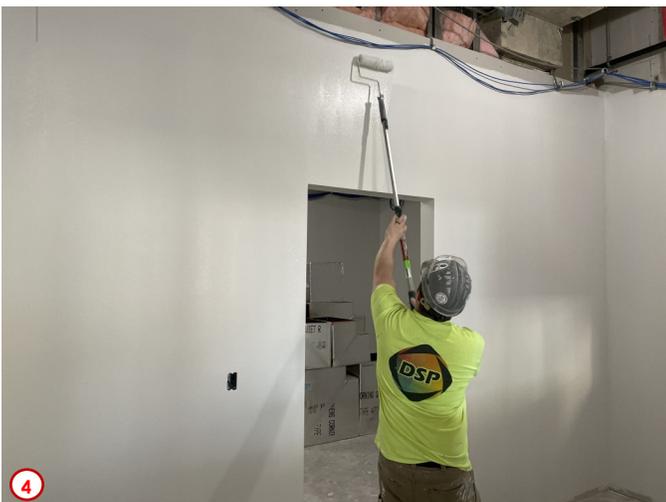
Photo #4 features one of painting contractors applying a layer of primer on the walls of the open area of the Library Office Suite now that the wallboard in this area has been taped, mudded, and sanded. From here the painting contractors will go on to apply two layers of finish paint before their work is complete.

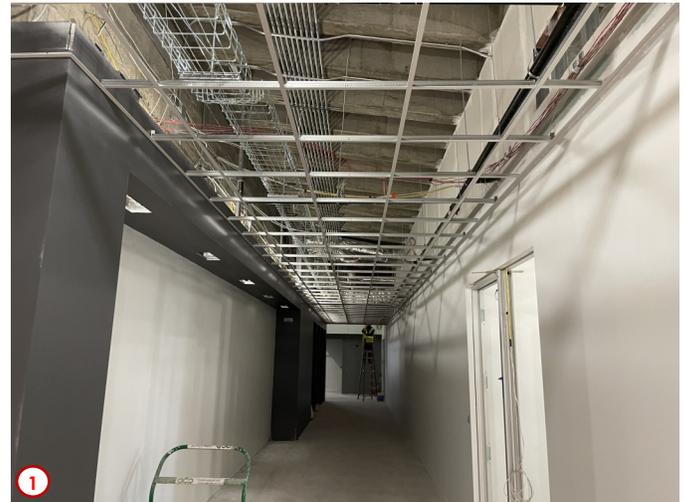
Photo #1 shows the now completed grid system for the suspended acoustical ceiling tile in the new north corridor on the second floor. With this grid in place several infrastructure items can be installed such as the sprinkler heads, air diffusers and return grilles, occupancy sensors, and light fixtures.

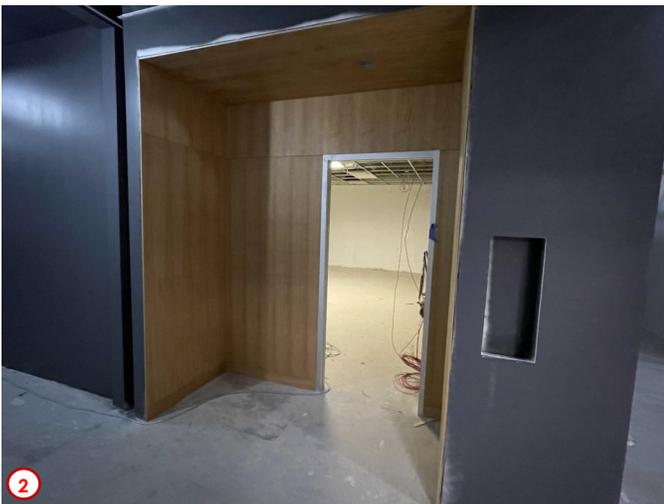
Photo #2 was taken of the new entry into one of the soon to be refurbished classrooms. Here one can see the entry being clad in a high-grade veneered plywood. Again, the previous entry was not ADA compliant so the entries were expanded so as to be code compliant.

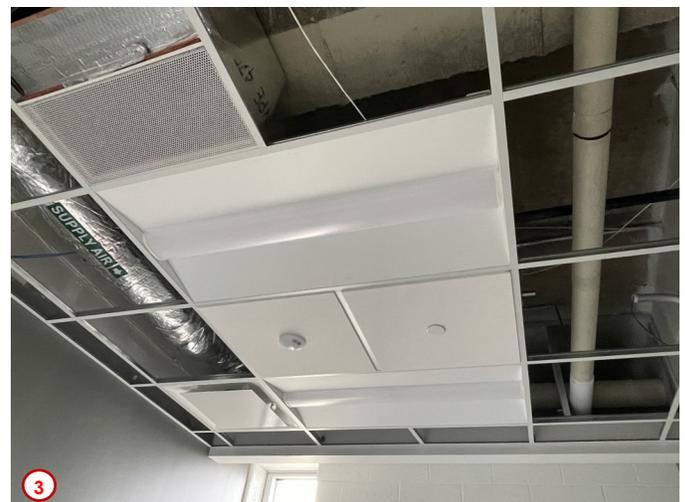
Photo #3 highlights the progress of finishing the ceilings in one of the many faculty offices in the new H/SS Division Office Suite. Here you can see the sprinkler head in place but also the light fixture, supply diffuser, return air grille, and the occupancy sensor. Once all the above needed inspections are conducted then the remaining tile will be installed.

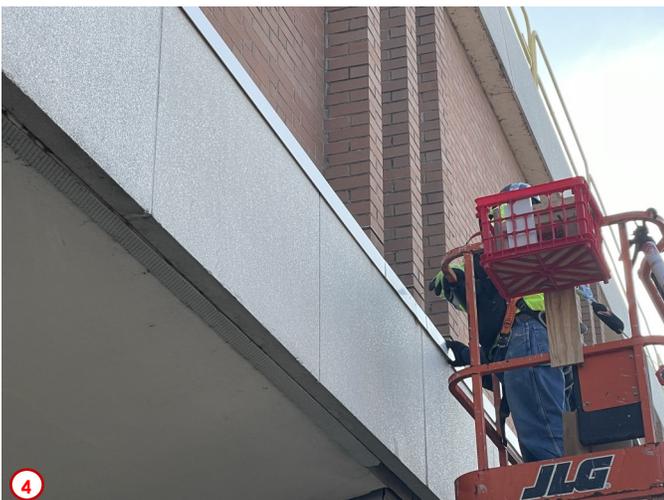
Photo #4 was taken outside the south face of the building and shows the contractors installing the metal coping around the perimeter of the second floor at the top of the precast fascia panels. The old coping had become weather and damaged over the years and was starting to fail in many locations. This new coping will hopefully last even longer and exceed expected performance criteria.
