Building Report | CLRC Renovations and Additions Project

05.20.22

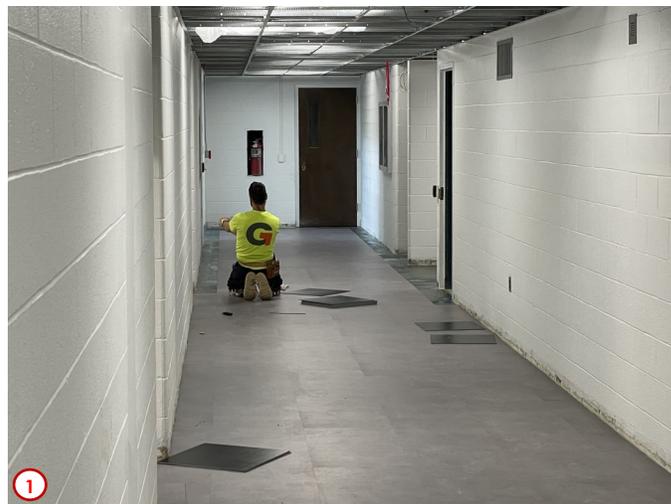
Photo #1 shows the flooring layers installing the LVT (luxury vinyl tile) in the basement corridors. Some of the main features we like about LVT over VCT (vinyl composition tile) is that it doesn't have to be stripped and waxed every year, and the color runs all the way through so scratches aren't as apparent. Therefore they are more robust and require less maintenance and therefore have a lower TCO (total cost of ownership).

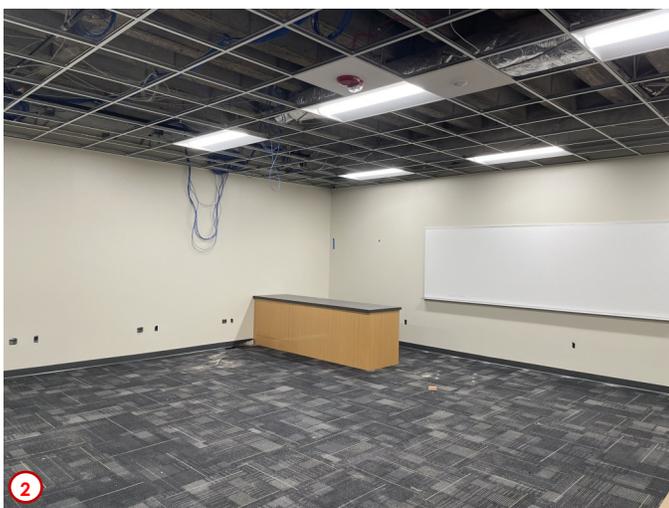
Photo #2 was taken in what will be the designated computer lab in the basement and shows nearly all of the finishes complete minus the ceiling tile. Also featured in the photo is the new marker board and teaching station. Once the ceiling is complete the only remaining items left to be installed in this room will be all of the instructional A/V equipment and the furniture.

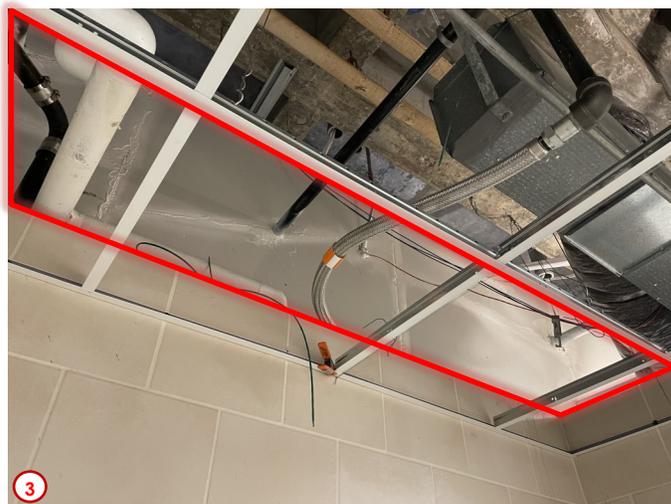
Photo #3 shows one of the small details that have been completed in the basement. Highlighted in the photo is a section of some additional framing, wallboard, and sound batt insulation (not shown) that was added to the top of the existing concrete block walls that divide the restrooms from each other and the adjacent corridor. This work will ensure better privacy and security in this area of the building.

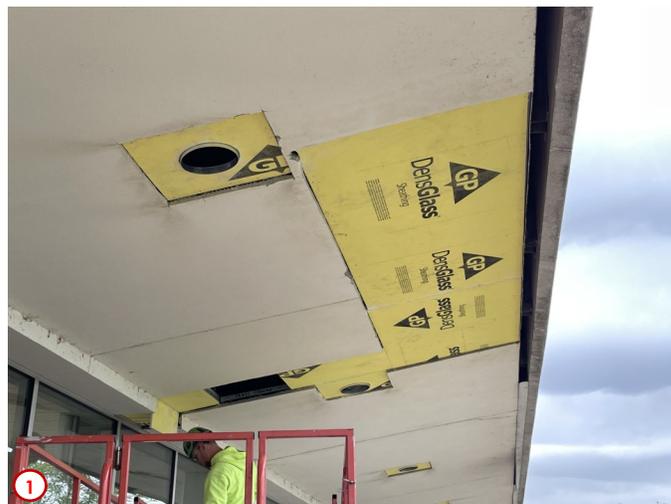
Photo #1 was taken outside the northeast corner of the building. Highlighted in this photo is the work being done to repair the soffit under the second floor where it had to be cut open to run some new plumbing lines. Once the substrate is complete plasterers will come in and install a scratch coat and final coat of synthetic stucco to match existing. The entirety of the soffit will be painted once all the patches and new LED lighting fixtures are installed.

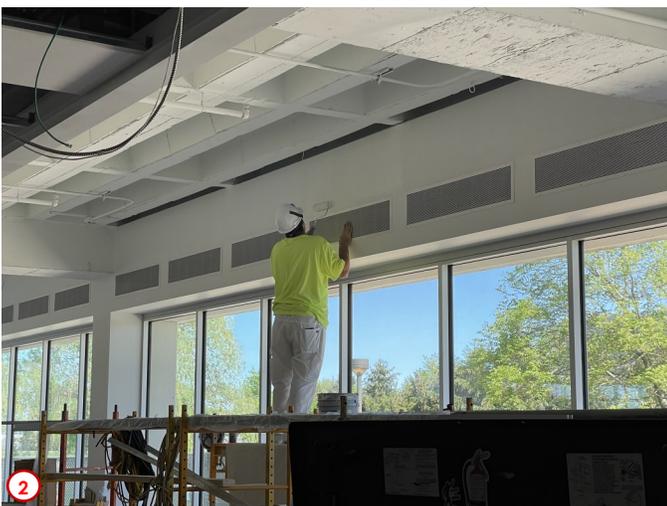
Photo #2 shows some of the many areas inside the library being finished. Here the bulkhead along the north perimeter wall is being primed and painted above the new air diffusers near an area where the ceiling will be left open to the structure above.

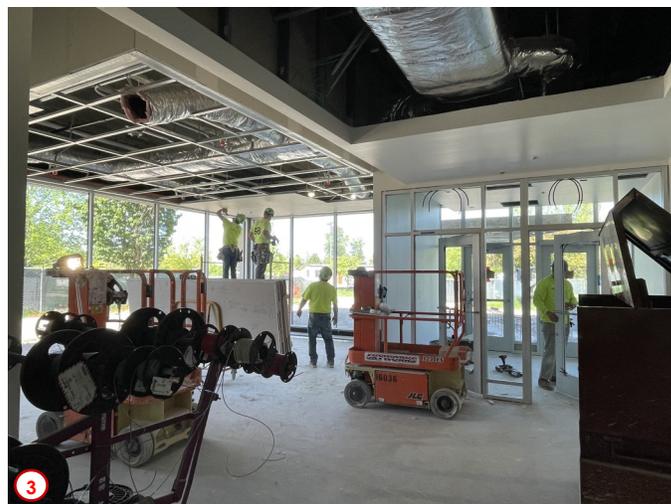
Photo #3 features the work that was happening near the new west entrance on the first floor. Here you can see the contractors installing the wallboard for the ceiling in the student commons area. Right next to that you can see the interior vestibule entry being installed at the same time.

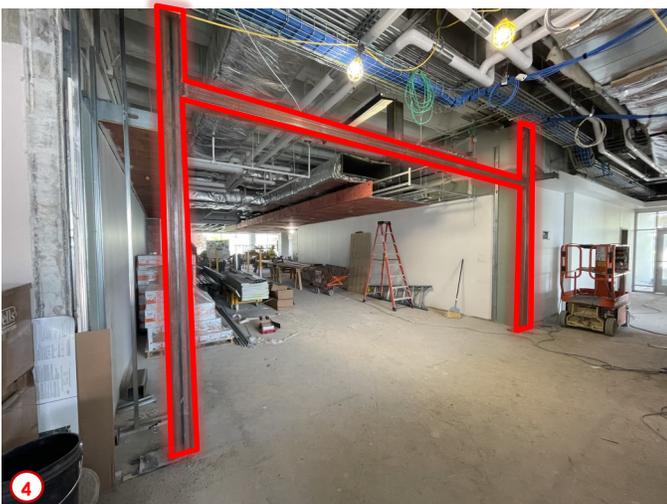
Photo #4 features the recently installed structural steel frame (highlighted in red) that will support the new overhead coiling door at the entrance of the library. Now that this frame is in the surrounding framing can be finished as well as the actual door unit being installed which weighs over 800 pounds.

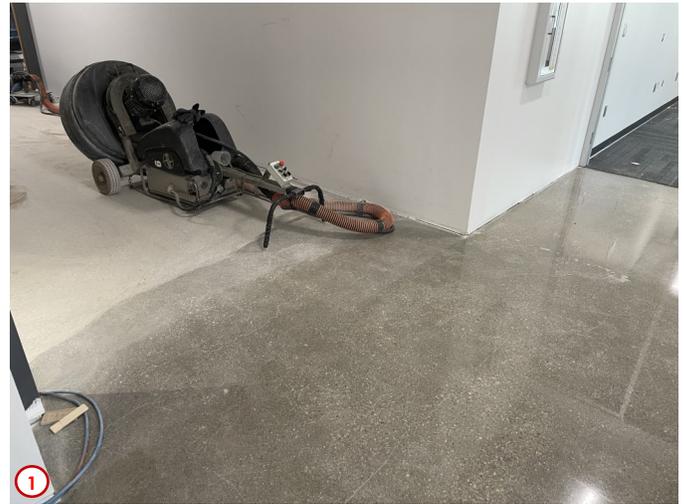
Photo #1 shows the results of the concrete polishing occurring on the second floor in the corridors. After the existing concrete is ground down to expose more of the aggregate it then is cleaned and polished to the level of gloss shown in this photo. This will be floor finish in the corridors on the first and second floor.

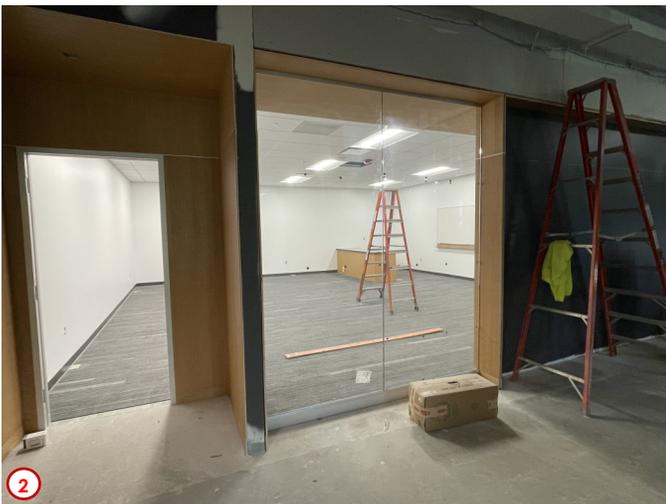
Photo #2 features one of the many areas on the second floor where the interior glazing is being installed. This photo features an installation at the entry into the new classroom on the west side. This particular installation will receive a privacy film coating which provide more privacy, but still will allow more natural light from the nearby windows into the deeper parts of the building interior such as this classroom.

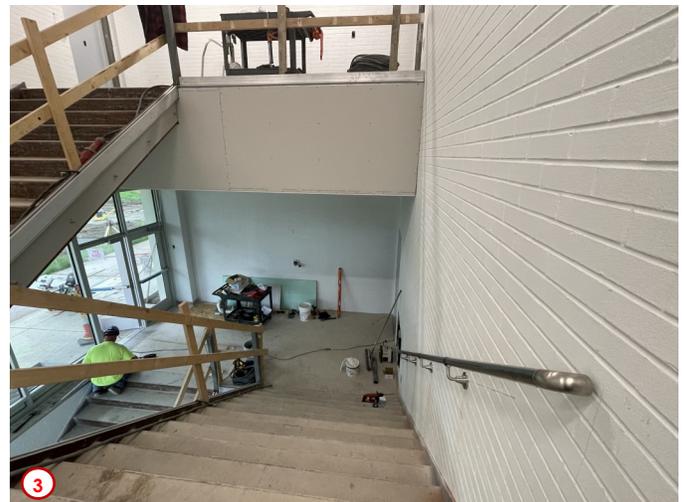
Photo #3 was taken in the east stair tower and shows some of the work happening in that space. On the right you can see the first of the new handrails now installed. In the background you can see the recently constructed bulkhead that will allow for a new ceiling to be installed that conceals the fire sprinkler branch lines under the 2nd floor landing.

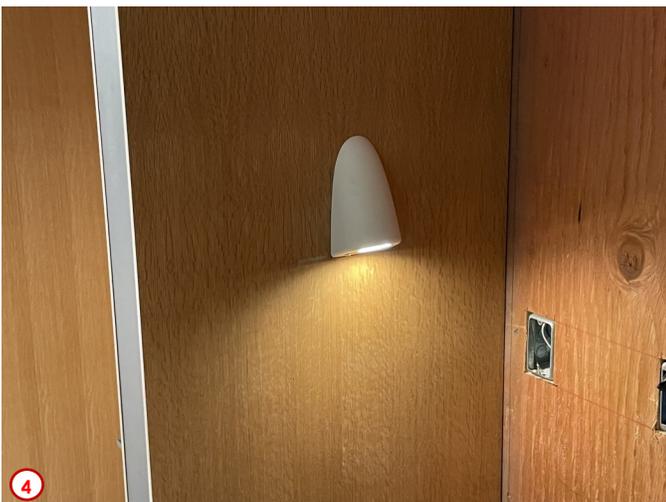
Photo #4 highlights some of finer details that are being installed on the second floor other than room finishes. Featured in this photo is one of the wall-mounted task lights that will illuminate the work surface in one of the new study cubbies along that line the north corridor near the H/SS Division Office Suite.
