Building Report | CLRC Renovations and Additions Project

07.08.22

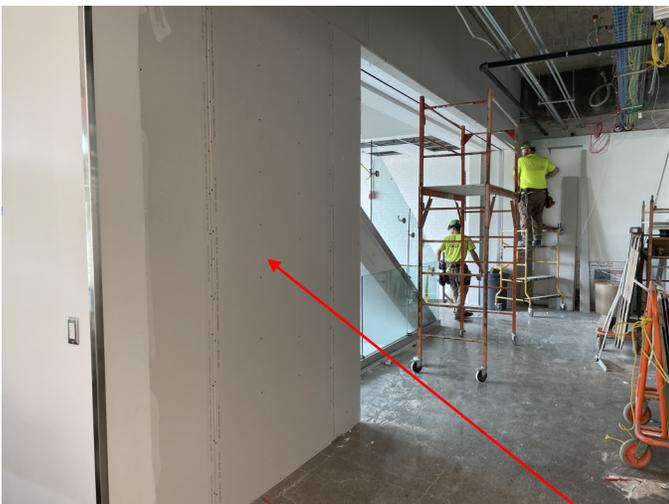
The top-left photo was taken near the west stair tower on the first floor and highlights the progress of the installation of the framing and wallboard for the pockets and track for the deployable fire curtain.

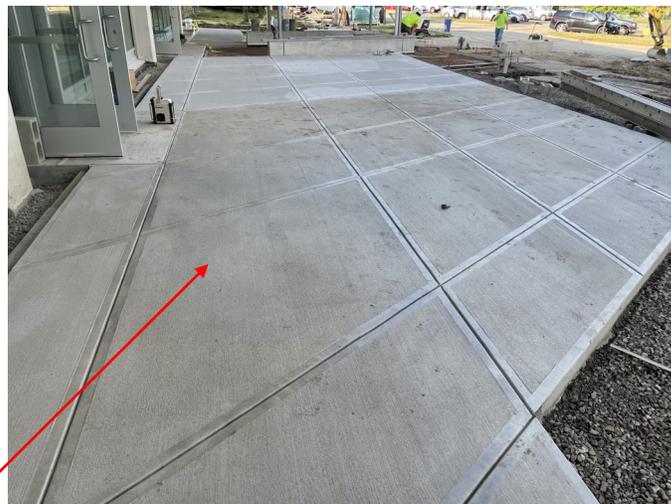
The top-right photo shows the now completed walks and patio area outside the new west entrance of the building.

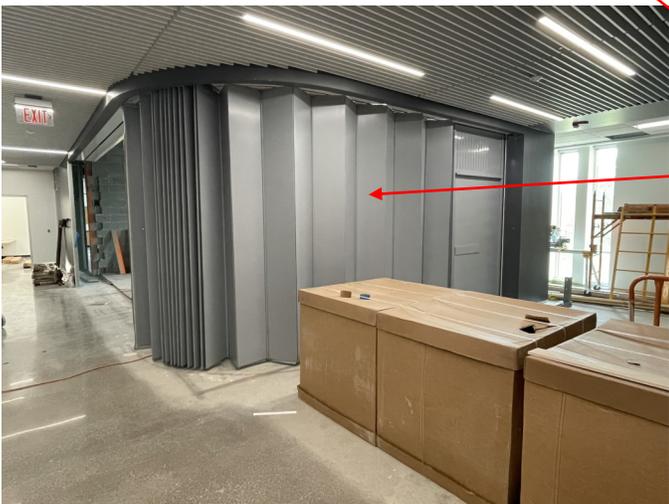
The bottom-left photo shows all the segments for the deployable fire curtain on the second floor at the western stair. The contractors still need to anchor it, and program the limits as well as connect it to the fire alarm system. Again, this curtain is what will create a fire-rated safety barrier around the open western stair tower in case of a fire emergency.

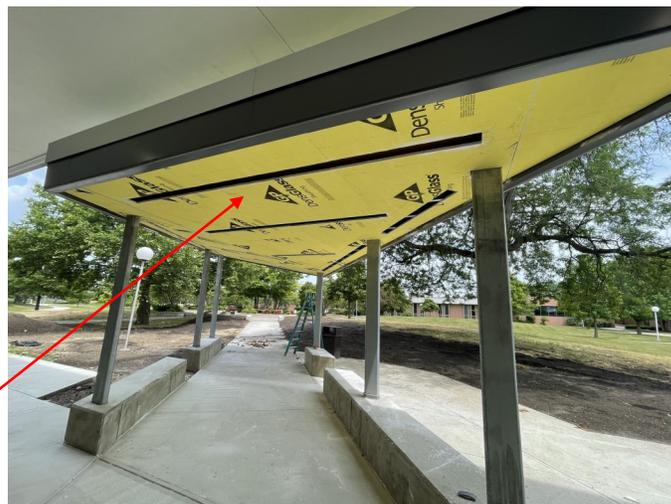
The bottom-right photo shows the progress of the finishing of the underside of the new entrance canopy on the east side of the first floor. The cut out slots will be where the future LED light fixtures will be installed. The underside will receive a synthetic stucco finish and painted to match the existing soffit of the building. Also, the downspouts will be installed next week that will help drain the rainwater and send it the underground storm water system nearby.

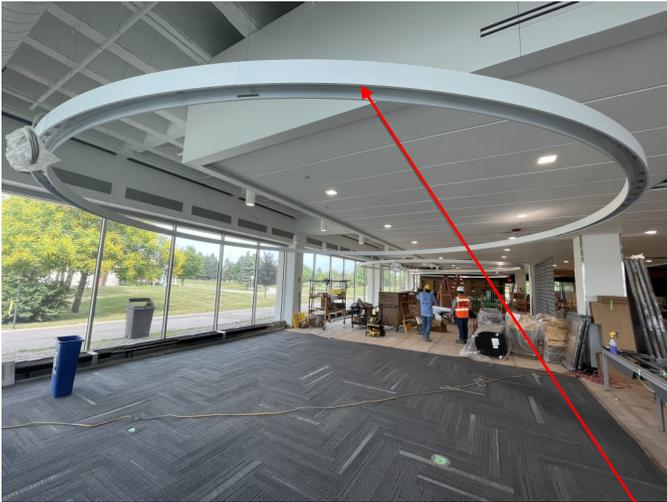
The top-left photo shows the new LED ring lights that were installed along the north curtain wall in the library. Each of the ring lights are 22 feet in diameter and are not only functional but are an intentionally designed showpiece for this space.

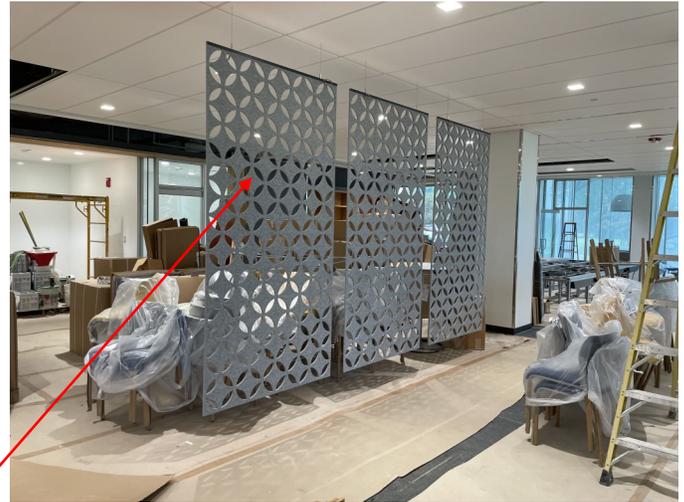
The top-right photo features an area of hanging acoustical privacy screens in the library.

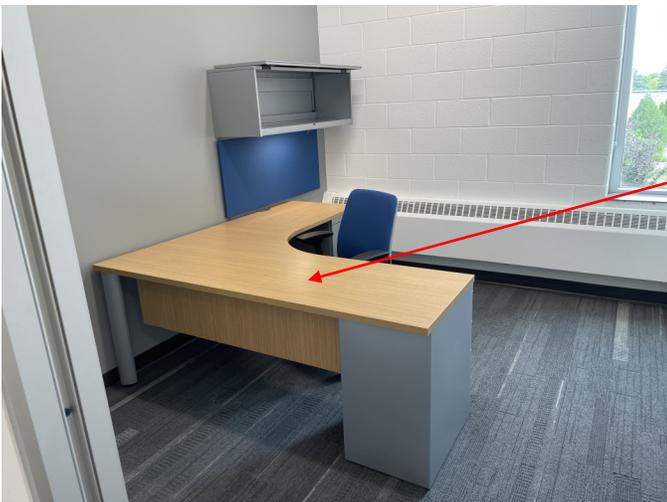
The middle-left photo shows some of the typical furniture installations happening on both the first and second floor of the building in all of the staff offices. This setup is typical to our new campus standard and consists of the L-shaped desk with two storage pedestal cabinets, a wall-mounted tackable surface, a lockable overhead bin, and a bookshelf (not pictured).

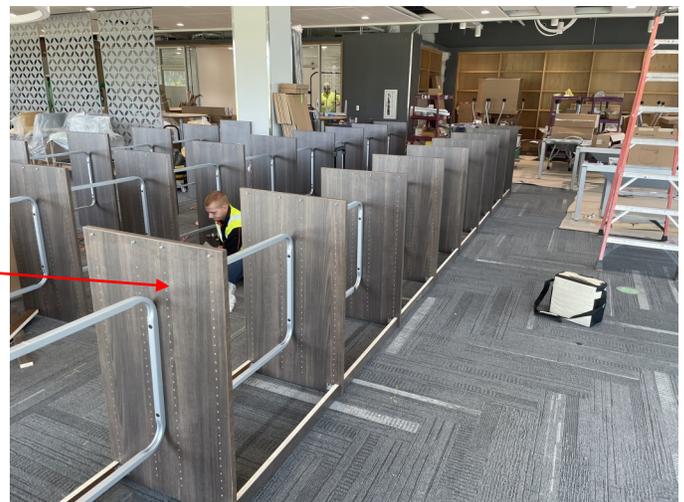
The bottom-right photo shows the very beginning of the installation of the new stacks for the library. The new stacks are intentionally shorter to not only be ADA compliant, but to offer sightlines throughout the library.

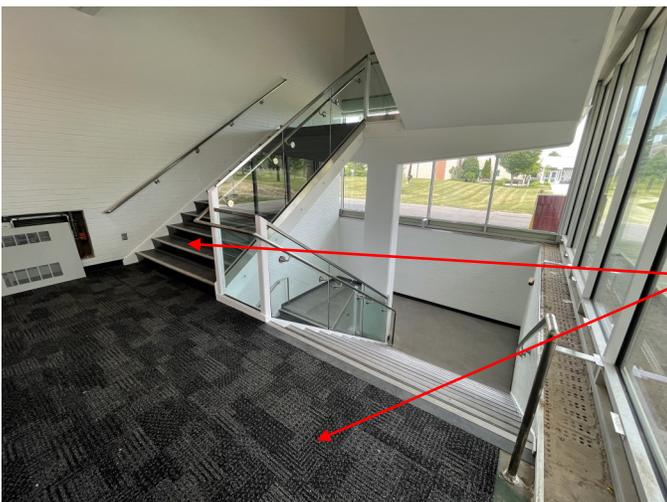
The bottom-left photo highlights some of the finish work in the eastern stair tower. Here one can see the new walk-off carpet near the entry. The glass railings are now complete, and the treads and risers have received their new finishes as well. Next week the custom fin-tube covers will be installed as well as additional support connections for the railings that still need them.
