Building Report | CLRC Renovations and Additions Project

10.8.21

The following are pictures from the week ending in 10.8.21 in regards to the CLRC Renovations and Additions Project. Overall this project is now at roughly 20% complete. There is a large amount of new framing being installed on the second floor with a lot more to complete. On the first floor more demolition of the old perimeter curtain walls has been completed. Soon the waterproofing process for the entirety of the south wall of the basement and portions of the east and west walls will be started. This work will allow us to hopefully finally address a long-time legacy issue with water penetrating the basement walls due to the high water table we deal with because of our proximity to Lake Erie. Once the waterproofing is complete the foundations for the two additions and the new entrance canopies can commence. It is the plan that the additions will be weather tight prior to winter conditions setting in. In the basement some final demolition of various old ceiling systems in the classrooms has been completed in preparation for the fire sprinkler lines starting to be installed.

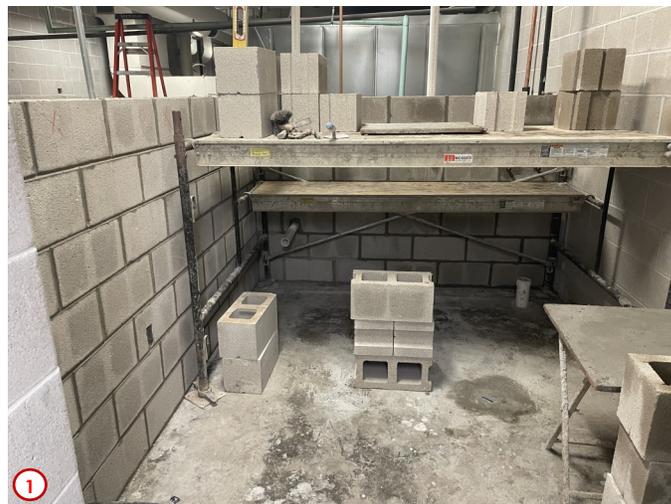
Photo #1 highlights the progress of the construction of the new janitorial closet in the basement of the CLRC. Again, the concrete for the floor slab has been placed and now the concrete block walls are being laid to fully enclose the space. You can see underneath the scaffolding the rough-ins for the future mop sink and oil separator along the east wall.

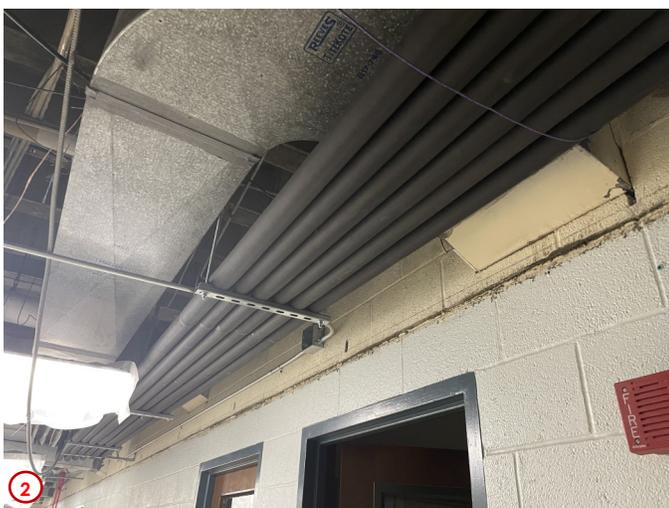
Photo #2 was taken in the south corridor of the basement looking up at the mechanical and electrical systems that will eventually be concealed by the future suspended acoustical ceiling tiles and grid. The black pipes that are featured in this photo have been insulated and run out side the building on the south face and have been installed to connect the exterior condensing units to the mini-split a/c units that service the server room. These existing condensing units currently reside on the west side of the building, but will be moved so that area can become the new main west entrance for the building.

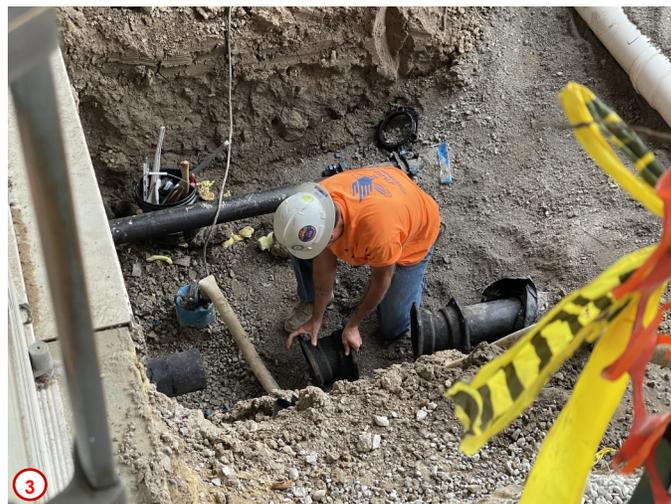
Photo #3 was taken outside the west side of the building and shows the excavation contractor installing the connections for the new main sprinkler supply line to the existing domestic water line that runs throughout the campus. Once inspected and tested this line will terminate at the new fire riser room that will be located under the western stairs in the basement. This area will then be backfilled and compacted so that eventually new sidewalks can be installed to allow pedestrians access in the future west entrance to the building.

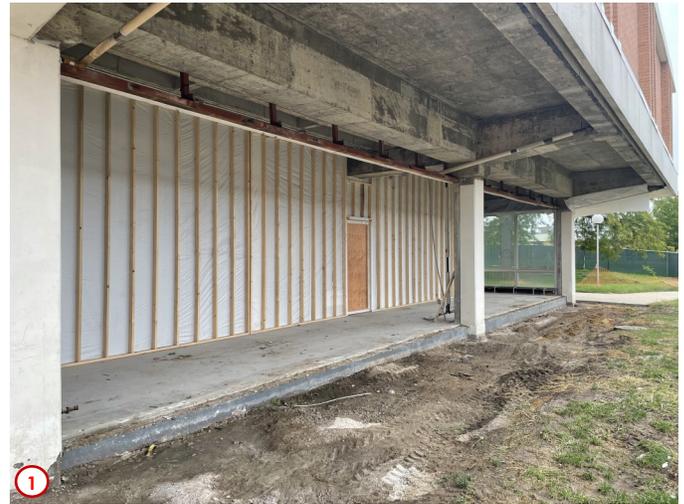
Photo #1 shows the now completed demolition of the old curtain wall system along the southeast portion of the first floor. In the next few weeks this area will be excavated so that the waterproofing system can be installed on exterior face of the basement wall. Once that is done the foundations for the addition in this area can be installed.

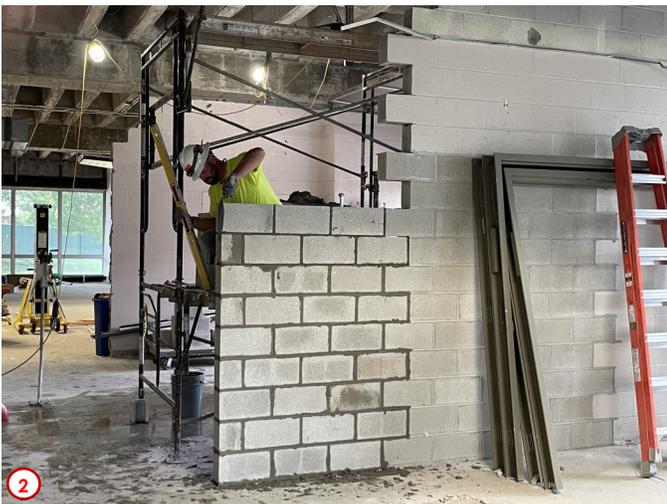
Photo #2 shows one of the masonry contractors installing some new concrete block for the wall that will eventually separate the receiving room/loading dock from the adjacent lounge area. The existing block wall in this area was suspect and so it was removed and a new portion of block wall was installed to ensure that the walls are structurally sound prior to receiving their finishes.

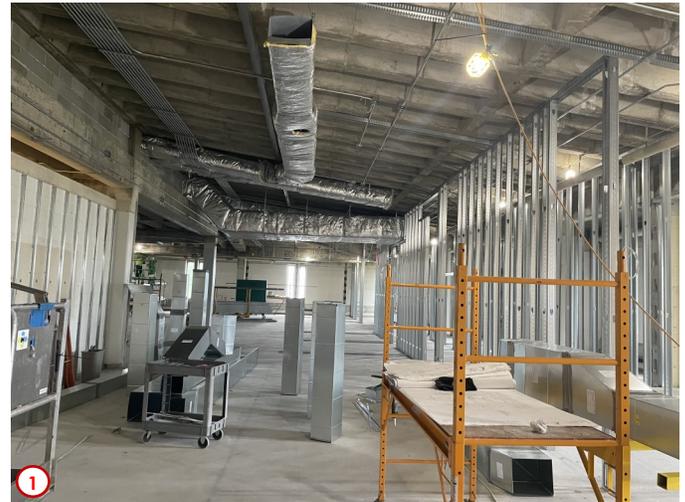
Photo #1 was taken in the area of the future H/SS Division Office Suite looking west. Along the right side you can see the stud walls forming that will be the faculty offices. On the left side you can see furring being applied to the existing masonry wall so that new wallboard can be installed. Then at the top you can see more of the existing duct-work has been insulated.

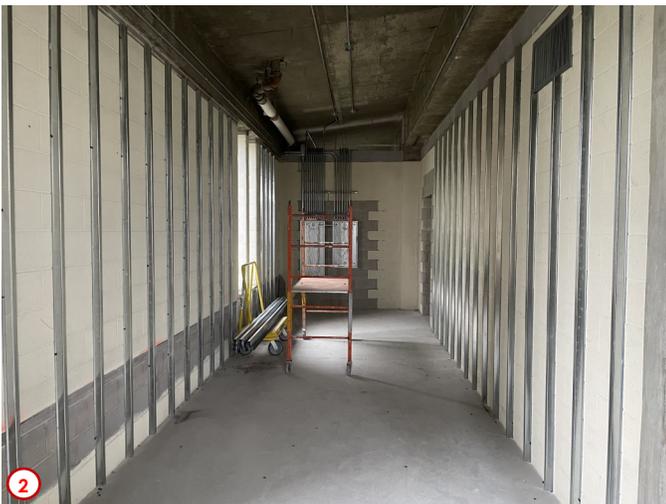
Photo #2 was taken in the area of the future staff lounge on the second floor of the CLRC. One can see that the existing block walls have been furred out and will eventually receive new wallboards and finishes.

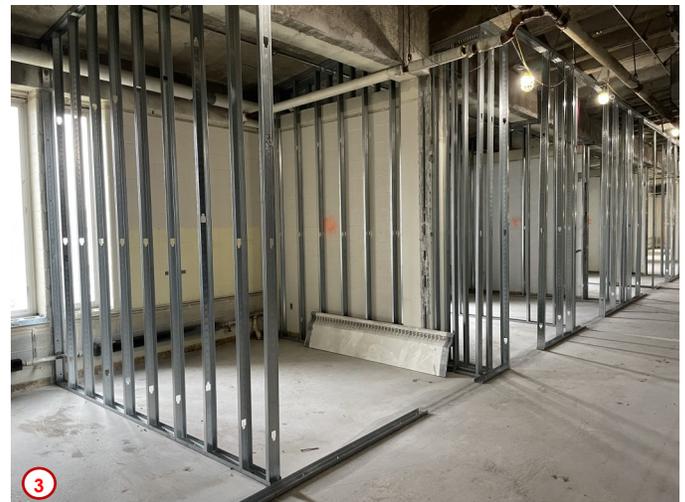
Photo #3 is a close-up detailed view of some of the new metal stud framing that will eventually form the faculty offices in the H/SS Division Office Suite.

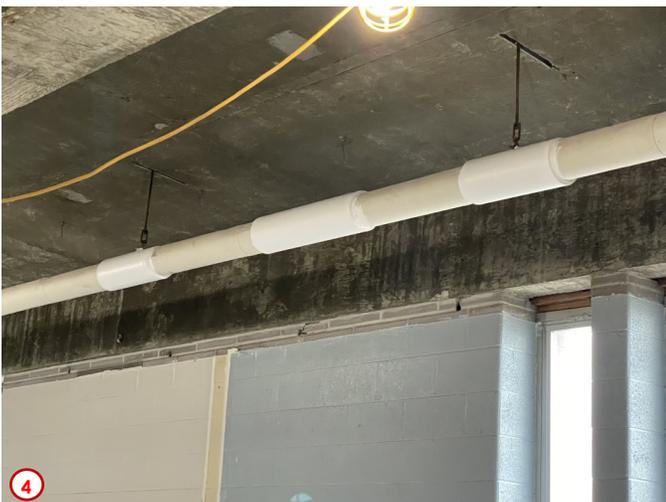
Photo #4 was taken in the area of the western stairs and highlights the efforts to insulate/reinsulate existing piping. The new insulation is easy to distinguish as it is brighter white. The insulation is being installed in areas where existing insulation was damaged or missing from abatement. This insulation is necessary so that the pipe don't "sweat" and condensation falls onto the future ceiling tiles below causing damage. Also it helps to maintain the temperature of the water running through it, as it is part of the hydronic portion of the building's HVAC system.
