Building Report | CLRC Renovations and Additions Project

12.17.21

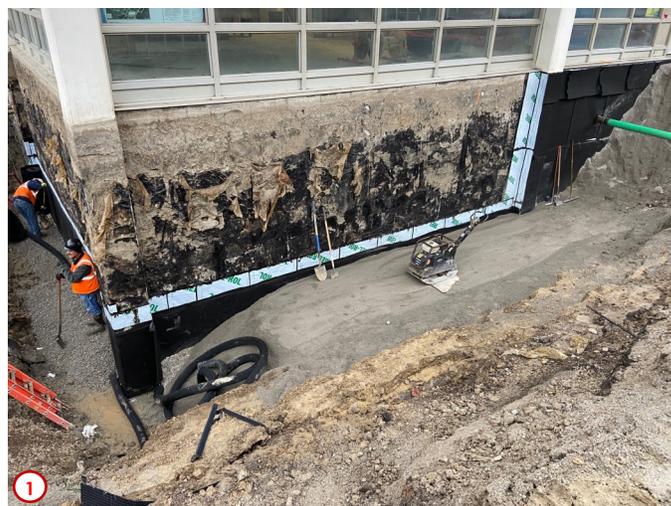
Photo #1 shows the last stretch of basement waterproofing being completed. Additional to the work for the waterproofing in this area to the building proper there will also be some new storm sewer work completed to provide better drainage for the area surround the CLRC.

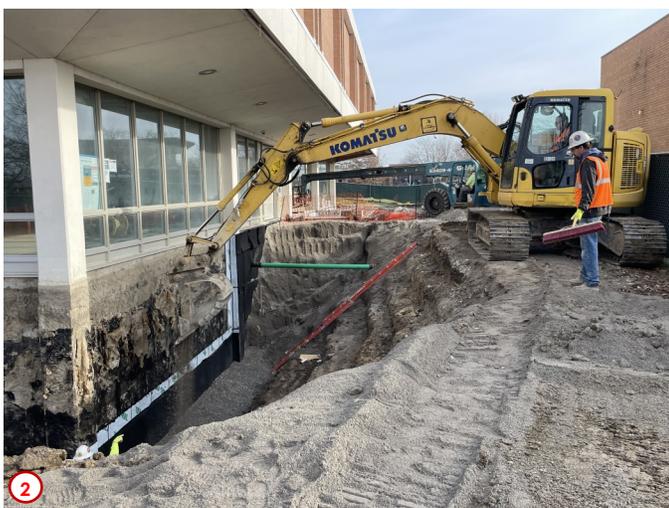
Photo #2 highlights part of the process of backfilling in around the basement walls. The backfilling is done in "lifts" and instead of placing back the old soil which was comprised of mostly clay and did not drain well the new fill is mostly crushed limestone that is compacted after being placed. This will serve as a good filtration system and provide a sturdy base for the new top soil and sidewalks that will be installed near the completion of the project in the spring.

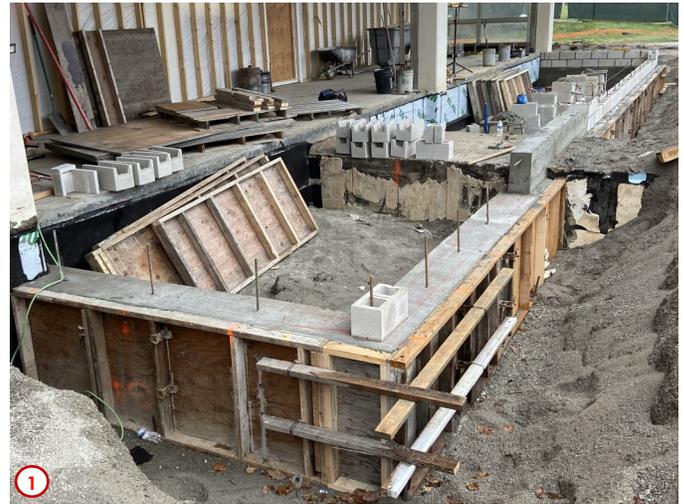
Photo #1 was taken earlier in the week and shows the foundation system concrete placed in the forms with the first of the concrete block being installed.

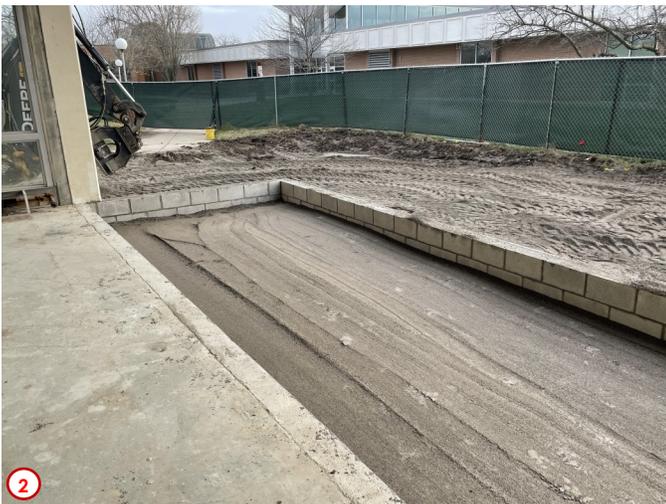
Photo #2 was taken in a similar area as Photo #1 and shows all the concrete block now in place. Additionally the stone base for the concrete floor slab was placed and compacted, and then the remaining of the backfill in the area was also brought in and compacted. Next week, weather permitting, the new concrete floor slab will be placed for the southeast addition.

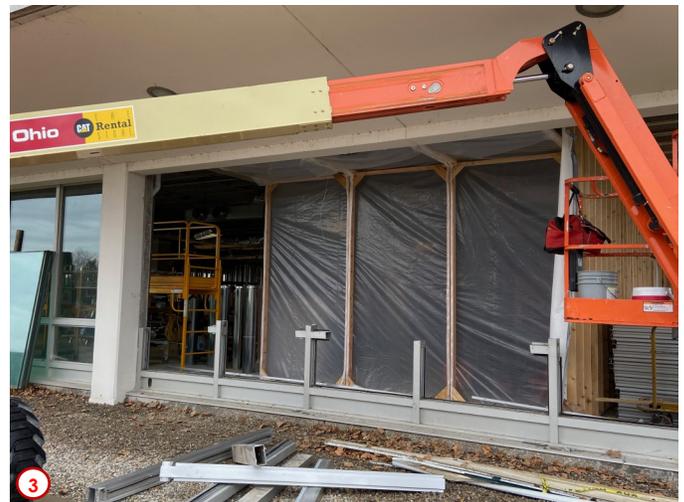
Photo #3 highlights the progress of the start of the installation of the new curtain wall system that encloses the perimeter of the first floor. The contractors have started at the northwest corner of the building and will work their way clockwise, and then they will move onto the second floor where all the existing window units will be replaced as well.

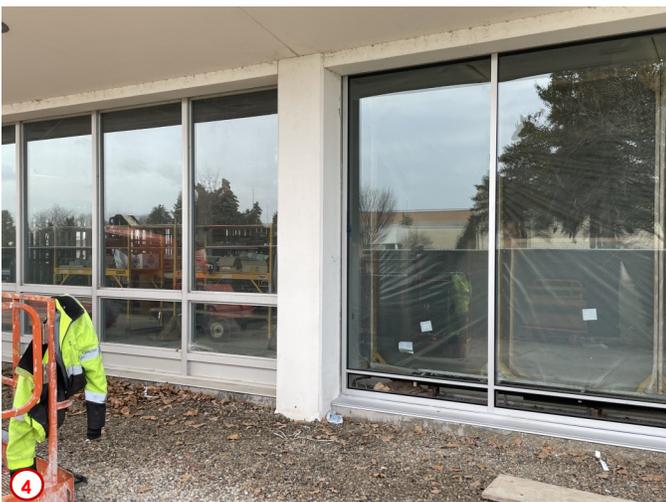
Photo #4 was taken later in the week in a similar location to that of Photo #3 and shows the first section of new curtain wall installed. The new curtain wall is on the right and the existing is on the left. This new curtain wall has a different look to it which will update the aesthetics of the exterior of the building, and is also much more energy efficient.

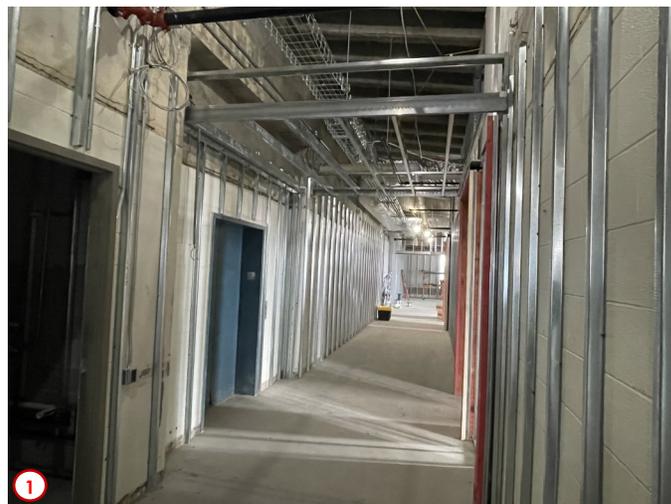
Photo #1 highlights the installation of some additional framing that is meant to help break up the south corridor, but more importantly mark the location of the elevator which will assist in wayfinding for the building occupants.

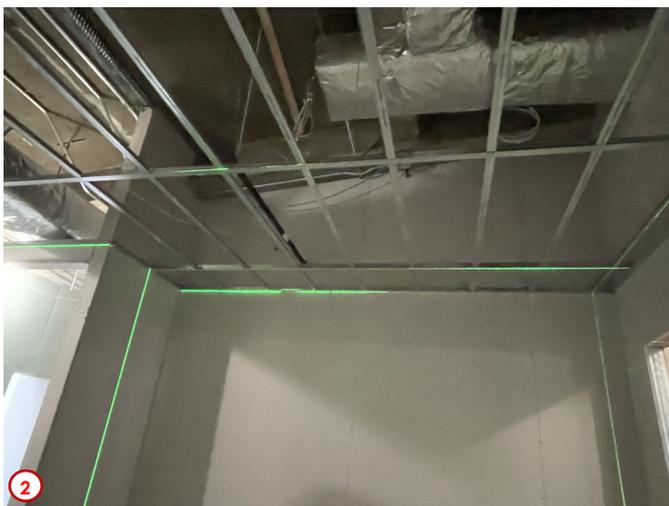
Photo #2 shows the progress of the start of the installation of some of the suspended ceiling grid in the H/SS Division Office Suite reception area. This is the first portion of ceiling systems to be installed on the second floor which is significant in that it means all of the above ceiling infrastructure is complete and has been inspected, tested, etc. and approved by the local building officials.

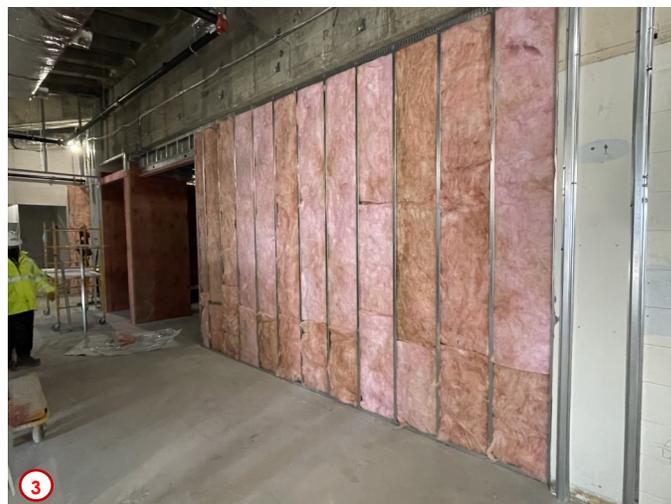
Photo #3 shows more building insulation having been installed in the stud spaces in the new wall framing. With these walls being interior the insulation isn't for heating and cooling reasons, but rather to help provide acoustical separation for the classrooms from the adjacent corridors.

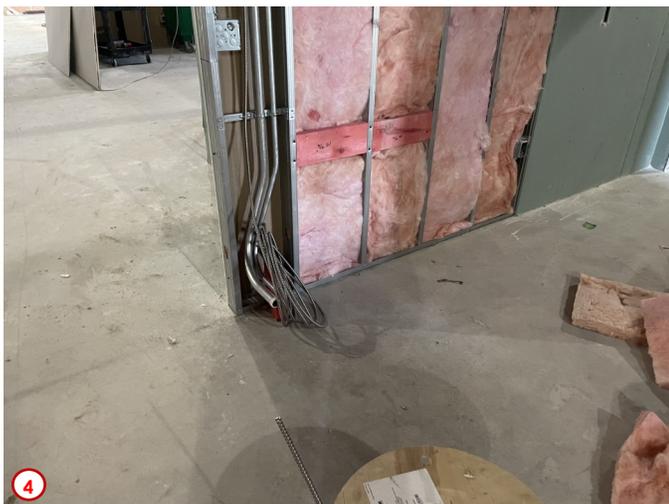
Photo #4 highlights some of the new electrical infrastructure being installed. This particular feed will help provide power to the future case-work for the reception area in the H/SS Division Office Suite. There is also provisions for the data cabling as well that will provide network access for the staff computer systems that will be installed once the building renovations are complete.
