Building Report | CLRC Renovations and Additions Project

7.30.21

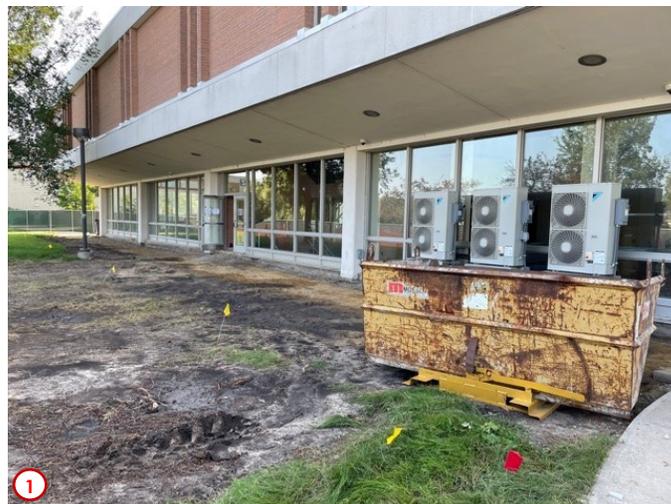
Photo #1 shows the site preparation that has been done already to prepare the installation of the new entry system on the west side of the first floor, as well the erection of the new entrance canopy and landscaping walls. This is part of the effort to change the 'back door' on the west side of the building into a new 'front door' off of Lot 7.

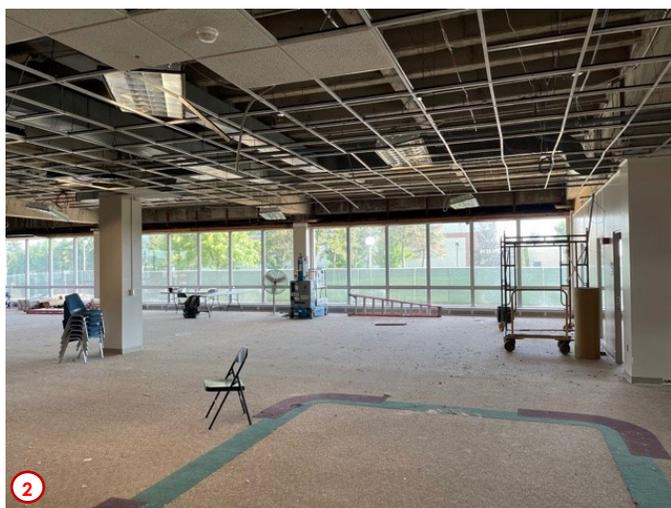
Photo #2 shows the progress of removing the existing finishes in the current Library. Here you can see the suspended ceiling tile and grid are being removed as well as the existing lighting being disconnected. Next the existing broadloom carpet will be removed to make way for new framing and finishes as part of the overall transformation of the building.

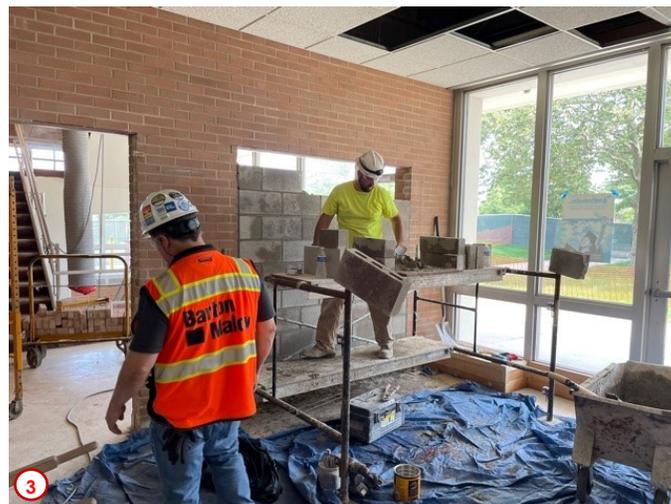
Photo #3 shows one of the masonry contractors installing new concrete masonry units (cmu) to block off the two old entries into the east stairwell. This area will then be cladded in metal furring strips and wallboard as this will be where a new conference room for use by employees or students will be located. A new single width door will be cut into the west wall of the stairwell (not seen in this photo) for means of access to that area.

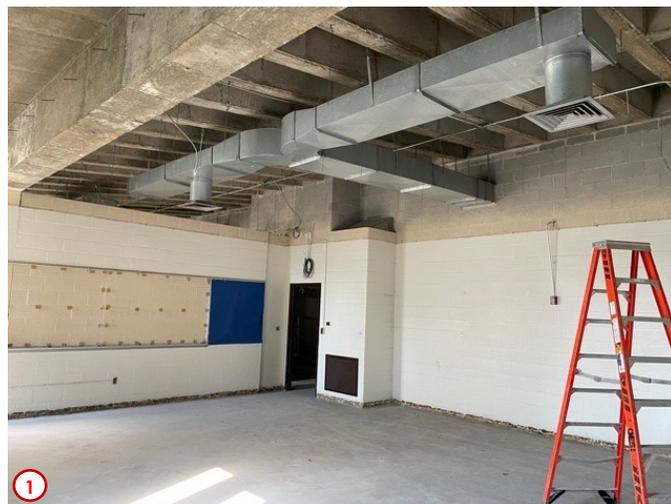
Photo #1 was taken in one of the existing classrooms. In all the classrooms that are being updated they will receive new finishes (ceiling and LED lighting, flooring, furniture, and A/V technology). All of the entryways will also be updated to meet with new accessibility code guidelines.

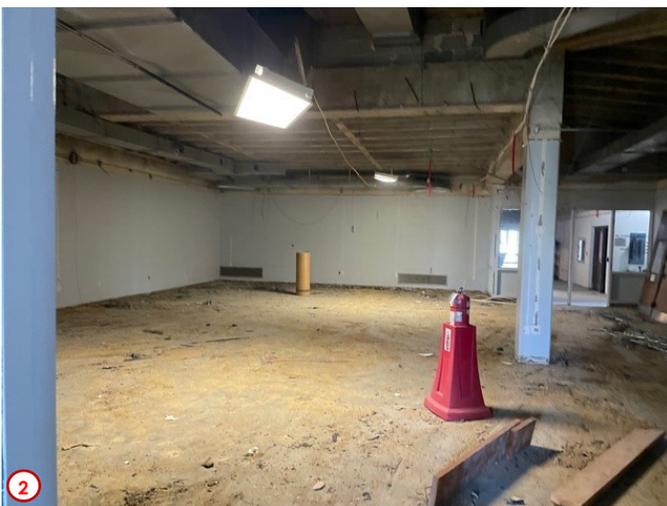
Photo #2 shows what is left of the space that used to be the Learning Assistance Lab (LAL) and Disabilities Services. This area will be divided up into a new classroom, building circulation, and offices.

Typical for the entirety of the second floor is that the asbestos abatement has been completed, and all materials that were of concern removed to ensure a healthier interior building environment for all occupants.

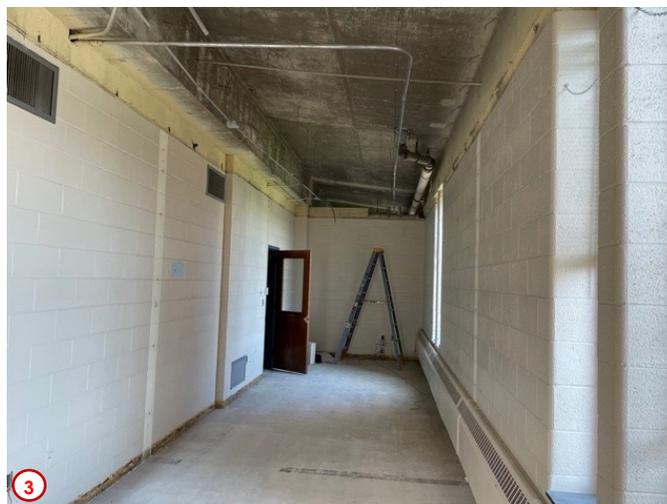
Photo #3 highlights the progress of the demolition work happening in the existing offices. This area used to be divided up for the Dean of H/SS Division and the Administrative Assistant. You can see that similar to the adjacent classrooms all existing finishes have been removed.

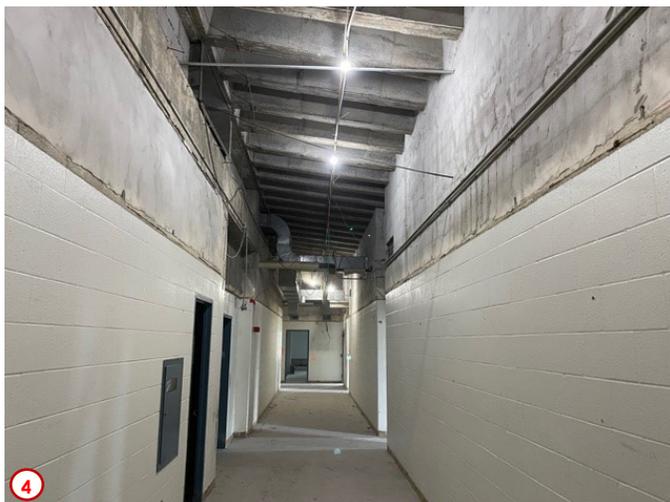
Photo #4 was taken in the south corridor looking east. Similar to the rest of the second floor all of the old finishes have been removed along with the required abatement completed. Now the contractors are focusing on disconnecting all of the existing HVAC and electrical connections in order to allow for wall demolition and eventually new construction as much of the second floor will be rearranged to better fit the new spaces being programmed in that area.

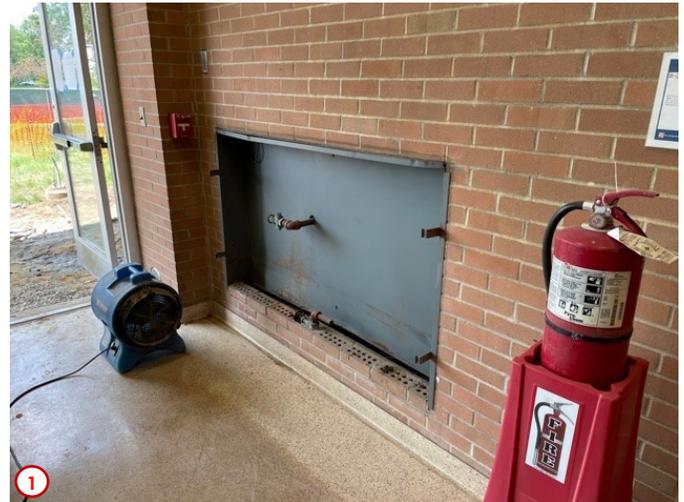
Photo #1 is of the first floor landing in the west stair well. Here one can see that the existing supplemental unit heater has been removed so that the wall it used to reside in can be removed per the new plans developed by the architect for the project.

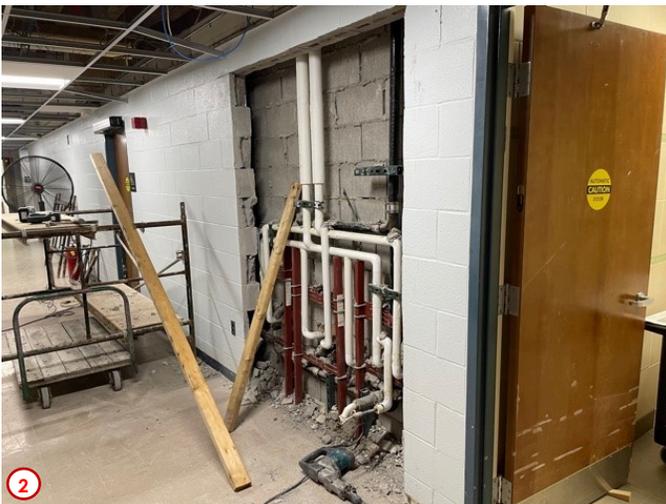
Photo #2 shows some of the old cmu wall removed in the basement near the men's restroom exposing the plumbing for the lavatories in that space. Rather than the existing galvanized steel domestic hot and cold water lines it was more cost efficient to simply re-plumb the building, which that process started in this particular location.

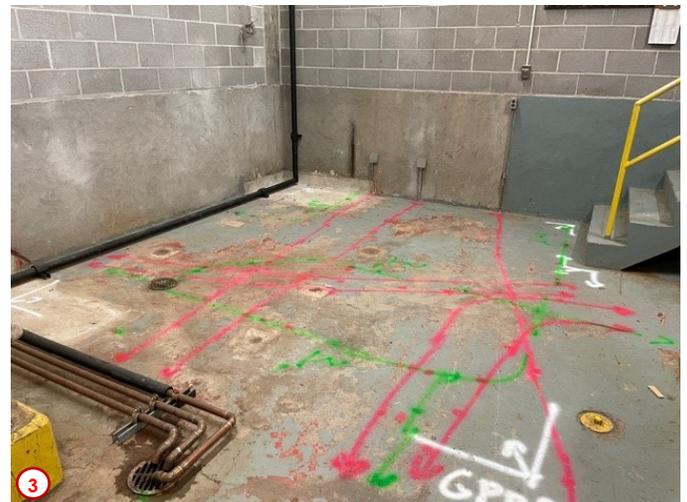
Photo #3 shows the corner of the existing mechanical room in the basement where the new janitor's closet will be constructed. Using GPR (ground penetrating radar) the contractor has noted the location of all the existing utilities and infrastructure located under the slab prior to the removal of the existing concrete floor slab and associated excavation.

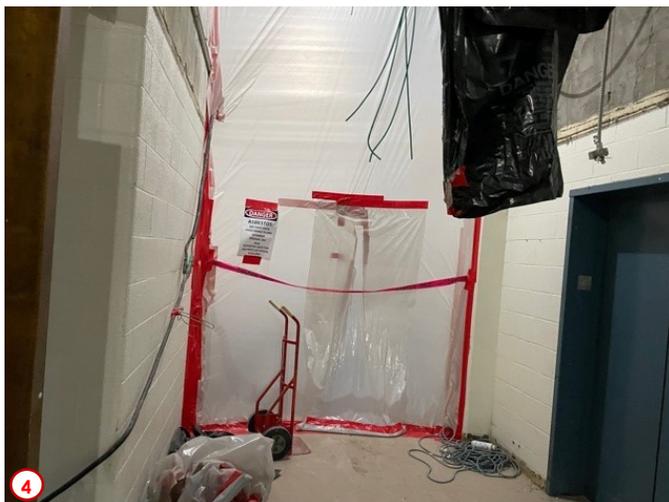
Photo #4 is not shown on the map on this sheet but instead simply highlights the fact that there is a lot of asbestos abatement associated with this project. In this building a lot of the floor tile and joints in the domestic and HVAC plumbing lines are all being abated. This picture highlights how the process is done with the contractors setting up secure negative pressure enclosures to ensure no possible contaminated airborne particles can migrate to other parts of the building while the offending material is being removed.
