Building Report | CLRC Renovations and Additions Project

8.6.21

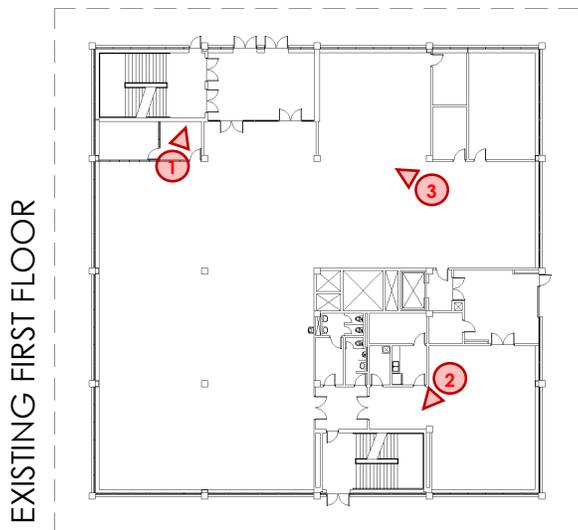
Photo #1 highlights the progress of the work at the first floor landing of the eastern stairwell. Both of the old double door openings have been filled in with cmu and existing brick, and then the new single door opening has been cut in and salvaged brick is being used to finish out the opening so the new door frame can be installed. This change was necessary to facilitate the new Library Staff Office Suite which will be partially located where the old main entrance to the space was located.

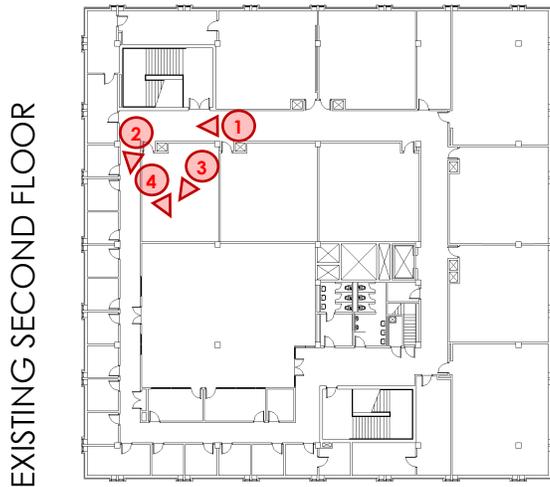
Photo #1 shows the demolition of the corner classroom nearest the old office corridor. It was necessary to remove this classroom to create the secure office suite to house the faculty and staff of the Humanities/ Social Sciences Division.

In both Photos 1 and 2 you can see that the old ceiling has been removed and therefore the roof and mechanical penthouse structural framing is exposed.

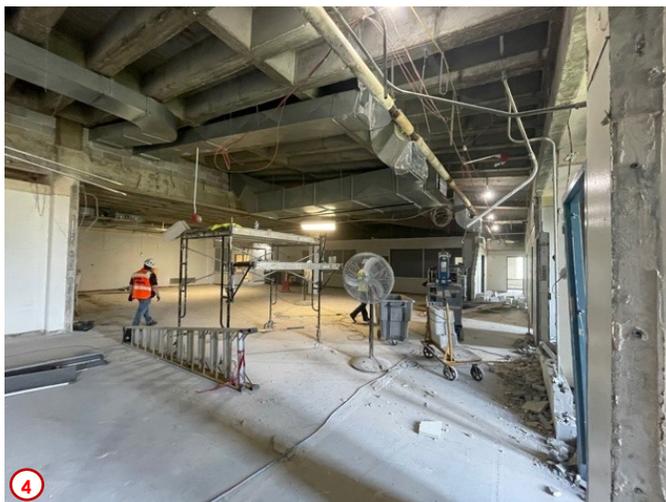
Photo #4 was also taken later in the week and shows the walls gone between the corner classroom and the old LAL space. Again, new framing for the H/SS Office Suite will be installed in this area as well as the necessary infrastructure for the new adjacent corridor. The contractor will be focused on the west side of the floor next week as far as demolition goes.
