# Building Report | CLRC Renovations and Additions Project

9.10.21

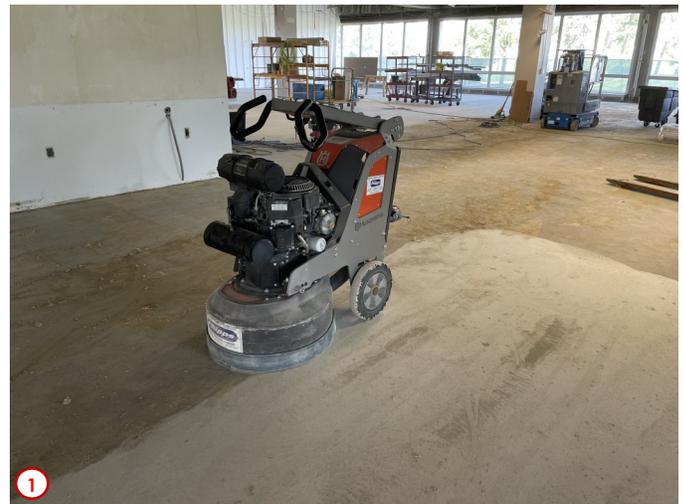
Photo #1 shows the progress of the removal of the mastic that was used to adhere the carpeting once in the Library to the floor slab. It was necessary to remove this to allow for the new wall framing, and so the new flooring to be installed in this area will be properly adhered to the slab and warranted by the manufacturer.

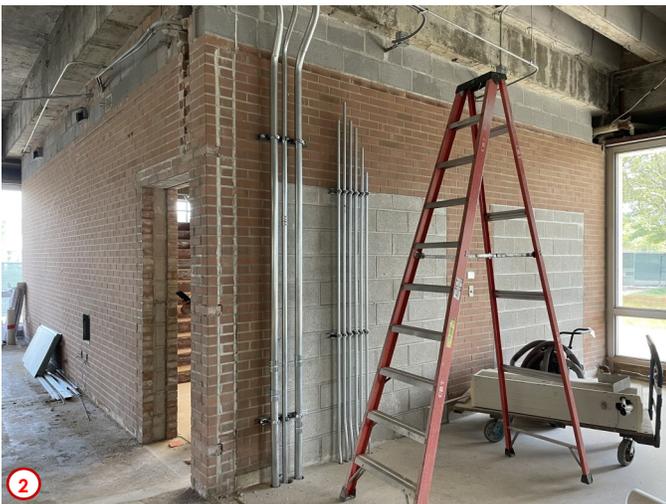
Photo #2 highlights the progress of some of the new electrical infrastructure being installed throughout the building. Here you can see some new conduits that will house wiring that is coming up from out of the basement electrical room and being dispersed throughout the building as the entire structure will be basically rewired with only a few spaces being the exception. These conduits will be concealed by wallboard that will be installed over metal furring wall studs.

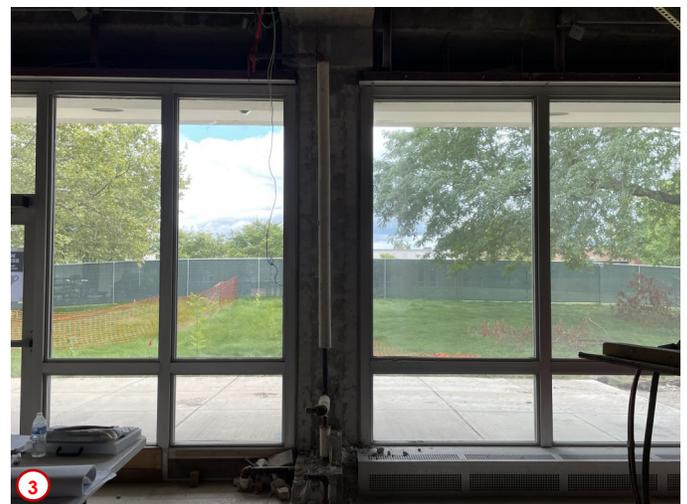
Photo #3 is of a now exposed existing plumbing draining line that will be reworked to allow new metal wall framing in this area to be installed soon. Again, this area will be part of the new Library Staff Office Suite.

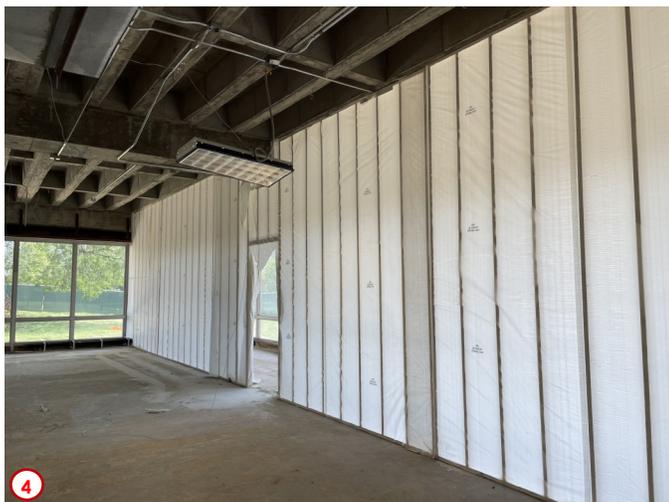
Photo #4 highlights some of the new temporary barriers that are being constructed on the first floor. These barriers are necessary because soon the replacement of the existing curtain walls (floor to ceiling window system) will be removed and replaced with a newer and more energy efficient system. These temporary barriers will help to keep the interior of the space as weather-proofed and heated or cooled as possible, especially considering the fact that we are now moving into autumn and cooler weather is settling into the region.

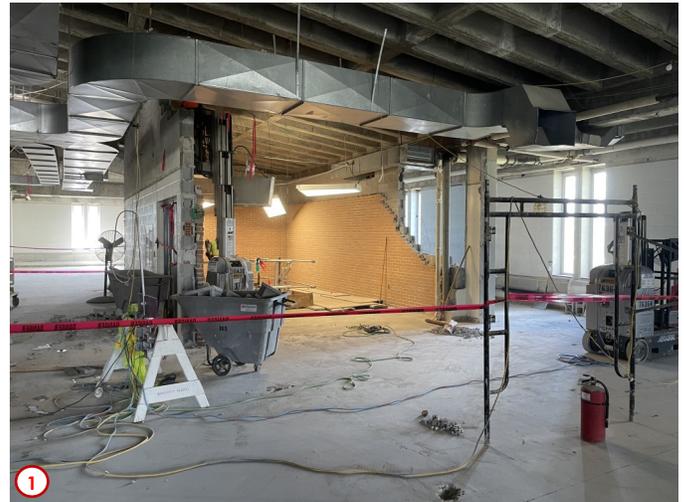
Photo #1 shows the progress of the start of the last major demolition work in the CLRC, and that is the removal of 3 of the 4 walls of the west stair on the first and second floors. These walls will be replaced by a retractable fire curtain that will deploy in case of a fire emergency. The removal of these walls will allow the creation of the open floor plan that was desired and to aid the infiltration of more natural light into the building interior.

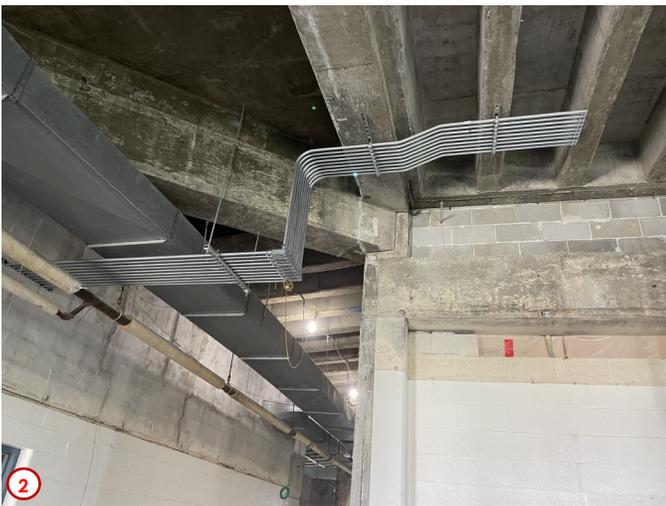
Photo #2 is similar to that #2 on the previous page and shows more of the installation of the new building electrical infrastructure, except this time on the second floor. These conduits terminate in what will be a new electrical closet near the south side of the future H/SS Division Staff Lounge.

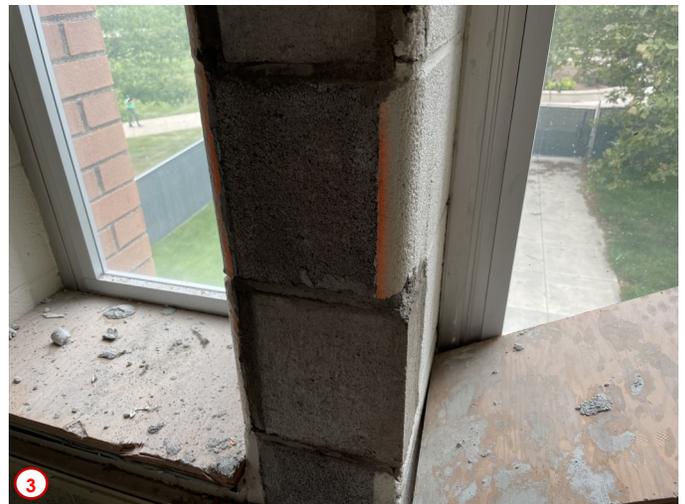
Photo #3 was taken in one of the old faculty offices. Here a wall that once terminated near the windows was removed, and therefore holes leftover from the old concrete blocks had to be filled in. As is typical for most of the building these existing block walls will receive furring strips and wallboard to conceal this condition and create a smooth finish.

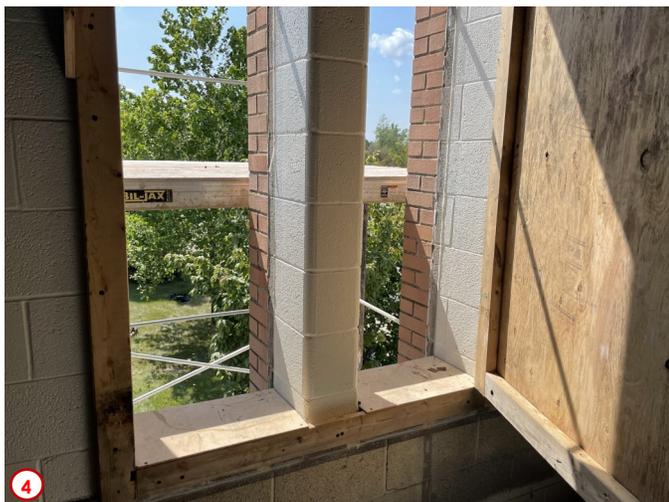
Photo #4 is of the temporary opening created with the removal of the old windows in the old southwest classroom on the second floor. Like the first floor all of the window units on the second floor will be replaced by newer and more energy efficient units.
