Building Report | CLRC Renovations and Additions Project

9.3.21

The following are pictures from the week ending in 9.3.21 in regards to the CLRC Renovations and Additions Project. This week was a lighter week as far as the amount of work getting done and so this week's report is a little lighter due to the switch over from demolition to new construction. However, when the new construction portion of the project starts there will be a lot of activity throughout the entire building. As noted in the report provisions were set up this week in order to get building materials to the second floor in preparation for the elevator shutting down for it's overhaul. Again, the all but the existing elevator shaft will be redone including new machinery and cab. Also coming up this week is the first of the three planned building electrical shutdowns. This so that the electrical contractors can disconnect and remove some old equipment as part of the overall demolition. Luckily the college already has in place natural gas-fired emergency generators that will power the existing IT Room in the basement so as not to disrupt campus-wide computing services.

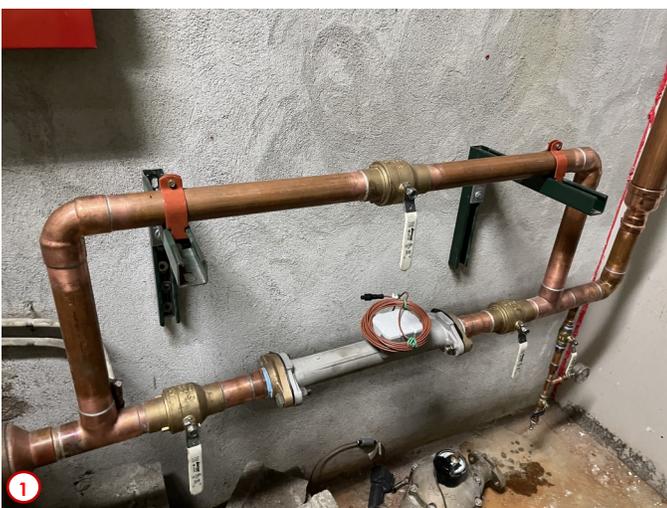
Photo #1 was taken in the northeast storage room under the eastern stairwell, and highlights the new domestic water feed and meter/valve for the building. The old domestic water feed was tied into the old fire riser that will be demoed as the new fire riser will located in the western portion of the building. The new valve (highlighted for your reference) has a new remote digital reader integrated into it which will allow for more accurate monitoring.

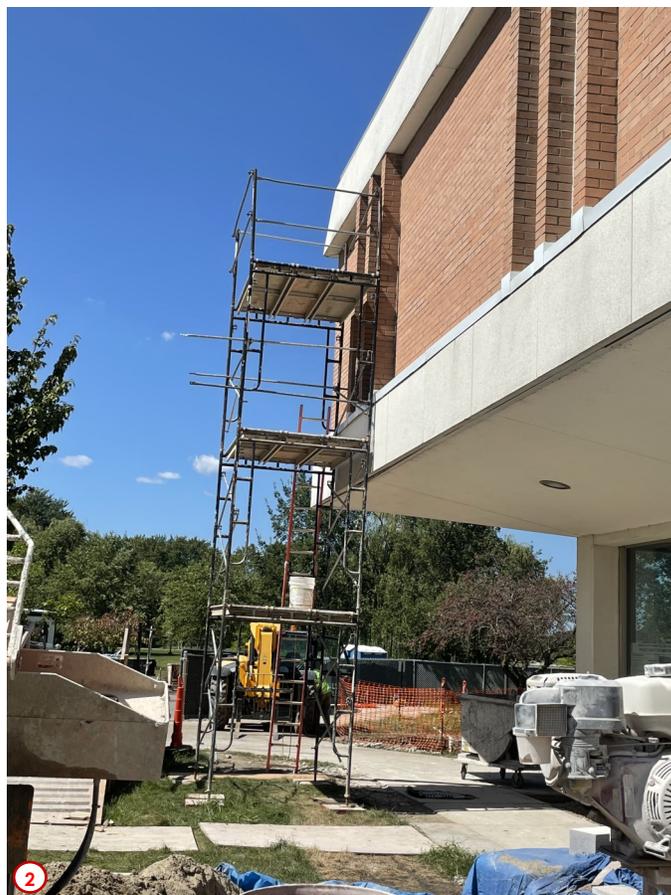
Photo #2 is an exterior shot on the south side of the building looking west. Here you can see scaffolding going up that will allow the contractors to convey building materials to the second floor through an existing window. This work was needed in preparation for the aforementioned elevator replacement that will hopefully start soon. Once the new elevator is in it will be kept offline for conveying materials and workers so as to help protect it from damage.

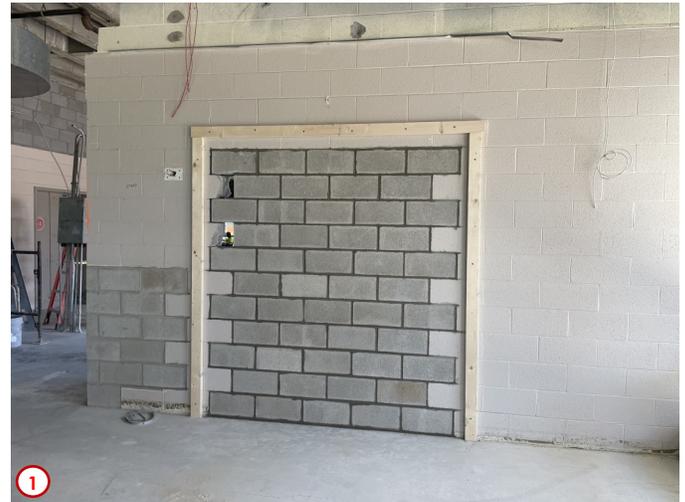
Photo #1 was taken in the area of the old Quiet Study Area of the Library. The new concrete block shown filled in the opening where the old double doors leading into the receiving area used to be located. This wall when finished will help to serve as a barrier between the revamped receiving area and the new café/student lounge along the south side of the new main first floor corridor.

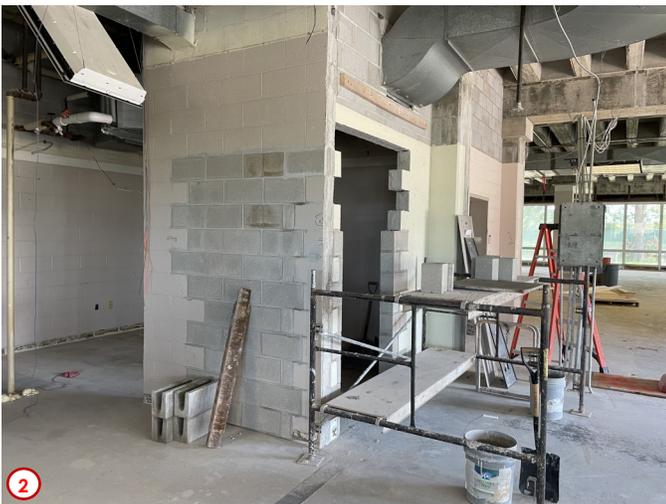
Photo #2 shows some more of the work needed to fill in old door ways and create new openings. This area will be where the new Private Room and Unisex Restroom will be located. After the project is completed there will be a unisex (or single occupant) restroom on all three floors. There is an existing unisex restroom already in the basement and then two new will be constructed on both the first and second floors.

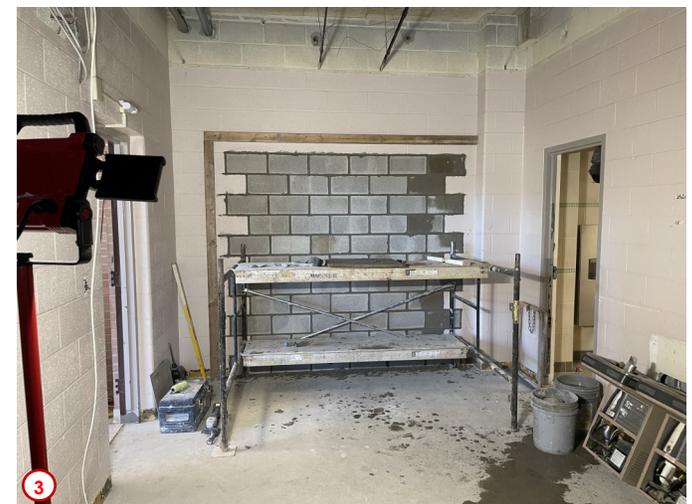
Photo #3 was taken near the old entry into the area that was the Quiet Study Area for the Library. As you can see the old entry is now blocked off by a new concrete block wall. This wall was necessary in order to create the proper flow in and out of the revamped and resized Library.

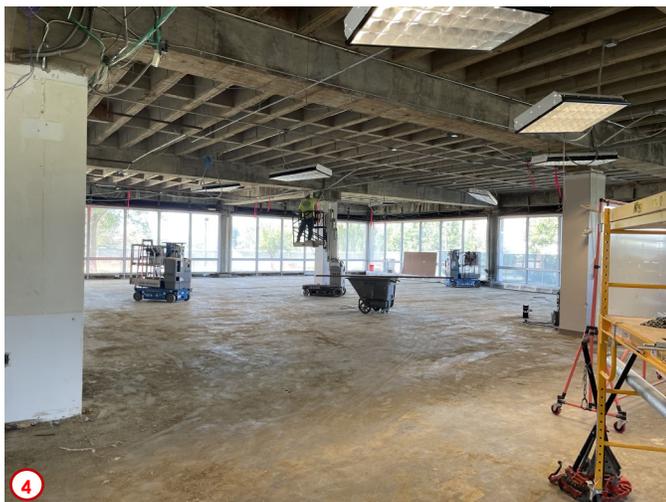
Photo #4 shows the process to complete the demolition of all the existing finished and mechanical/electrical systems in the Library. All of the existing carpet and mastic have been removed. Now the existing concrete floor slab can be ground down to remove any remaining mastic and to properly receive new frame and finishes when new construction happens in this portion of the building.

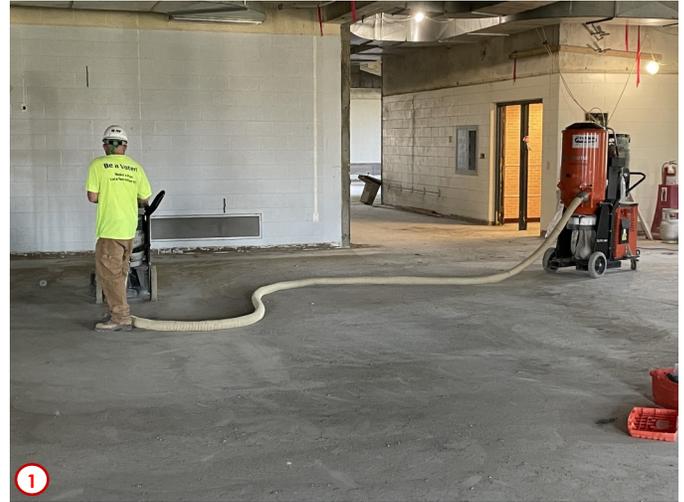
Photo #1 highlights the efforts by the contractors to prep the existing second concrete floor slab to receive new wall framing and finishes as part of the overall project happening in that area of the building. Here the contractors are using a machine to remove any last remaining mastic that used to hold down the old floor finishes.

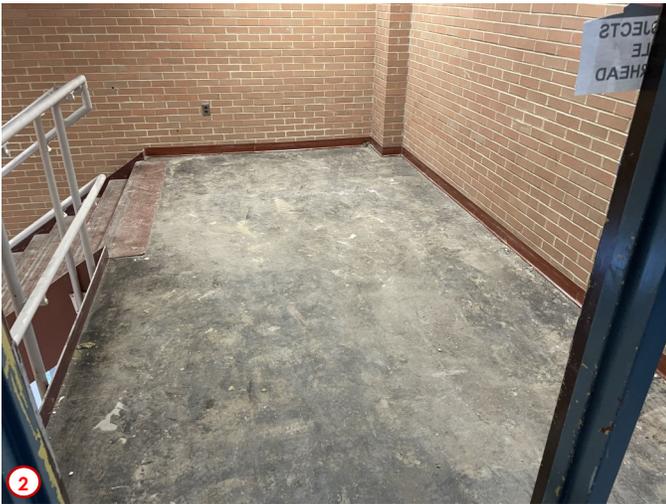
Photo #2 was taken in the western stairwell on the second floor. Here you can see the existing flooring has been removed. This process will be repeated in the eastern stairwell also. The stairs will receive new floor finishes, and code compliant railings, ceilings and LED lighting.

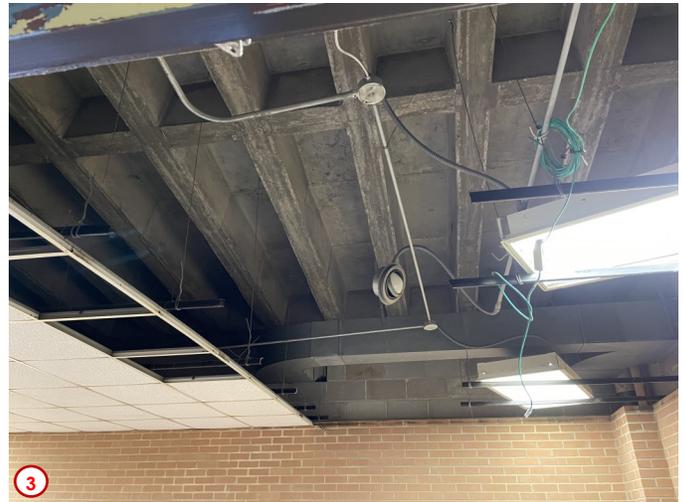
Similar to Photo #2 the bottom-right Photo #3 was also taken in the western stairwell. Here you can see the demolition process has started on the ceilings in the stair well.
