Building Report | HR Relocation Project

7.30.21

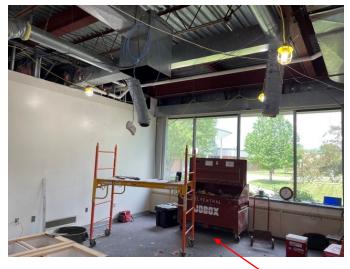
The top-left photo shows the old employee lounge area after demolition was completed with all of the finishes (ceiling, wall, and floor) having been removed in order to allow for the new wall framing to be installed.

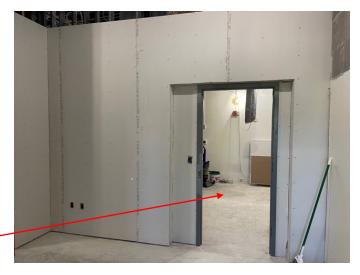
The bottom-right photo shows the new passage door from the HR Office Suite into the adjacent Conference Room (A-153). The reasoning for this new door was twofold: 1) it provided the needed second form of egress from the HR Suite for life safety reasons, and 2) it allows for HR to have immediate access to a conference room to aid in their operations. For example, when they are conducting interviews, meeting with insurance representatives, etc. This door will have access control so as to again reinforce the idea of employee confidentiality and record security.
