MONROE COUNTY
COMMUNITY COLLEGE

5-Year Master Plan

October 2018

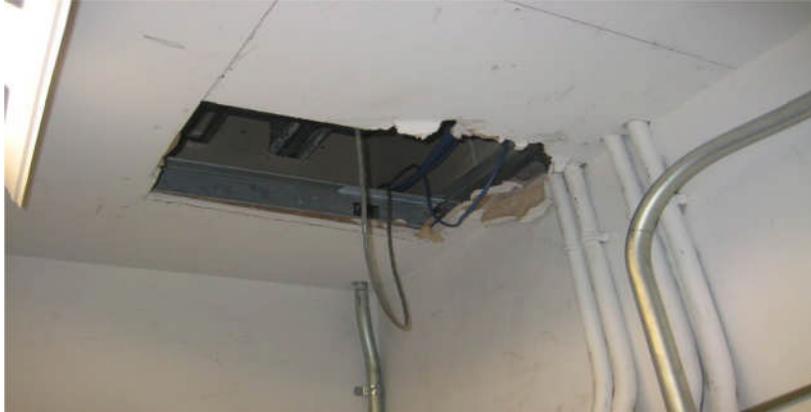
Whitman Center – breach in fire-rated ceiling assembly.

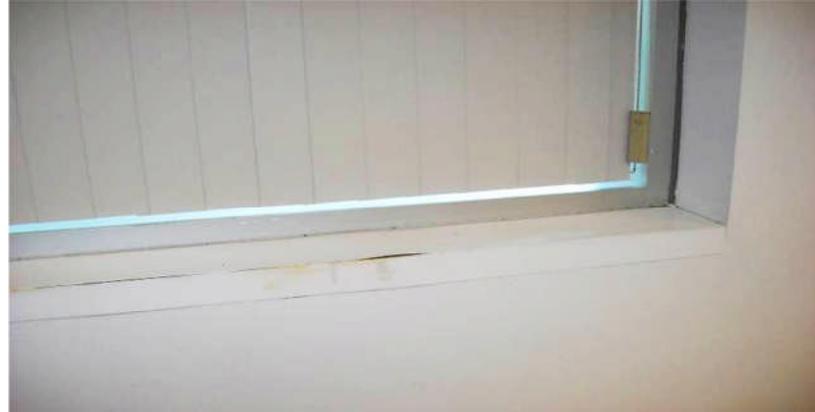
Whitman Center – water infiltration along exterior wall has caused deterioration of the plastic-laminated windowsills.

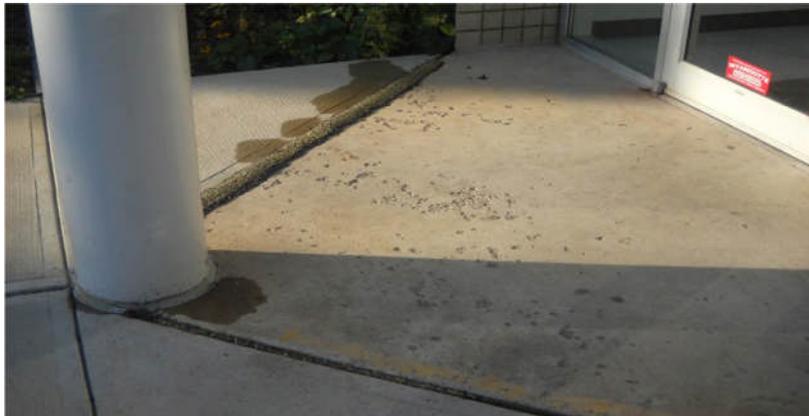
Whitman Center – settlement/heaving of exterior concrete slab (at main entrance) presents a tripping hazard.

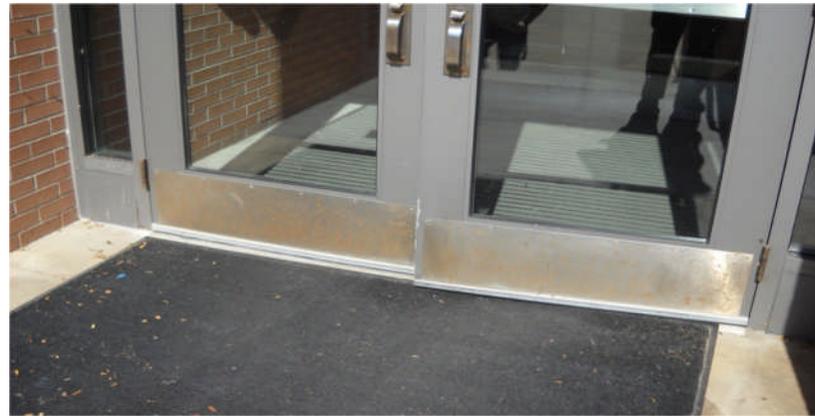
Student Services/Administration - Aluminum entrance doors and hardware at end of life.

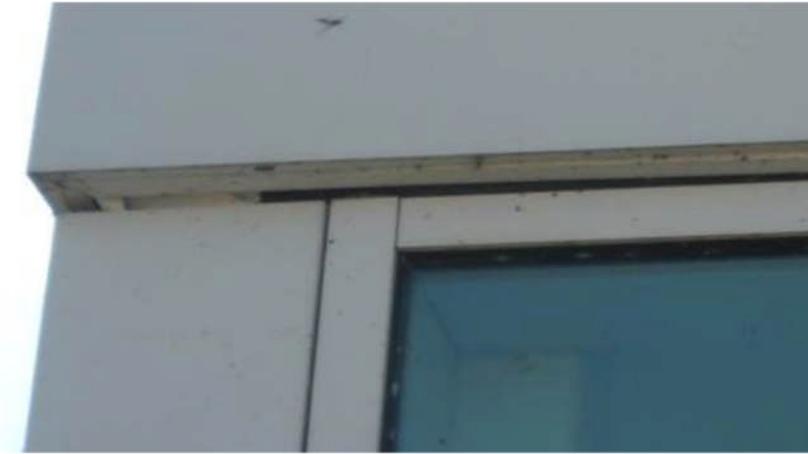
La-Z-Boy Center – It appears there is a void within the exterior aluminum, curtain wall assembly allowing the environment to enter the interior.

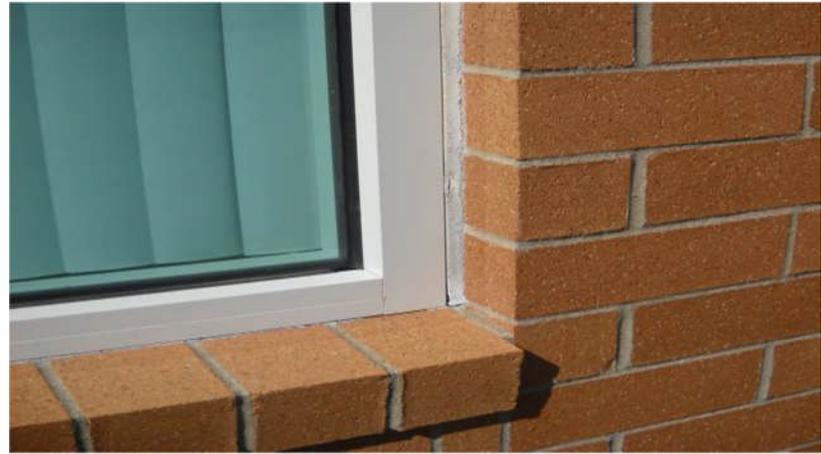
Health Education Building – Typical sealant joint is at end of life.

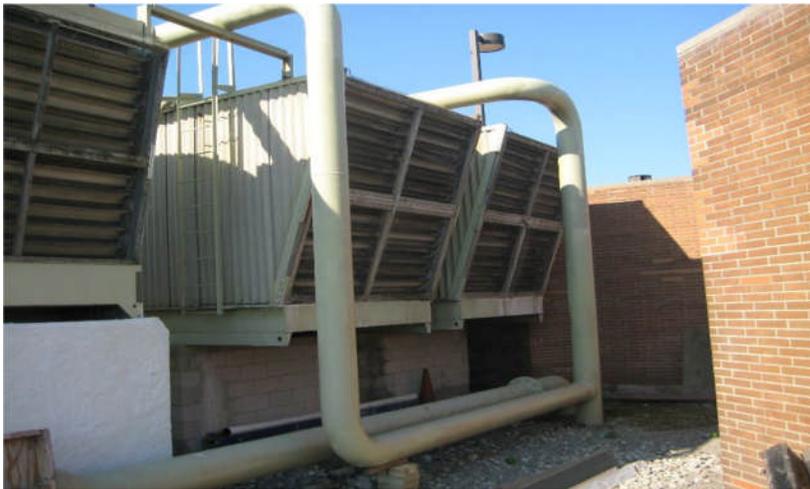
Physical Plant – Cooling tower and basins are near end of life.

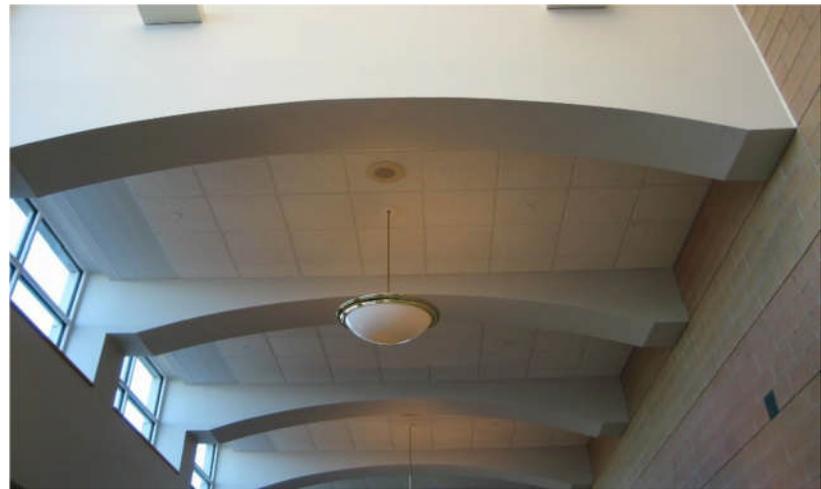
Health Education Building – Daylighting controls for the Atrium would save energy.
