# Building Report | CLRC Renovations and Additions Project

07.29.22

The following are pictures from the week ending in 07.29.22 in regards to the CLRC Renovations and Additions Project. Construction is wrapping up and soon items such as wayfinding signage and building equipment like courtesy phones will be installed. Landscaping will be planted soon along with the rest of the new flatwork (sidewalks) placed so it is cured properly cured for the start of the Fall Semester. There are a few areas of wall graphics that are on site and will be installed soon. The remainder of the furniture will be arriving soon, and starting next week the process of placing the books on the new shelves in the library will begin. Towards the end of next week a vendor will be on site to power wash the building as the project comes to a close. The remainder of the programming for the front end controls for the HVAC systems is wrapping up and soon the building be visible for our power systems operators. Existing furniture that is being stored on site for the lower level will be moved back into the building, installed, and properly cleaned.

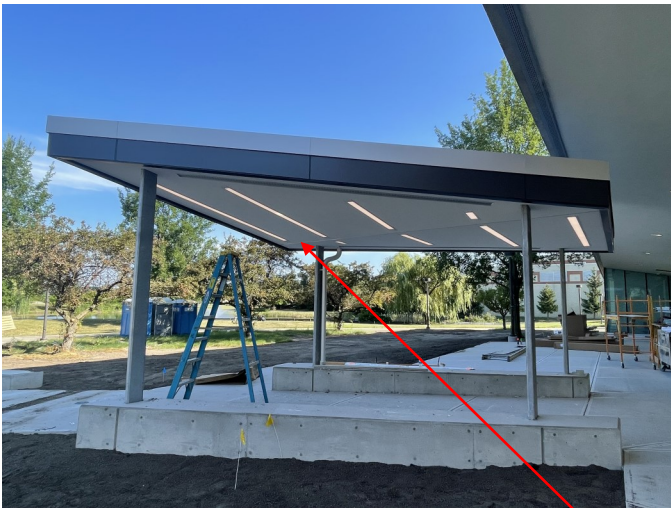
The top-left photo features the now complete new west entrance canopy. In fact, both canopies are now completed and ready to protect the new entrances from rain.

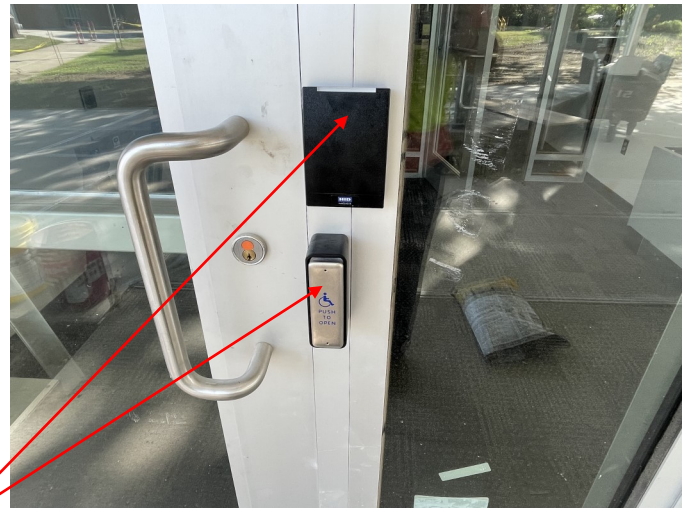
The top-right photo shows one example of the final building access control devices being installed. Featured are the key card pad and ADA door opener button at the new east entry.

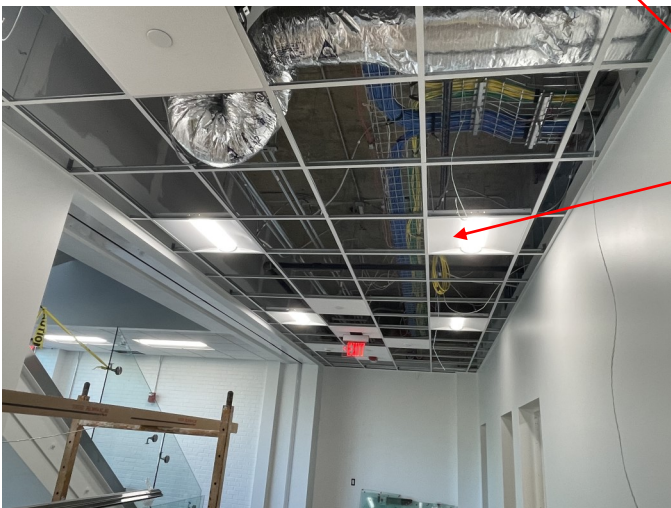
The bottom-left photo shows the progress of the finished ceiling being installed to the east side of the west stair tower. Since the fire shutters are in and their enclosures framed and finished the remainder of the finishes around them can be completed. Wall primer and finish paint has also been applied in this area.

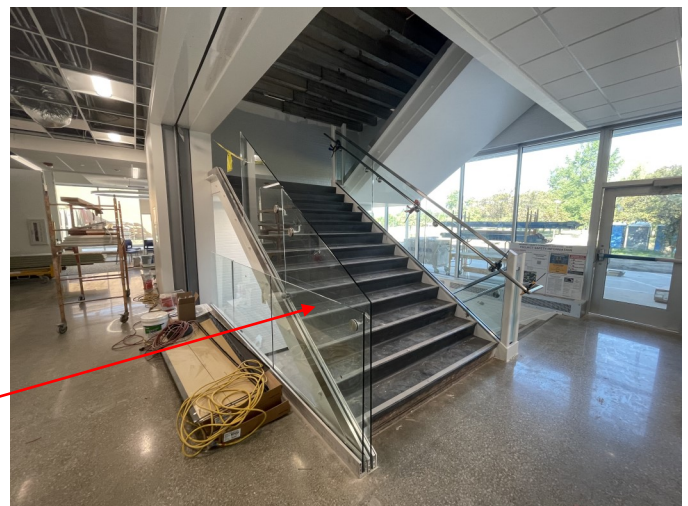
The bottom-right photo the new glass railing system being installed at the west stair tower. This is the same system that has already been installed for the east stair tower. Once all the glass panels are in a metal finish cap will be installed and the railings will receive the rest of their anchors so that they are solid and secure to properly serve building occupants.

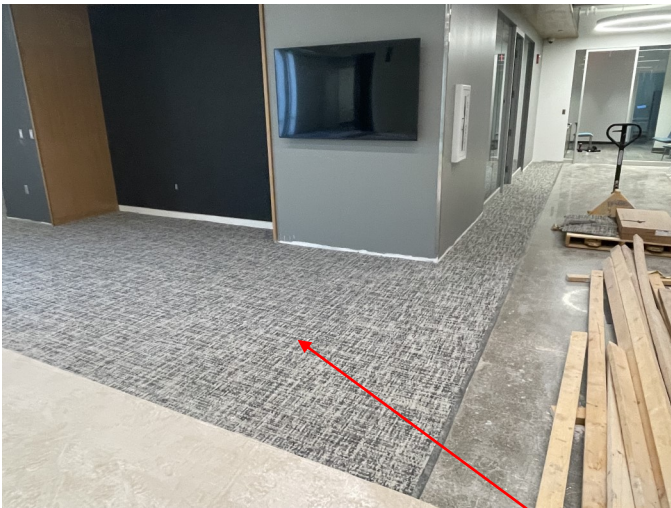
The top-left photo highlights the installation of the remaining carpet planks on the second floor in the commons area at the top of the western stair tower. Now the contractors will move on to installing the rubber wall base to complete their work.

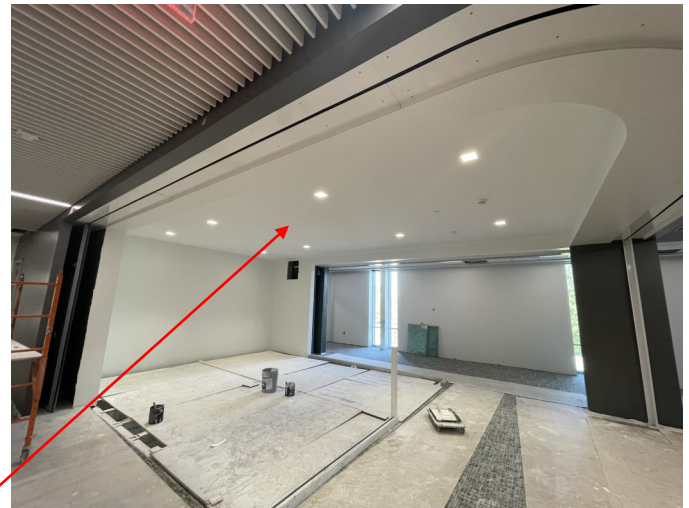
The top-right photo features the now finished ceiling at the top of the west stair tower. The wallboard has been finished and the new lighting is in place and working as designed.

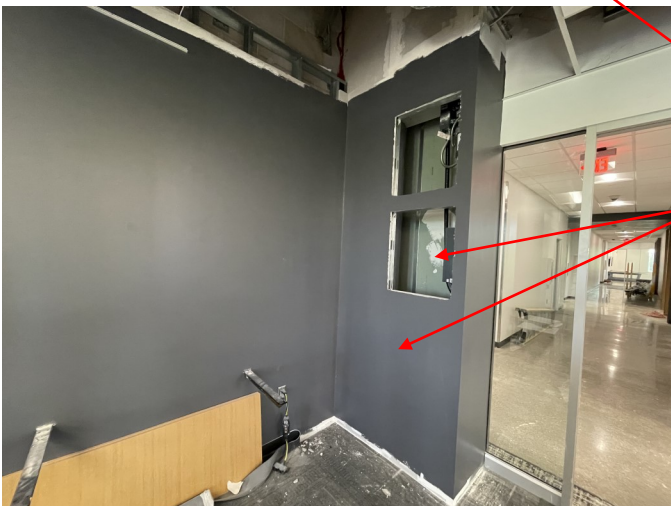
The middle-left photo was taken inside the Student Publications Area and highlights the work being done to enclose the back side of the pocket for the fire shutter. A pair of access panels will be installed which will allow for maintenance of the shutter in the future.

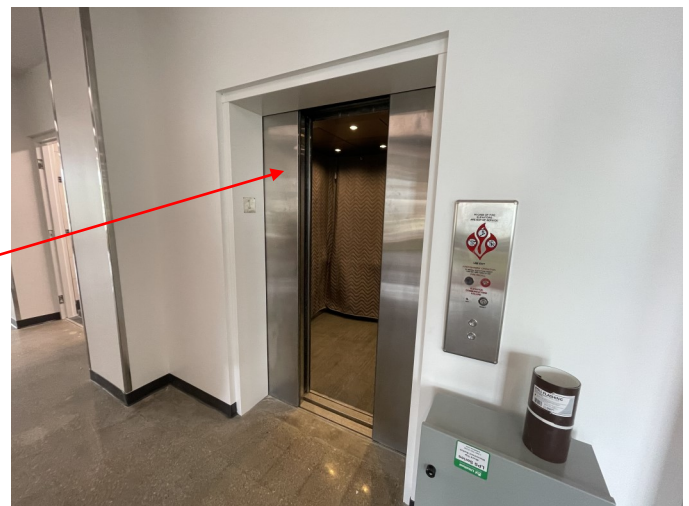
The bottom-right photo was taken in the library and shows the elevator in action as it passed its inspection today. This new elevator contain many ADA features that the previous model did not which will increase the accessibility in the building.

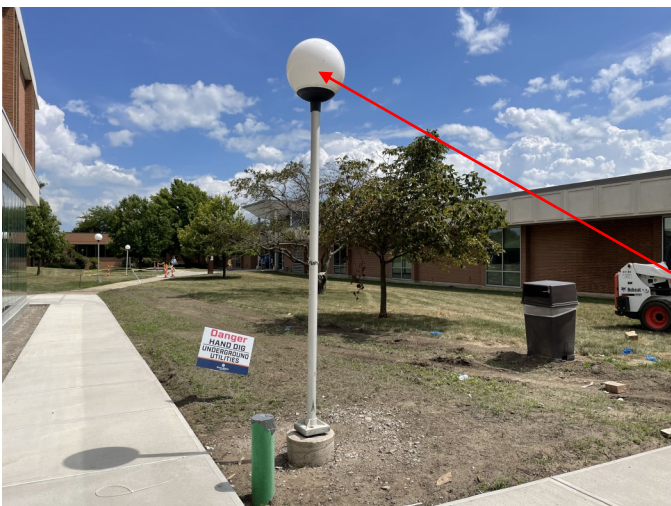
The bottom-left photo was taken outside the south end of the building and shows one of the existing sidewalk lights that were relocated as part of the project now in place and ready for use. Overall there were several lights that had to be relocated for this project due the additions, canopies, and sidewalk re-configurations.
