Building Report | CLRC Renovations and Additions Project

11.19.21

The following are pictures from the week ending in 11.19.21 in regards to the CLRC Renovations and Additions Project. More progress was made this past week with the targeted waterproofing for the basement walls. In the next couple of weeks enough will be completed and backfilled so that the foundation system for the addition at the southeast corner can be completed. With the majority of the rough framing completed on the second floor a lot more detailing can be completed as that area is being completed. The first floor rough framing is coming along well, and should be wrapping up in the next few weeks also. More new mechanical infrastructure was installed on the first floor as the contractors push to have all the above ceiling work finished so it can be inspected at a later time. With the upcoming holiday season there will be some shorter workweeks coming up which will slow down some of the current work, but since this was accounted for in the overall schedule won't pose a problem as we are still on track for a June 2022 finish for the project.

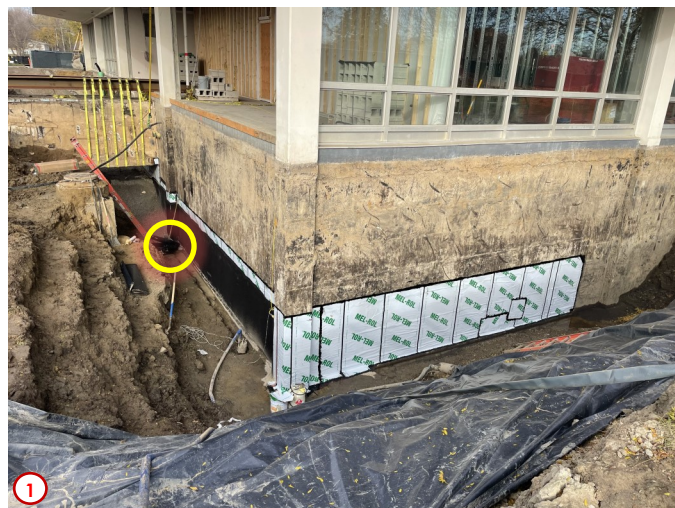
Photo #1 was taken earlier in the week and shows the work being done to waterproof the basement walls and backfill to make way for the future addition in this area. Highlighted for you is the new drain tile that is being placed adjacent to the footing. The previous version of this tile was installed incorrectly at the wrong depth and therefore was ineffective. This is just one of the many legacy items that are being corrected with this project.

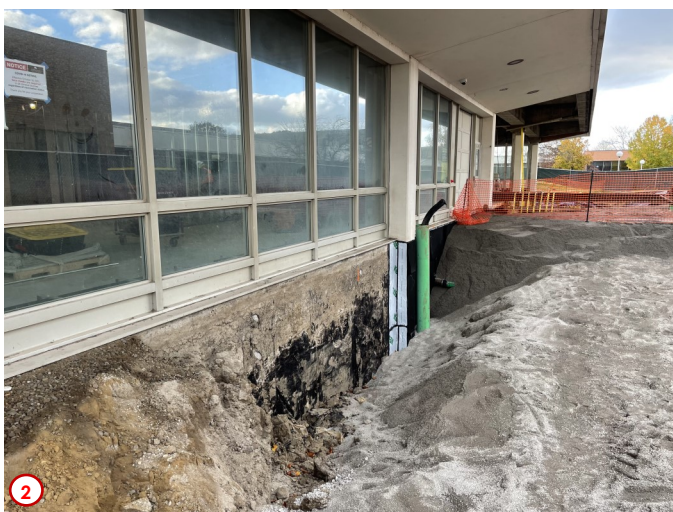
Photo #2 highlights the progress of the targeted waterproofing for the basement. The contractors are focusing on backfilling the southeast corner. This is because of two main reasons: the foundation system for the addition in this area can be installed. Also, so the pad for the condensing units that service the main server room in the basement can be relocated here.

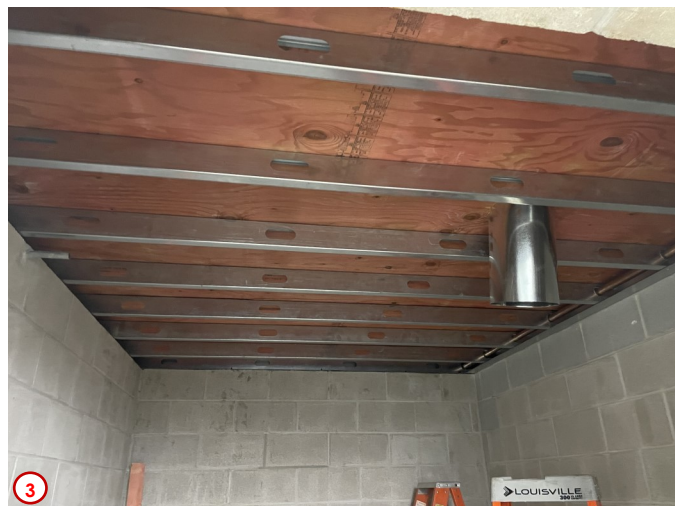
Photo #3 shows that the framing and wood decking has been completed for the hard ceiling in the new janitor's closet in the basement. Once the electrical and mechanical infrastructure is in place the wallboard can be installed.

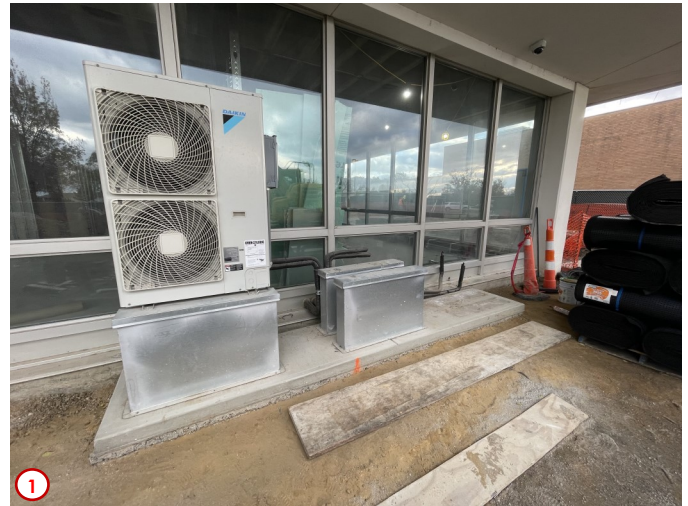
Photo #1 was taken near the southwest corner of the building. Here you can see the condensing units that are connected to the main server room in the basement. These units are sitting where the new main west entry into the building will be located, and there need to be relocated. These units will sit temporarily inside the old receiving area until their new pads are poured on the south face of the building.

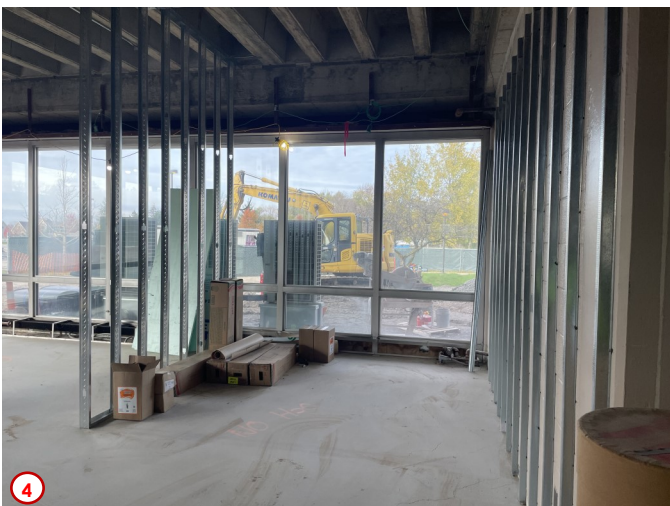
Photo #4 shows the framing being installed for what will be the new west entry at the end of the new main corridor. Here you can see aforementioned condensing units outside the curtain wall window system that are in the process of being relocated so the new entry system can be installed linking the first floor to Parking Lot 7 at the southwest corner of campus.

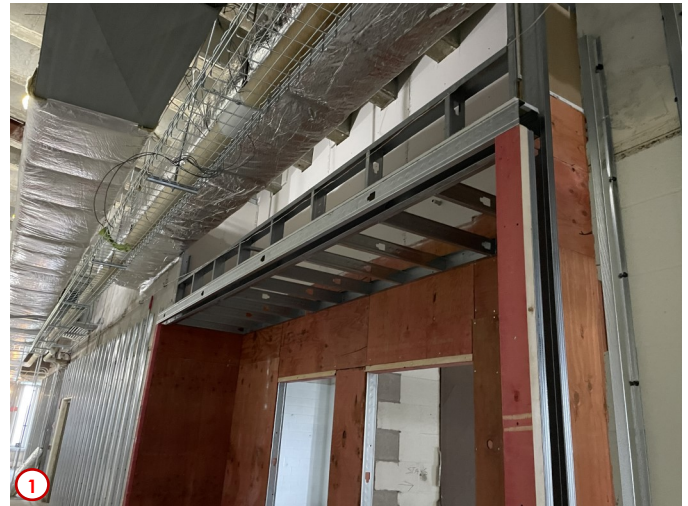
Photo #1 shows some of the typical detailed framing that is happening at each of the classroom entry ways. This new constructed bulkhead will receive wallboard at a later time to help finish it out. It is areas like this which will receive special finishes that will help with wayfinding, and add character and help provide a nicer overall environment throughout the building helping it to have a warmer and pleasant feel as opposed the colder more sterile feel that used to exist in the building.

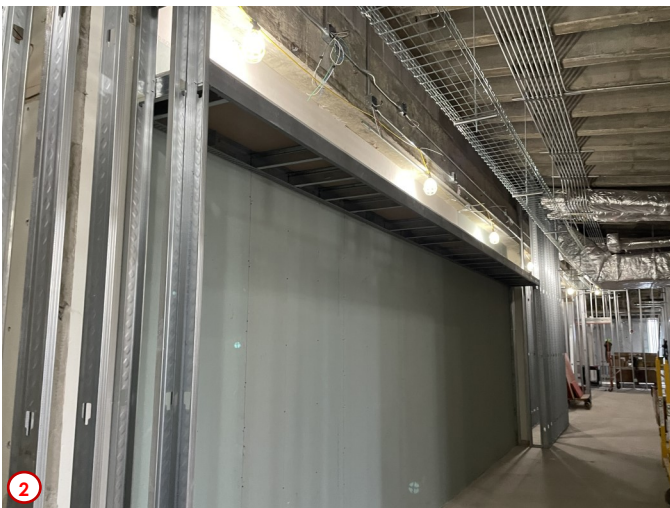
Photo #2 was taken to show more of the detailing happening as far as the rough framing on the second floor. Here you can see yet another area of bulkhead that has been framed in and ready for wiring and wallboard at a later time.

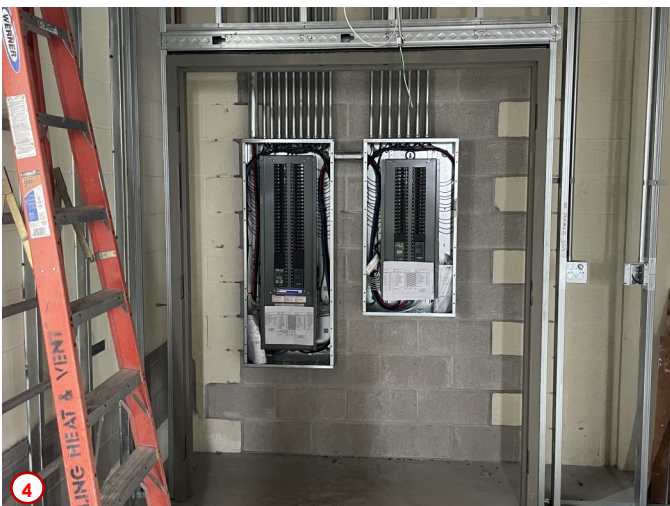
Photo #4 shows more progress being made as far as the installation of the new electrical infrastructure. Here you can see that the wires have been run through all the conduits and terminated at the panels. Now the panels and breakers are getting installed and the wiring terminated at the appropriate location. Again, this is all needed because all the old panels in the corridors are being pulled into dedicated electrical closets for safety reasons as well as upgrading to current building code standards.
