Building Report | Life Sciences Façade & Addition

1.19.18

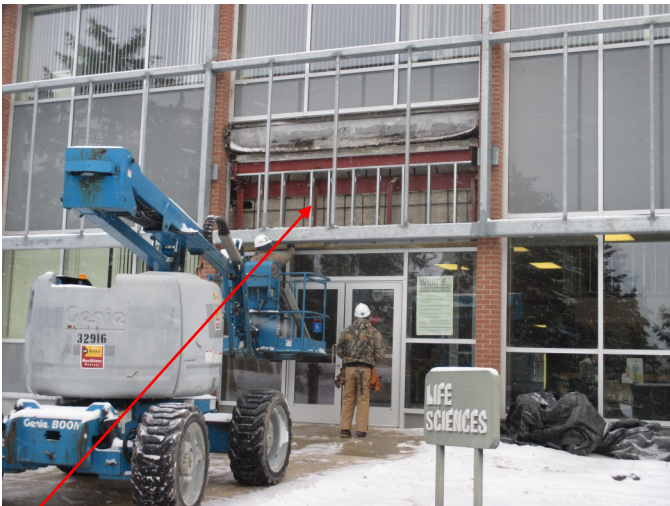
The top-left photo shows some of the work earlier this week above the south entrance of the existing building. You can see some new light-gauge metal framing has been added. Next the contractor will install some wood sheathing and then eventually some corrugated metal panels to match the north side of the building and addition.

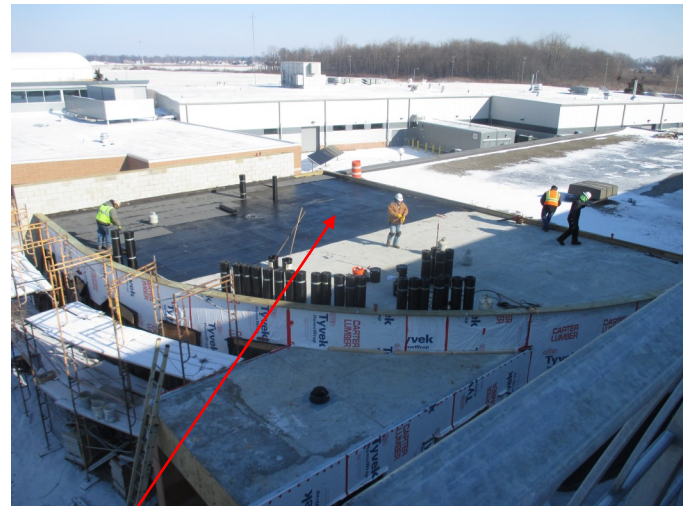
The top-right photo shows the progress of the installation of the first layer of roofing for the addition. Technically now that this first layer has been installed the addition is weatherproofed enough that the contractors can start insulating the interior and installing wallboard. Additional layers of roofing will be installed later weather permitting.

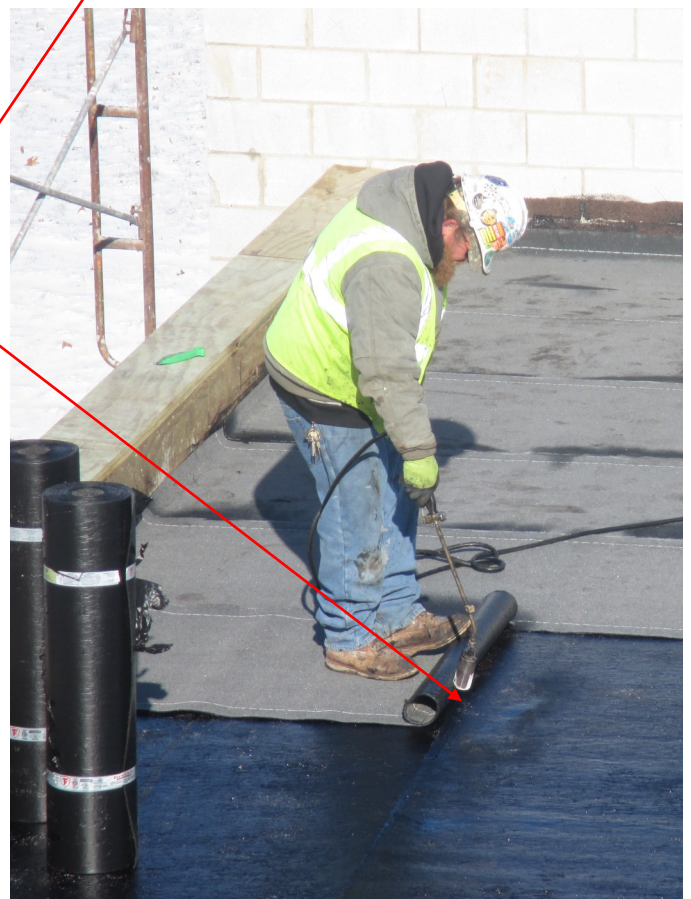
The bottom-right photo is a close-up of the process of the roof installation. You can see a layer of membrane being "torched down" so that it is properly adhered to the concrete roof deck.

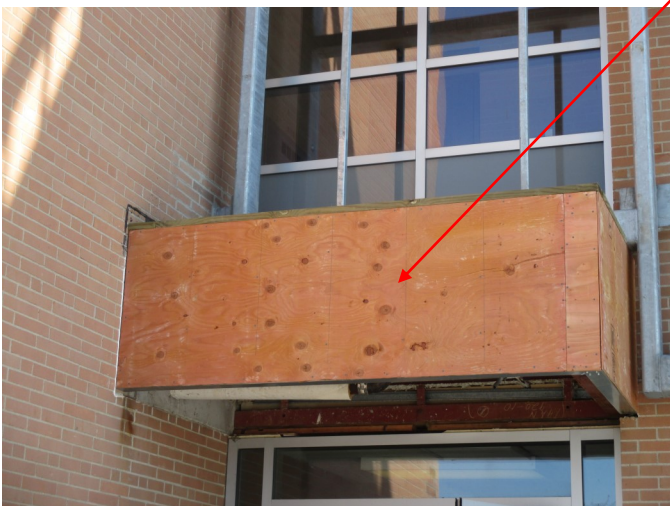
The bottom-left photo shows the southwest entrance framing and sheathing now complete and ready for it metal panel veneer.
