Building Report | Life Sciences Façade & Addition

11.17.17

The following are pictures from the week of Nov. 13 - 17, 2017 in regards to the Life Sciences Building Façade Improvements and Addition Project. There was a great amount of work completed this week with the installation of the roof and floor slabs for the addition, as well as the support steel for the new shade system on the south and east facades of the building. With the roof and floor slabs now in place and ready that opens things up for even more trades to be on site, and so we should see the processes for the addition completion start moving more rapidly. Now that all the support steel for the new shade systems on all four faces of the building the new mesh panels can start to be installed. These panels should all be installed within the next few weeks and will dramatically change the overall exterior look of the building.

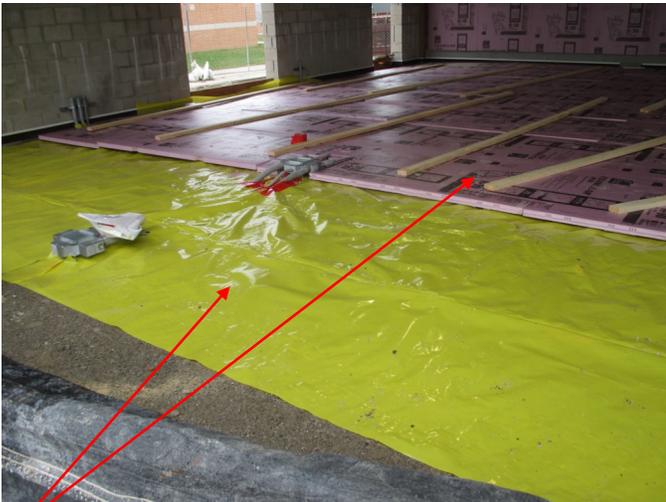
The top-left photo highlights the preparation for the installation of the concrete floor slab of the addition. Here you can see the under slab vapor barrier and rigid insulation being placed.

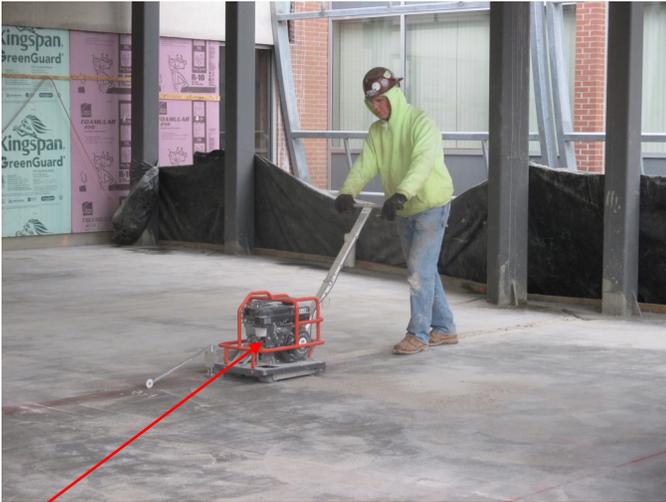
The top-left photo shows one of the contractors cutting the control joints in the floor slab. This joint will help to keep cracks in the future from telegraphing through the slab.

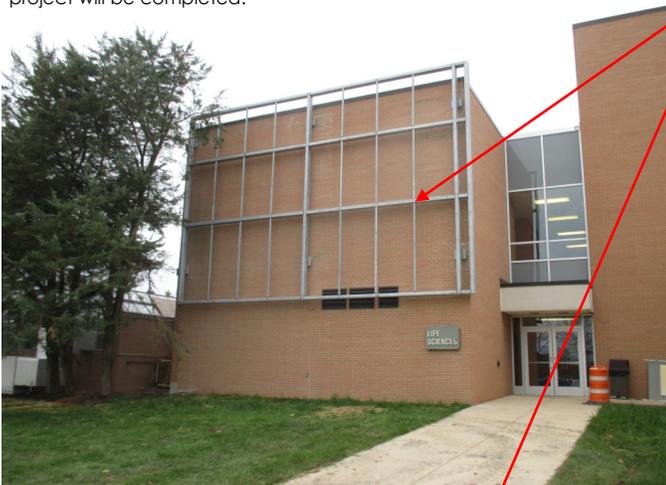
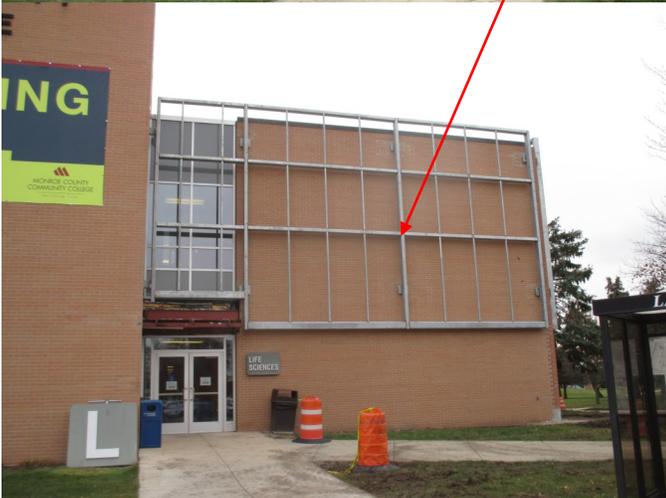
The bottom-left photos show the completed installation of the support for the new shade systems on the east and west faces of the Life Sciences Building. Now that the support steel is in the mesh panels can now be installed and then the façade improvements portion of the project will be completed.

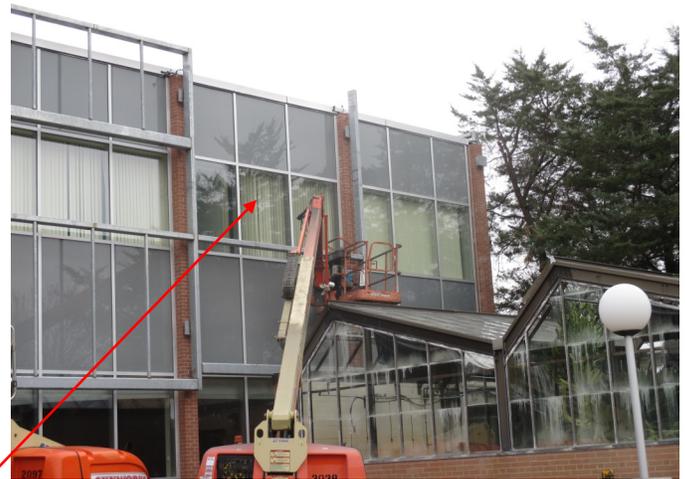
The top-right photo highlights the installation of the last few bays of support steel on the south face of the building. The installation of the steel in this area will take a little longer as it is more difficult due to working around the greenhouse and connecting corridor.

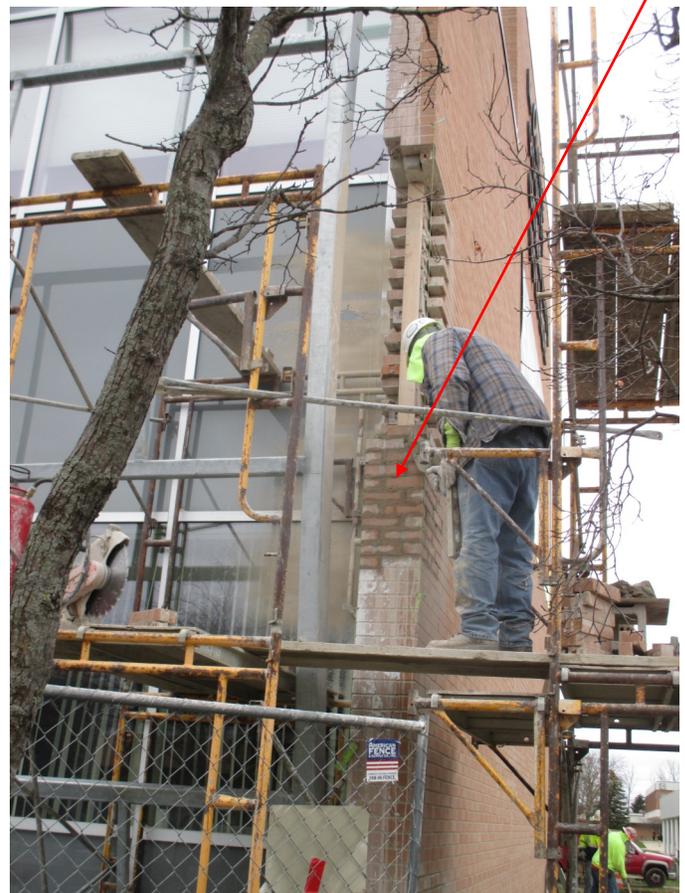
The bottom-right photo shows some of the final brick restoration work happening around the building. This is one of three piers left for the mason to reconstruct after the installation of the new support steel for new panel system. After this the masons will move on to the north block wall and curved wall of the addition.
