Building Report | Life Sciences Façade & Addition

9.8.17

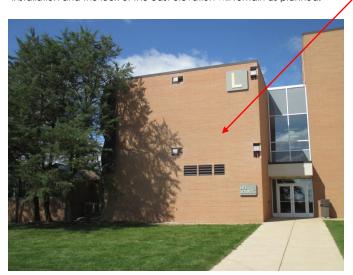
The bottom-right photo shows the progress of the final parts of demolition of the old brick ribs on the north side of the building. This rib was the last remaining portion of the major demolition.
