Building Report | CLRC Renovations and Additions Project

04.01.22

The following are pictures from the week ending in 04.01.22 in regards to the CLRC Renovations and Additions Project. Despite the less than cooperative weather this week (strong winds and heavy rains) a good amount of the work needed to replace the existing roof on the upper portion of the building is nearly complete. Once the upper portion is complete the roofing contractors will focus on the remainder of the roof that surrounds the mechanical penthouse. A lot more of the finishing of the second floor occurred as well with more painting and ceiling grid installation. Next week some of first sets of custom casework will arrive and be installed. Over 90% of the rough framing on the first floor is now complete, and nearly all of the Library Office Suite has received wallboard which now can be finished. Very little work happened in the basement this week, however that will change next week as those spaces will become more of a focus. Overall the project is just around 75% complete as we are still on target to reach substantial completion on June 3rd of 2022.

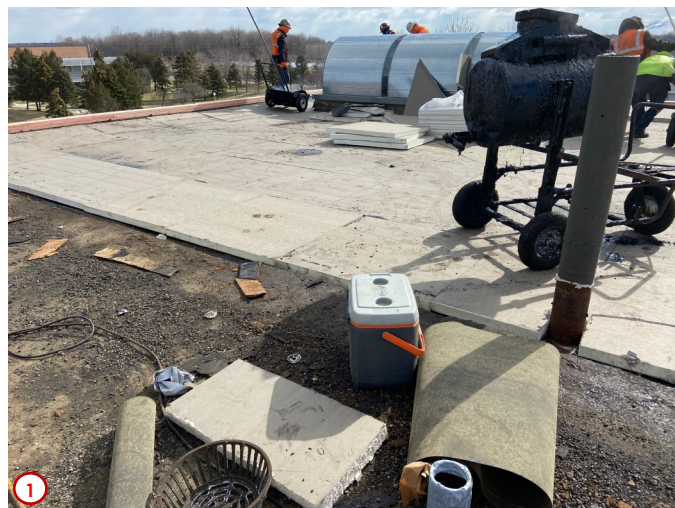
Photo #1 was taken earlier in the week and shows a small portion of high roof above the mechanical penthouse stripped and now receiving one of its two layers of rigid insulation. With the weather this time of the year being so active and quick to change they only expose as much roof as they can replace in a day so as to try and keep the interior of the building as weather-proofed as possible.

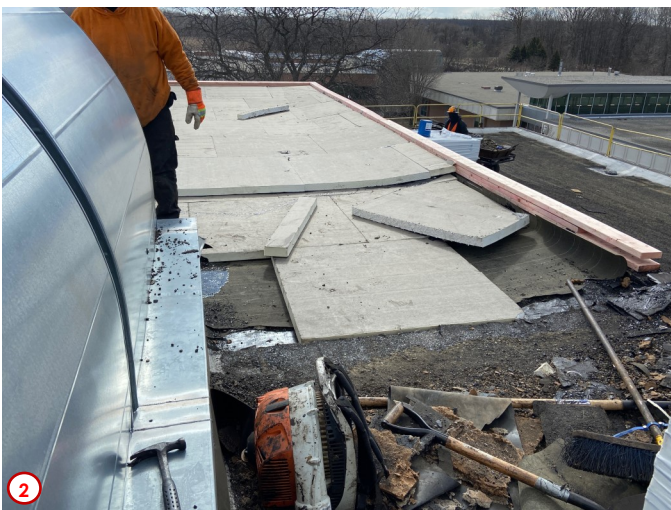
Photo #2 shows the southeast edge of the high roof and features not only the two new layers of rigid insulation being installed, but also the new treated 2x lumber around the perimeter. This wood block will serve not only as the edge curb, but will eventually be covered in the membrane roofing and eventually a pre-finished metal coping.

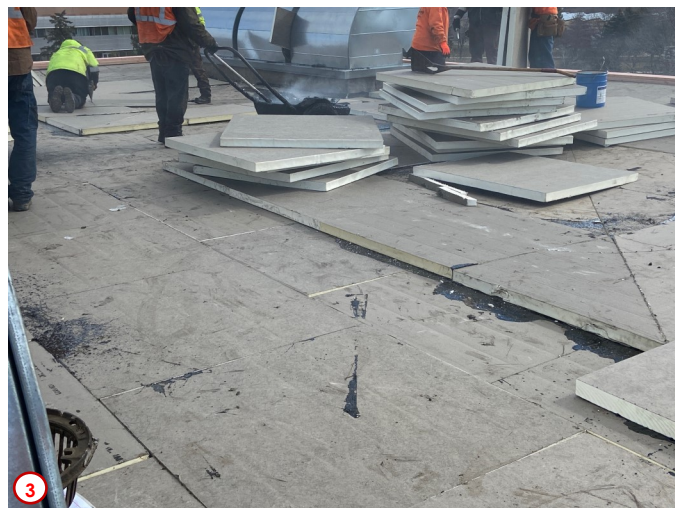
Photo #3 was taken in the approximately the same areas as Photo #1, but later in the week. Here you can see the roofing contractors applying a coating of hot asphaltic cement which helps adhere the layers of rigid insulation together and to the roof substrate.

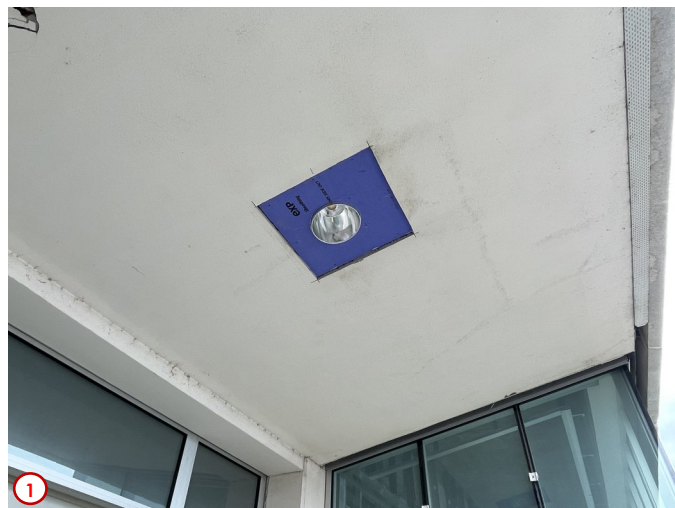
Photo #1 highlights one of the many instances where an existing can downlight has been removed in the building soffit and replaced with a new energy-efficient LED alternative. The process is quite labor intensive and involves installing new treated backboard, new stucco to match, skim-coating the whole soffit and then painting for a smooth finish free of any indications of new work.

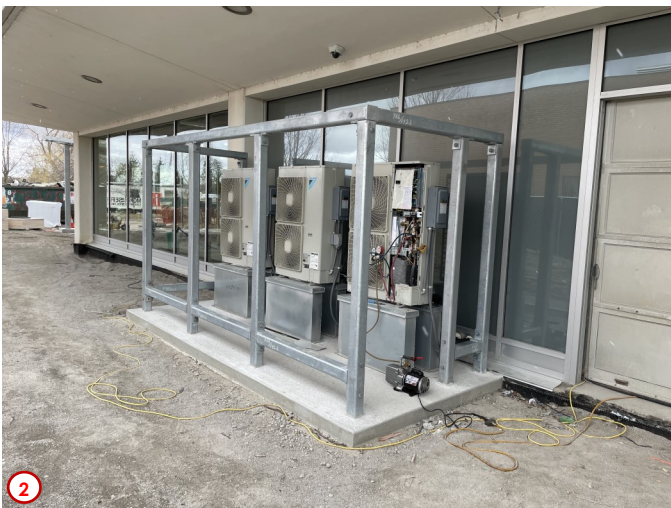
Photo #2 highlights the progress of relocating the condensers for the mini-split HVAC units for the main server room in the basement from their temporary location on the other side of the curtain wall in the loading dock area outside to their new dedicated concrete pad as featured. This process takes some time as each unit is moved individually so that only one unit is offline in the server room so as to maintain proper temperatures for the sensitive equipment housed in that space.

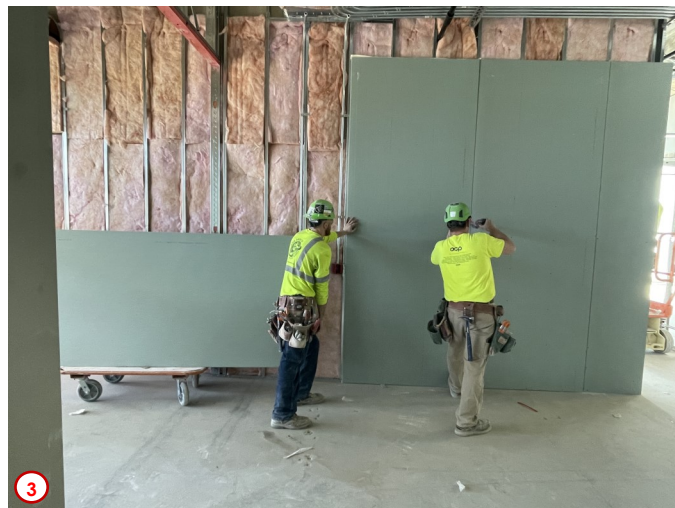
Photo #3 shows some of the carpenters installing the new gypsum board over the wall between the new classroom and the main corridor near the southeast addition. In the back you can see the voids between the metal studs have been filled with a fiberglass batt insulation to help cut down on noise transmission from the corridor into the classroom.

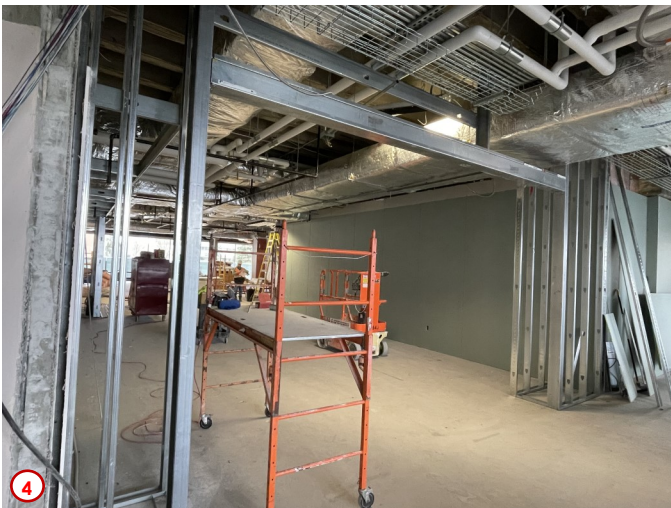
Photo #4 highlights the progress of the work needed to complete the rough framing for the entry into the new library area. The framing shown will help support the future overhead coiling gate which will help close off the library when not in use. This gate is similar to those you see at stores in a shopping mall. Unlike prior to the renovations this will allow the library to operate on different hours than that of the rest of building.

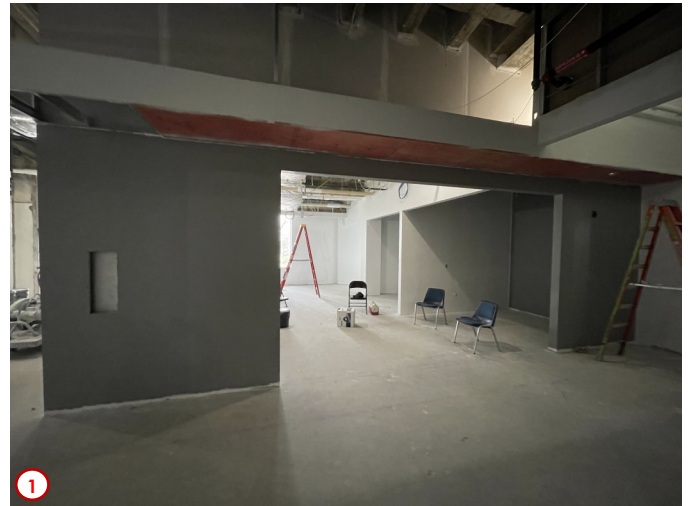
Photo #1 was taken near the entrance to the future Writing Center and shows the area now freshly painted. All the base and accent walls have been painted according per the intended design from the architects.

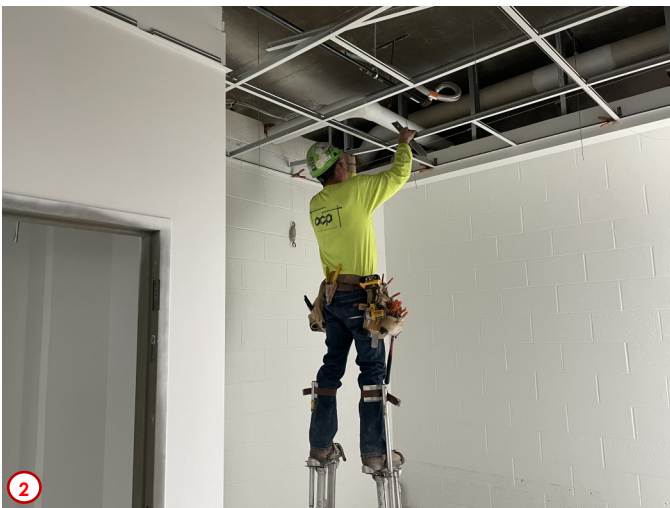
Photo #2 shows one of contractors (on stilts) installing the suspended ceiling grid in the Storage Room off of the Student Publications Space. Nearly all the spaces receiving suspended ceiling have been completed, and next week the concentration will be to finish the corridors. Once the second floor is complete the focus will be on the first floor and the basement.

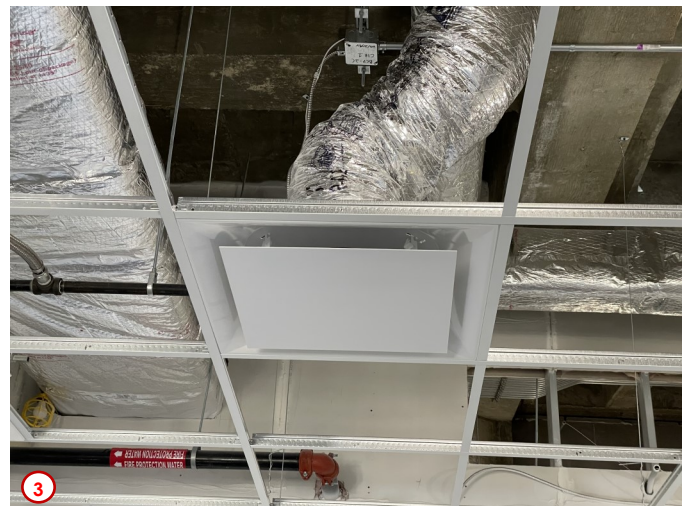
Photo #3 highlights more of the installation of some of the in-ceiling infrastructure. Featured in this photo is one of literally hundreds of diffusers that will help deliver conditioned air into interior of the building. You can also see the flexible duct connects to the trunk lines terminating into the top of this diffuser.

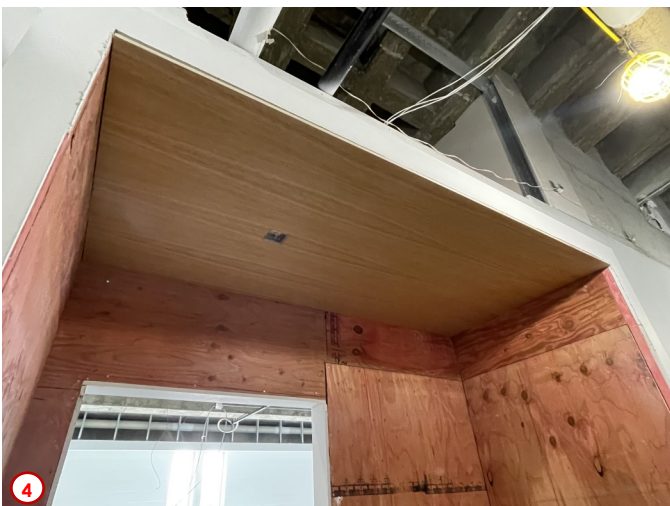
Photo #4 features the start of another finish starting to be installed. Here you can see one of the accent wood panels that will surround the entry door into this classroom now installed. Next the finish contractors will move on to installing the panels on the walls that will match the ceiling. Together the wood accent panels will help to provide a warmer and more natural selection of colors and materials to the building interior.
