Building Report | Parking Lot Renovations | Lots 1 & 2

8.16.19

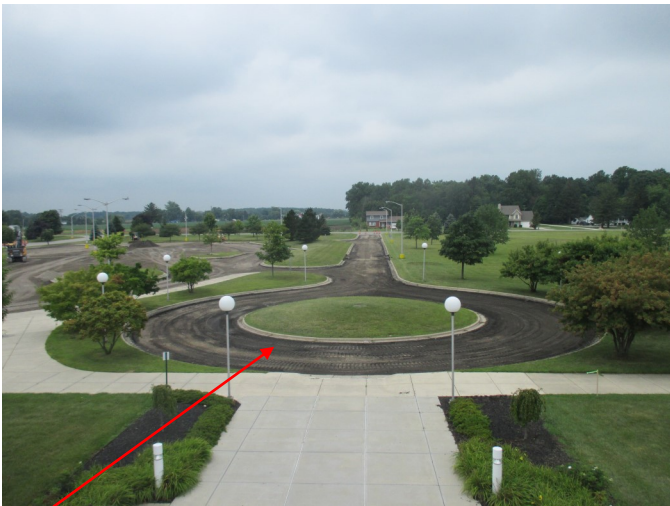
The top-left photo the circular drop off area at the end of the drive in front of the Health Education Building that is connected to Parking Lot 1. This area along with the adjacent lot will be re-paved.

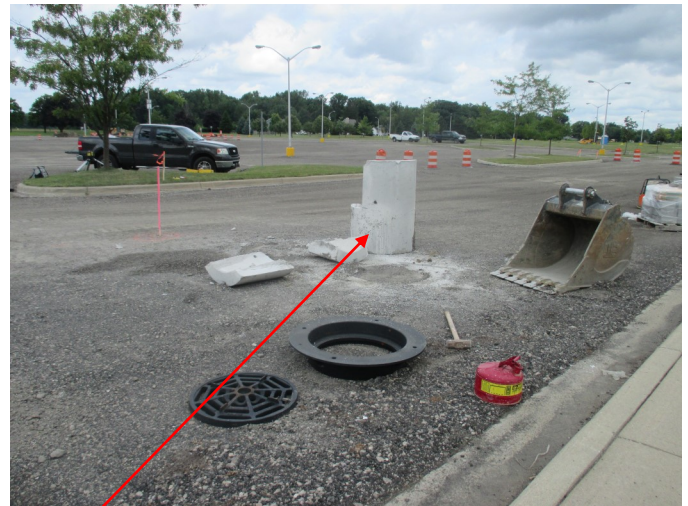
The top-right photo shows one of two existing storm water structures from Lot 2 that has been pulled and will be repaired before being re-installed. The collar on this particular structure was collapsing.
