# Building Report | LZB Center Masonry Clean & Sealing

10.25.19

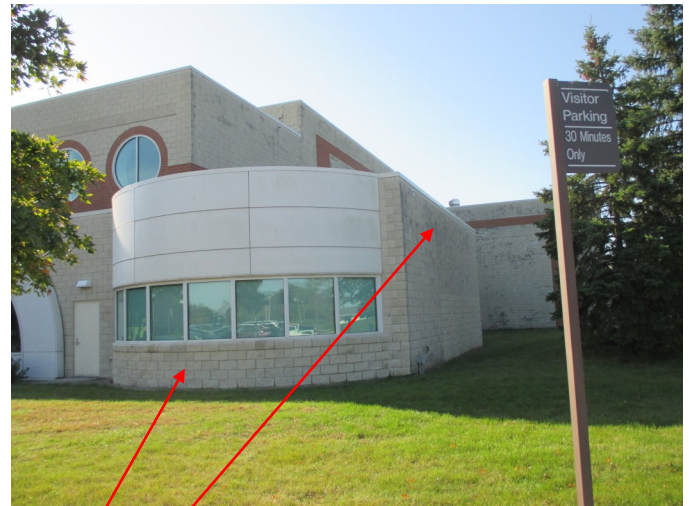
In the top-right photo you can see the stark difference between a façade that is cleaned compared to another that has not been completed. Here the façade outside the Board Room has been cleaned where the northern façade of the Scene Shop has yet to be touched.

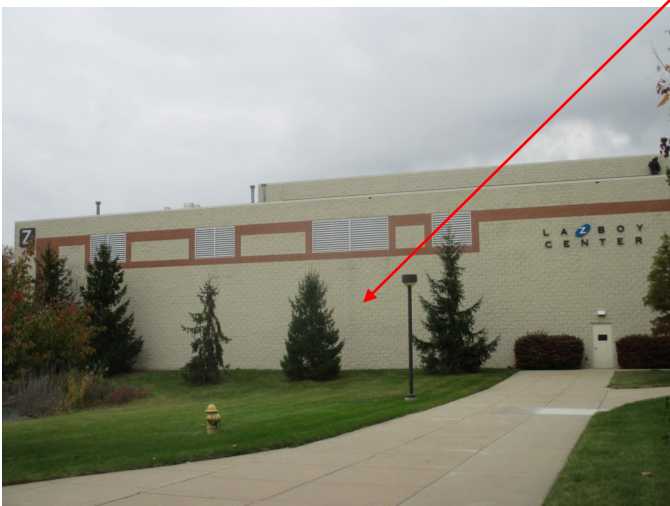
In the bottom-left photo you can see the finished southern façade of the building that is now ready for the application of the sealer.

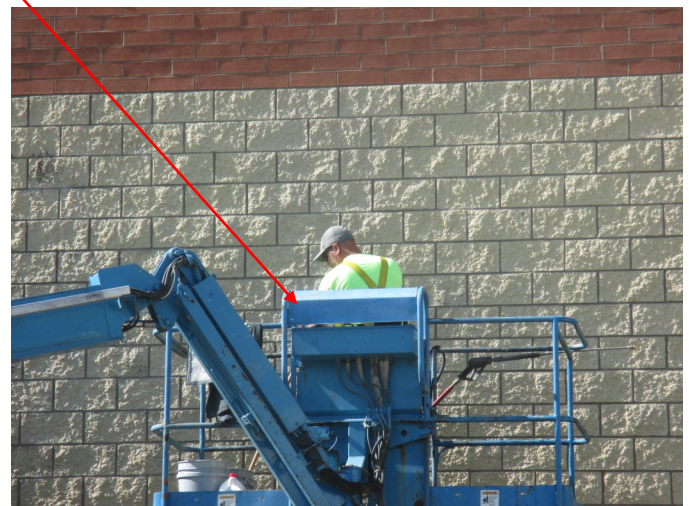
The bottom-right photo shows one of the methods by which the contractor has had to use in order to reach all of the areas of the building. Here they are using a lift to complete their work.
