# Building Report | CLRC Renovations and Additions Project

01.07.22

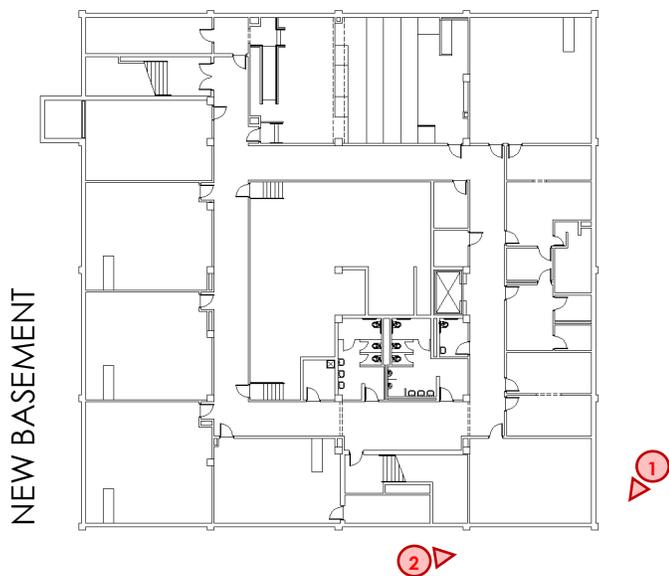
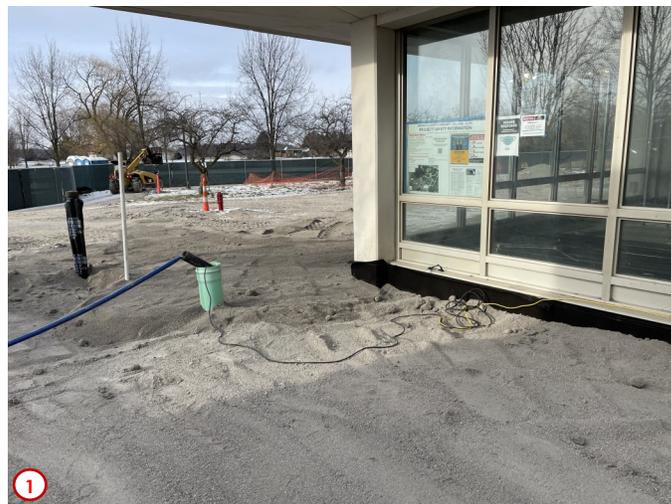
Photos 1 and 2 shows the final step completed for the targeted basement waterproofing as the area has been backfilled.

As proof of concept with all of the precipitation we have received lately there was a lot of moisture in the area that has been pumped out by the contractors, and yet the basement stayed dry! The last remaining portion of work needed in this area is the work needed to either rebuild or replace the storm water basin. The location is marked by the green pipe coming up out of the ground in both photos. Again, this basin is critical to making sure the excessive amount of site water in this area is properly conveyed to the site drainage system. This another example of a legacy item that has been incorporated into this project and will hopefully finally solve another long-standing issue for us.

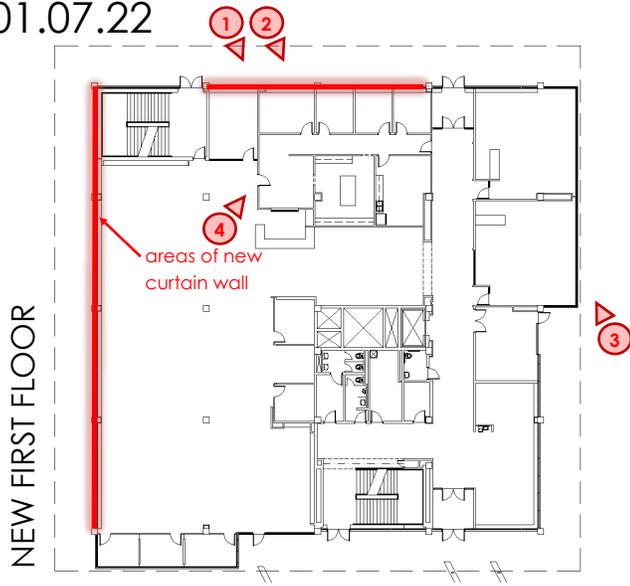
Photo #1 was taken earlier in the week and shows the glazing contractors installing some of the new curtain wall frames at the old west entrance of the Library. A row of offices now line this wall and so the old entry door system was removed.

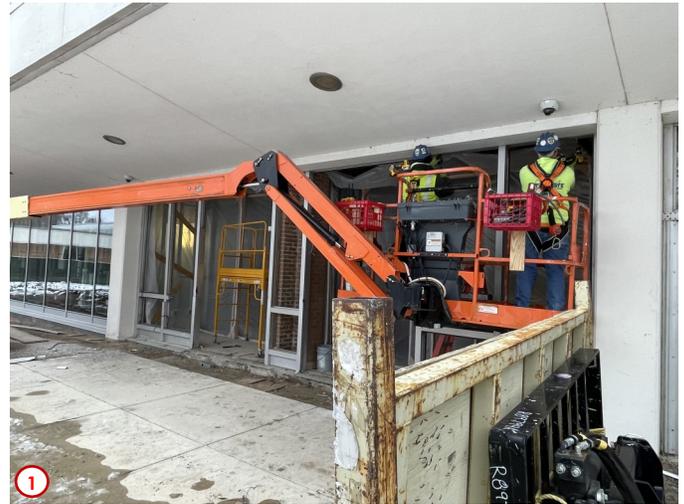
Photo #2 was taken later in the week and shows the new curtain wall system in place. The new entrance system will be installed in the south bay (or left most segment as seen in the photo) on this side of the building.

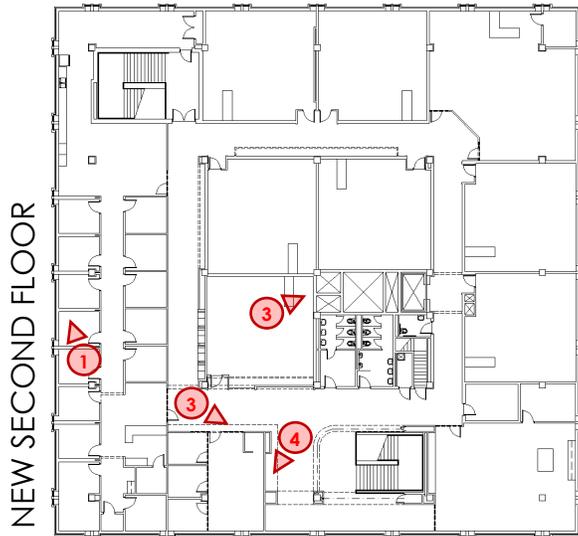
Photo #1 features one of the many instances where the wires have been pulled and whips ready to connect to the future lights in the ceiling in the H/SS Division Office Suite.

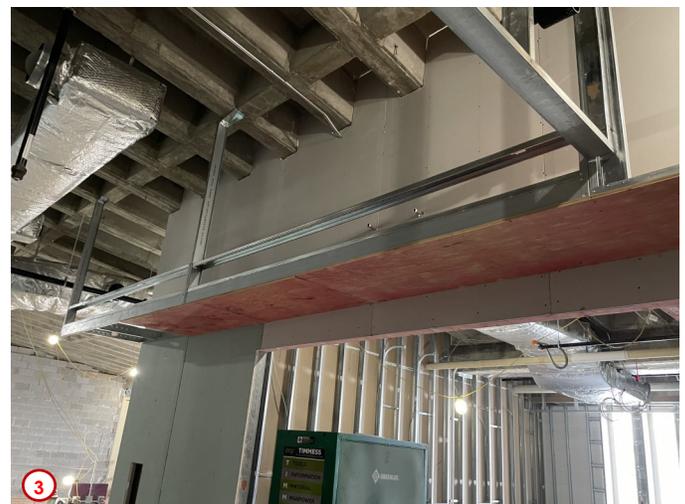
Photo #4 shows some of the need supports for future countertops, shelving systems, etc. now in place. With all of this infrastructure in place the wallboard can be finished.
