Building Report | CLRC Renovations and Additions Project

03.18.22

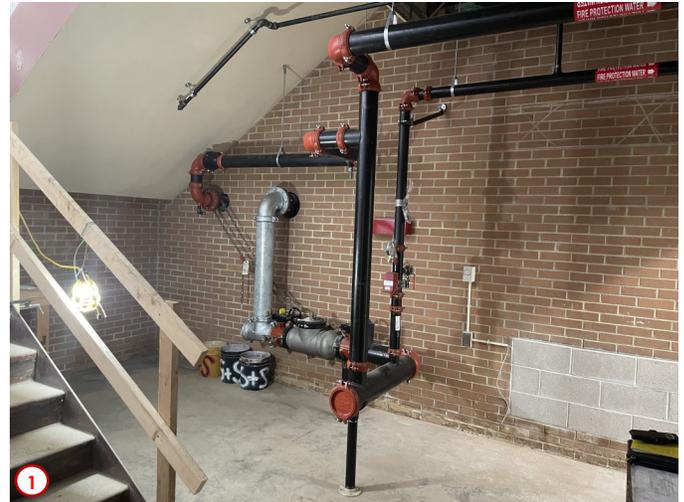
Photo #1 shows the progress of the installation of the new fire riser in basement near the west stair tower. Once completed the fire-rated partition that will help separate the new room in which this unit will reside will start being constructed.

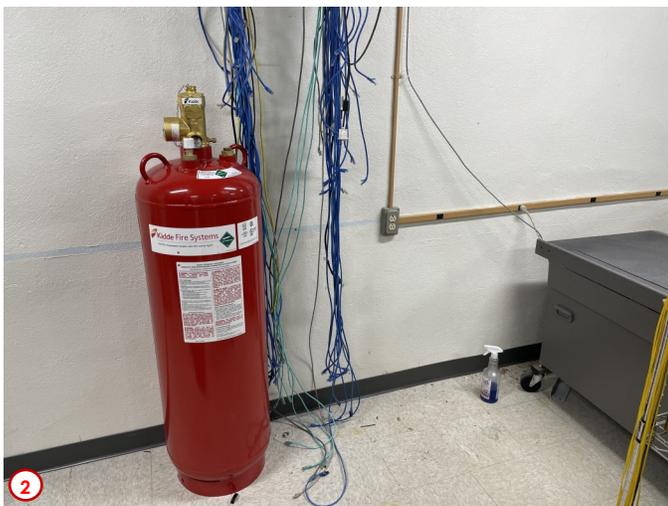
Photo #2 shows the new chemical storage tank for the unique fire suppression system that will be installed in the main server room. Because water is not the optimal system to be used in a space populated by so much valuable and critical computer equipment we have opted to have what is called a FM 200 (or dry chemical) system installed instead. Since fire is a chemical reaction and requires heat, oxygen, and fuel in order to burn the FM 200 system removes the heat from the equation thus inhibiting the fire's ability to sustain itself rather than using a deluge of water to accomplish the end goal of putting out the flames.

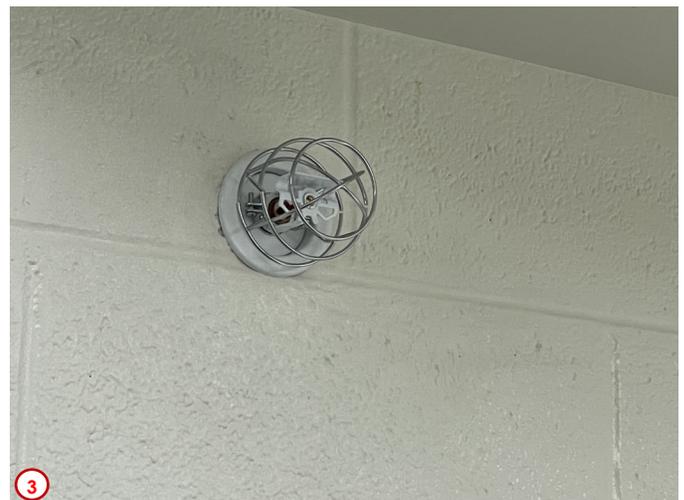
Photo #3 was taken of some of the very last components of the building's new fire suppression system now installed. Up to now all the sprinkler heads that have been installed have been those that will be concealed in the ceilings in drop down heads. However, that application is not allowed in all areas per the building code which means sometimes other installations are required. Here is a wall-mounted head with a protective cage in the southeast corner of one of the Middle College offices. This setup is required because of the hard ceiling in this area and considering future means by which to service the head, so this arrangement is ideal for maintenance.

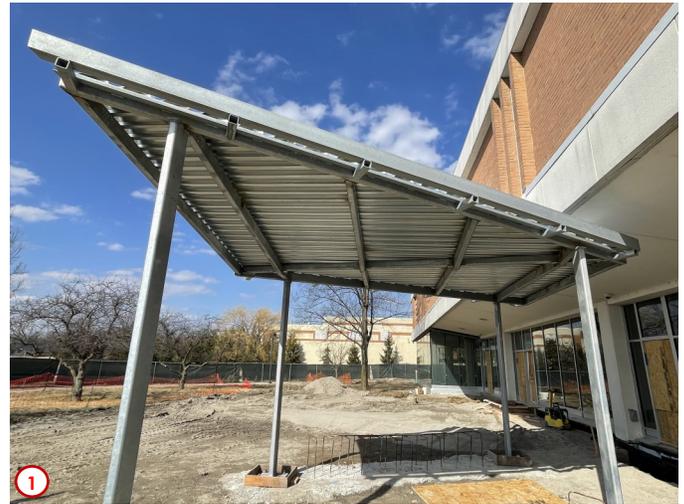
Photo #1 highlights the progress of the work needed to complete the new western entrance canopy. The structural steel for both canopies is now in place, and therefore the contractors can begin the process of installing the framing which will then lead to the finishes being installed.

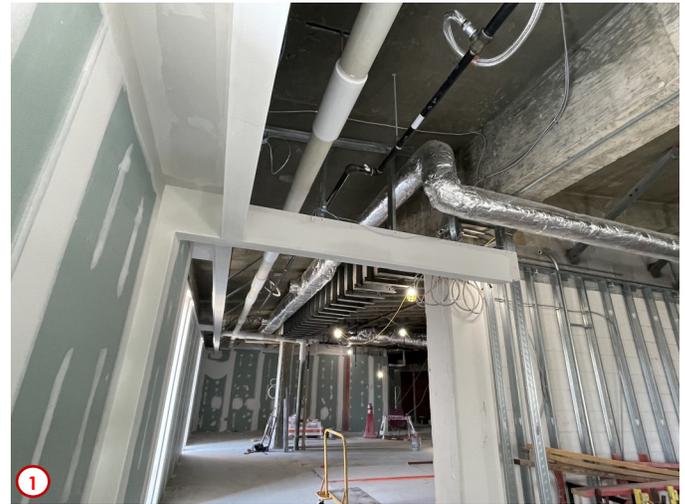
Photo #1 was taken inside of what will be the Student Publications Room on the second floor. This is just one of many areas that are being finished so that the painters who have been concentrating on the north side of the second floor can move over and finish painting on the south end before moving downstairs.

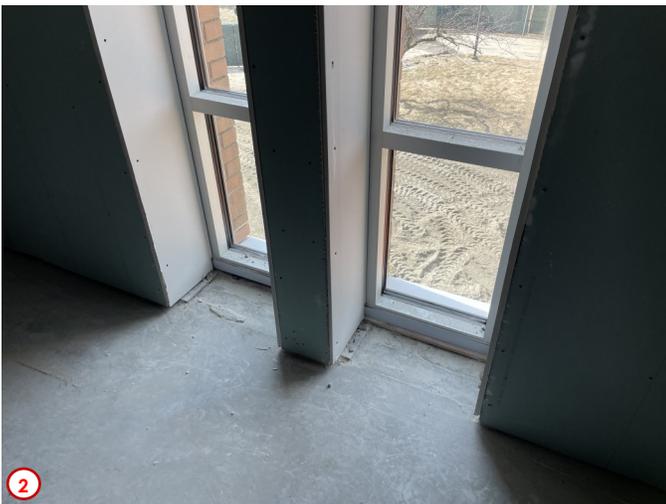
Photo #2 shows the area around the windows where the low block wall was removed to expose more area for natural light infiltration now cleaned up, framed in, and finished. Seeing that this work is done will allow the painters to move into this area.

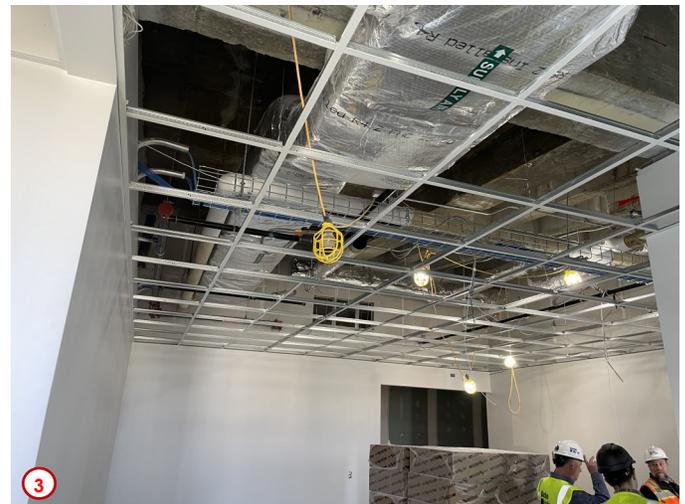
Photo #3 shows just one of many areas on the second floor where the suspended ceiling tile grid has been installed. Next the electricians will move into to start installing the new LED light fixtures, and then tiles can go in after all the inspections have been conducted.

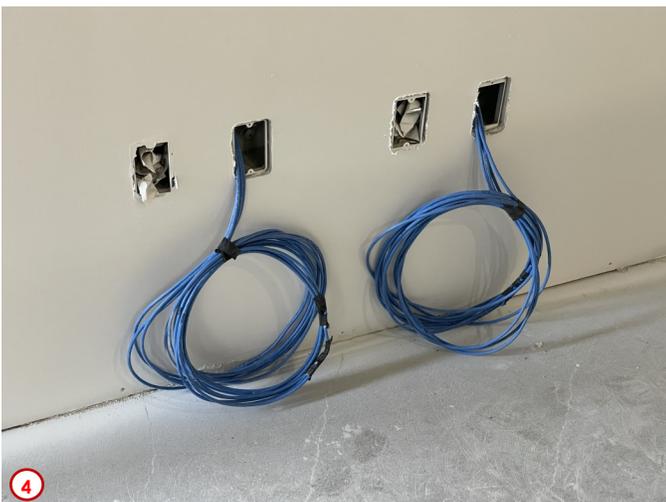
Photo #4 was taken of one of the many instances where more of the low-voltage cabling has been pulled and ready for termination. The instance shown happens to be in what is the Adjunct Faculty Office on the second floor in the H/SS Division Office. This data cabling will eventually allow cables to be connected through furniture systems that will be populated by computers for staff use.
