Building Report | DEI Ctr./Stud. Govt. Room Renovations

10.1.21

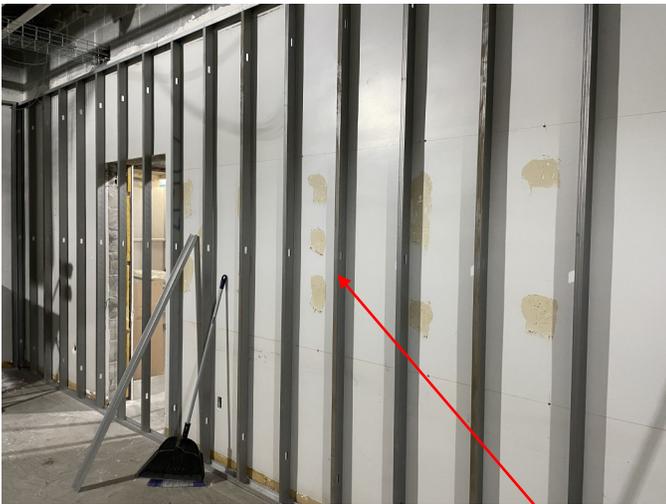
The top-left photo shows some more metal stud furring strips being installed in the future Student Government Room, but this time along the existing east wall. Next week this same system will be installed along the existing west wall, however spray-foam insulation will be placed in the cavities to help acoustically separate this space from the adjacent office suite immediately to the west.

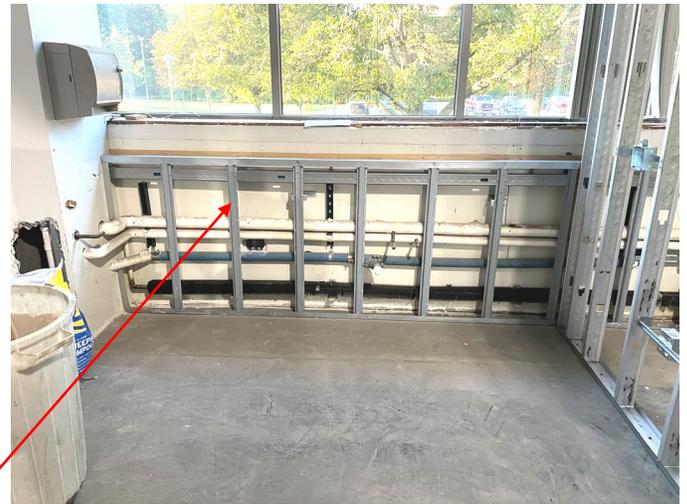
The top-right photo shows some of the new metal stud furring strips being installed on the south face of the future Student Government Room. This framing will help to conceal the existing plumbing in this area and provide a wall for some future cabinetry to be installed at a later time.

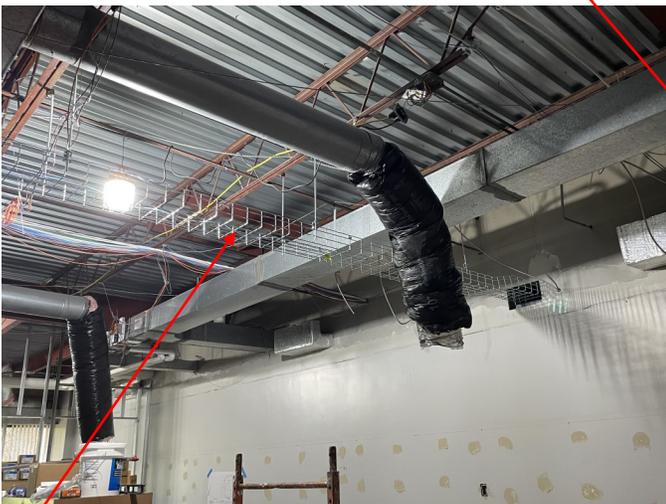
The bottom-left photo shows the remaining portion of the cable tray for this space now properly installed and ready to house future information systems communication lines. This cable tray connects across the corridor to the new set installed there and eventually terminates in the south IT Room.

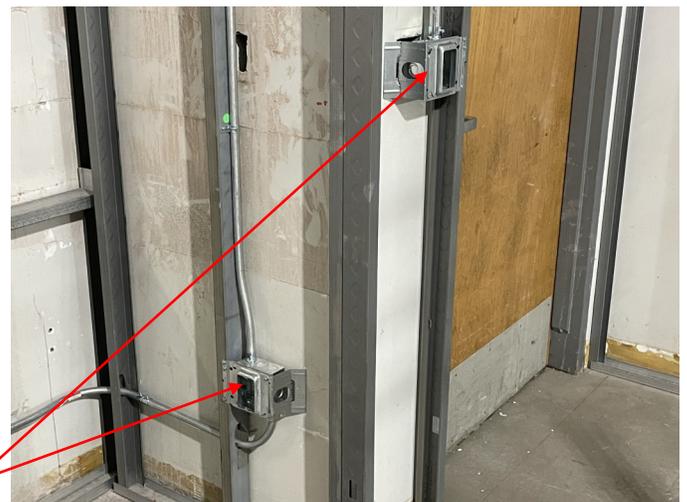
The bottom-right photo shows more of the new electrical infrastructure being installed. Here you can see new light switch and outlet boxes in place with connecting conduit in addition. The next steps will be for the electricians to pull the new wiring through the conduits and properly terminate at the boxes.
