Building Report | E/W Tech Renovations & Addition

8.16.19

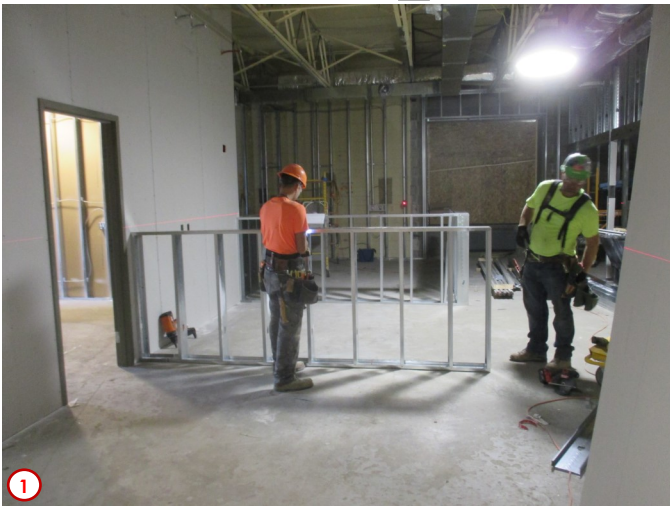
Photo #1 was taken in the future I.S. Department Suite and shows the progress of the framing for the partial height walls that will form the cubicles for the staff in that area. Photo #2 shows the continued progress of the metal framing installation for the new media rooms and e-Learning Office, as well as the new HVAC ductwork for the computer lab located in this area as well. Photo #3 shows the new supporting beam, column, and masonry walls that carry the existing mezzanine above what will be the Workroom for the Learning Assistance Lab. Photo #4 highlights another area of the existing buildings where more asbestos is being remediated. Between the two buildings five additional areas were addressed this past week.

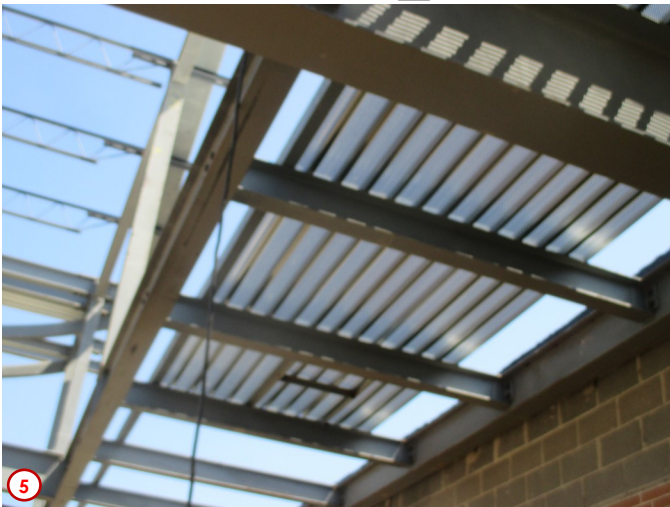
Photo #5 shows the acoustical metal decking starting to go in on top of the structural framing which flanks both sides of the future Academic Commons area. This metal decking will receive sound insulating batts before the final roofing goes to assist with sound control when this space is finished. Photo #6 is in the same approximate area as #5, however shows the iron workers starting to install the metal structure need to house the future clerestory windows. Photo #7 was taken in East Tech where you can see the masonry walls of the future vending area being installed, and the wall framing for the future Faculty Lounge in the background. Photo #8 shows the door frames and walls being erected in the future office suite for the CIS Program.

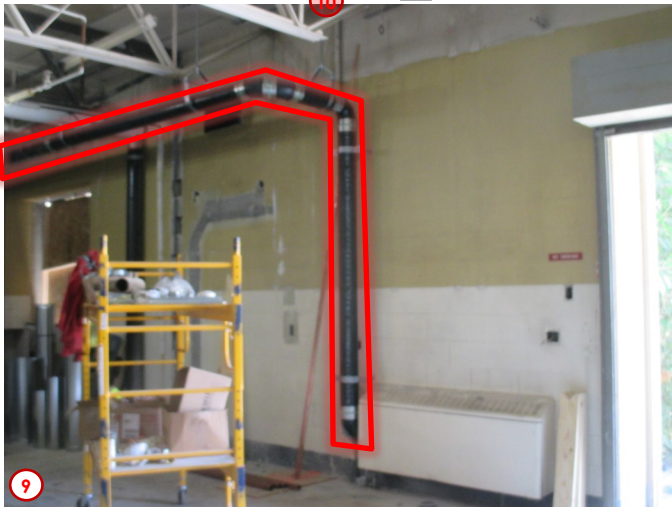
Photos #9 and #10 highlight some of the new infrastructure being installed in both East and West Tech. Highlighted in #9 is some of the piping from the roof overflow drains that connect to the sheep's tongue on the exterior of the building shown in #10. Photo #11 shows the progress of the electrical contractors work where they are removing all the old electrical panels from the corridors and relocating them to the new Electrical Room. These openings will be filled in with brick to match existing, and in the end all the corridors will receive a whitewash finish. Photo #12 was taken in the West Tech basement and shows the beginning of the work for the new building-wide fire sprinkler system. The highlighted portion shows the new connection near the recently installed water department valve.
