# Building Report | E/W Tech Renovations & Addition

8.30.19

The following are pictures from week of 8.26.19 - 8.30.19 in regards to the East/West Technology Buildings Renovations and Addition Project. We have hit another milestone with this project as all of the major structural support steel for the addition is now complete. However, there are at least two to three weeks worth of framing installation left to do until items such as the roofing, curtain wall system, etc. can be installed which will help weather-proof the addition. A major part of the work that will be happening in these buildings that is a separate project that coincides with the construction happening now is the existing domestic hot and cold water pipe lining which will start next week with mobilization and last all the way to the end of the year. Similar to the addition of the whole building fire sprinkler system the E/W Tech buildings will be the first of the original buildings on campus to have all of existing domestic water piping system to be epoxy lined that will help solve many legacy issues for the College, and eliminate yet another deferred maintenance item.

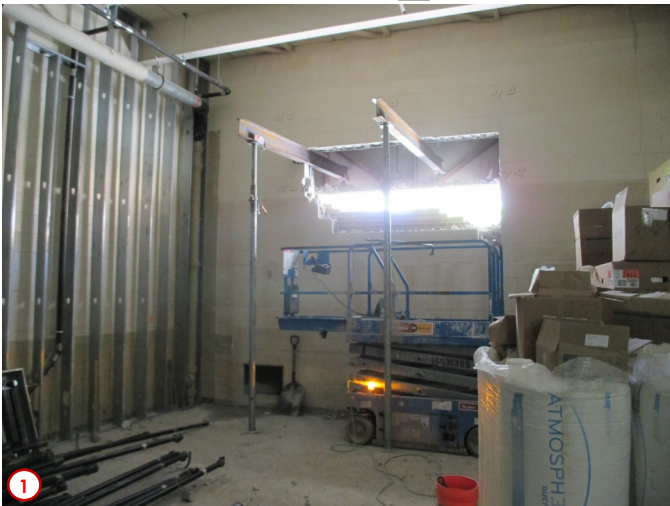
Photo #1 shows the beginning of the demolition to create the opening for the new overhead and service doors for future Innovation Lab, and Photo #2 was taken from outside the building after the work was completed. The temporary support poles will be removed once the new steel lintel has been installed. Photo #3 in the area of new Open Tutoring Lab in West Tech. You can see in the photo the metal furring studs have been installed, the openings for the spiral duct have been cut through the existing wall, and the new spiral duct that will feed the addition is sitting and waiting to be installed. Photo #4 shows some of new brick work that has been installed that is helping to trim up areas where old walls were removed as part of the renovation process.

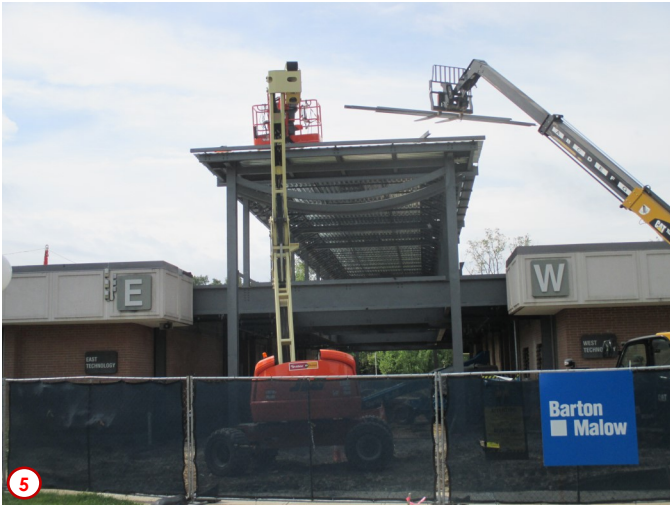
Photo #5 shows the ironworkers completing the structural support steel for the addition. This work is now complete, and now the carpenters can complete their portion so that the roofers and glazers can then install what they need to enclose the addition. Photo #6 is a closeup of some of rough framing on the high bay of the addition where the future clerestory windows will be installed. Photo #7 is in East Tech and shows the wall studs and door/curtain wall frames now installed in the staff co-working center. Photo #8 is of the now completed concrete block wall that encloses the future Vending Area in East Tech.

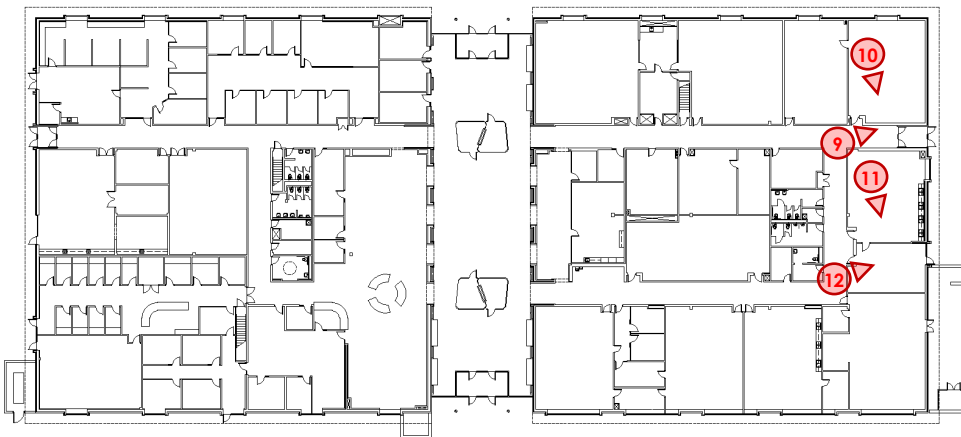
Photos #9 and 10 show the progress of the installation of the new south wall in the northeast classroom that will help extend the main circulation route to the east side of East Tech. This new area of corridor will create a straight east/west means of travel through the finished building. Prior the corridor used to dead end into an old classroom wall. Now someone will be able to travel all the way from Parking Lot 7 straight through to the Administration Building. Photos #11 and 12 show the masons filling the openings that were for the old staff offices that were removed in East Tech. This area where the old corridor used to exit the building will now become a storage room that will be dedicated to the adjacent art classrooms.

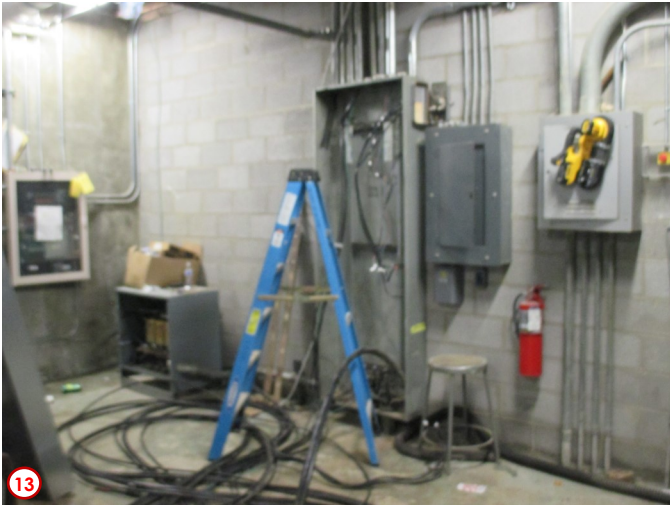
Photo #13 was taken in the West Tech Basement Electrical Room. Here the electrical contractors are removing old panels and beginning the installation of new infrastructure that will power the renovated areas in East and West as well as the addition. Photo #14 shows a temporary electric water heater that was installed that will service the adjacent Ceramics Lab for the next few months. This unit was necessary during the time period of the aforementioned domestic hot and cold water pipe lining project. Once the pipe lining is completed this water heater will be removed. Photo #13 shows one of the first of hundreds new fire sprinkler heads to be installed during this project. Photo #14 shows an example of how the existing domestic water lines will be epoxy coated (essentially spraying a new PVC pipe inside an existing pipe).
