Building Report | E/W Tech Renovations & Addition

10.11.19

The following are pictures from the weeks ending in 10.4.19 and 10.11.19 in regards to the East/West Technology Buildings Renovations and Addition Project. My personal schedule didn't permit me to file a report last week so this report is a combination of the last two weeks worth of construction observation. Areas in the old West Tech are starting to taking form as finishing continues as far as wall board installation. Some areas are even seeing the board being taped and mudded. There has been an increase in the rough framing happening in the old East Tech. More fire protection, HVAC, and electrical infrastructure continues to be installed in both East and West Tech as well as the addition. The roof on the high bay portion of the addition is nearly complete as well as the low-roof and tie's adjacent to the existing buildings. The new windows are starting to be installed around the perimeter of the existing buildings, and due to the rain this

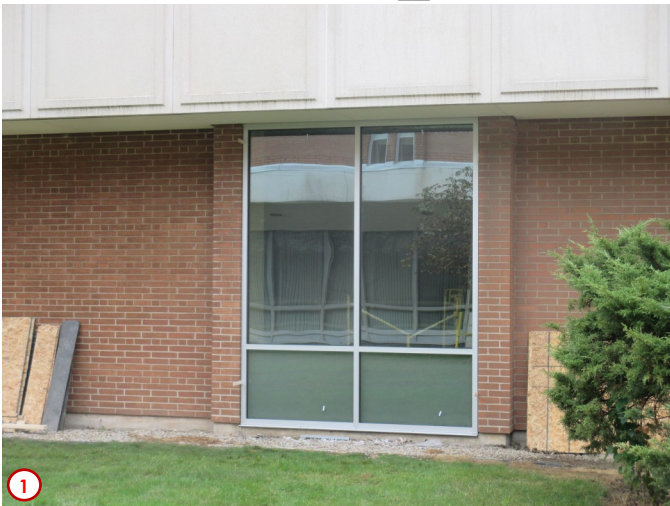
Photo #1 was taken outside the northwest corner of West Tech and shows the first of the new windows installed. These new windows were selected so that they match what is currently installed at the Life Sciences Building as part of a campus-wide effort to have a more cohesive look as far as building fenestration goes aesthetically. Photo #2 shows the progress of finalizing the new entry to the future I.S. Department Office Suite. This new entry will not only be secure, but also ADA compliant and replaces an old entry system that did not meet with either of these criteria. Photo #3 shows more former electrical panel locations being filled in. Photo #4 shows a detail in the Business Division Office Suite co-working area ceiling that was recently completed.

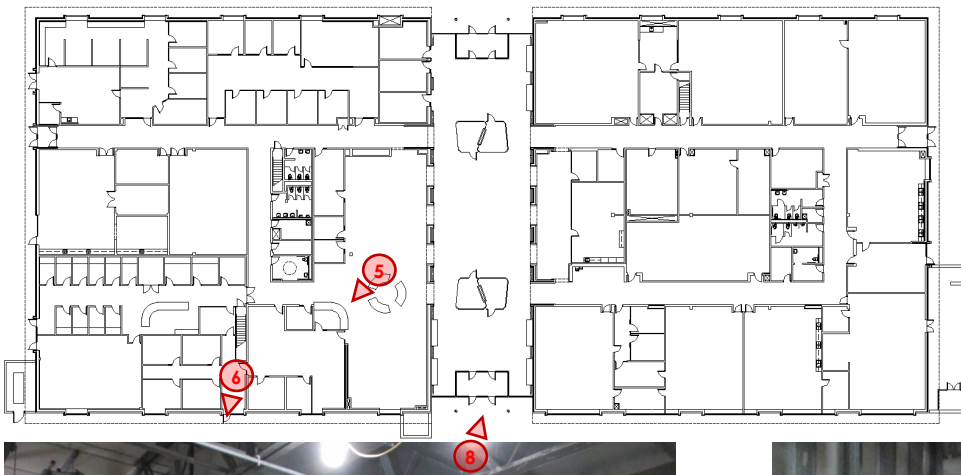
Photo #5 highlights the progress of work that is being done to finish framing in the new Learning Assistance Lab (LAL) area. Photo #6 is a photo of an area in the future Disability Services Area where a previous window and low wall were removed to make way for a new exit door. Photo #7 is not shown on the floor plan to the left but was taken from atop the high-roof area of the addition, and it shows the roofing contractor installing the hybrid built-up system on top of the addition. Photo #8 was taken outside the south-west side of the addition and not only can you see the roofing contractor at work, but also you can see the spray foam insulation (yellow in color) installed on the structural support steel in the façade.

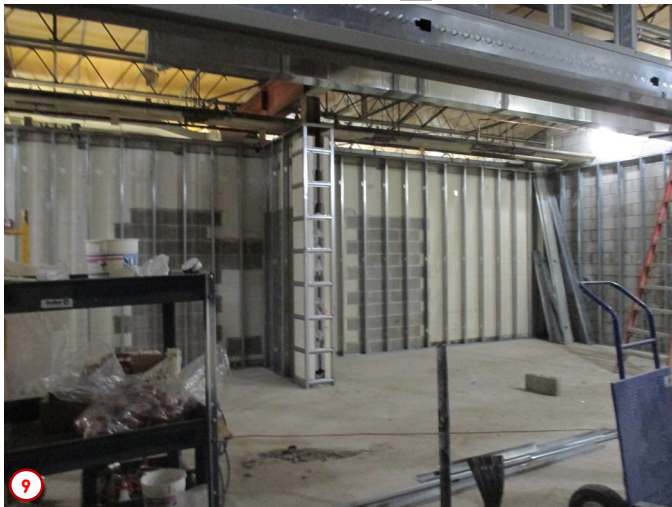
Photo #9 shows more metal stud framing going up in the future Faculty Lounge in East Tech. This framing will help conceal the existing walls and will receive gypsum board (drywall) veneer as part of the finishing process. Photo #10 highlights some of HVAC infrastructure in the future Co-Working Center in East Tech. Photo #11 similar to Photo #9 shows some of the framing going up in the future Technology Enhanced Active Learning (TEAL) classroom in East Tech. Photo #12 shows a depressed area in the new masonry corridor wall where a future wall-mounted terminal unit will be installed which will help supplement the HVAC system in this area to help keep it warm in the winter (which is a typical practice in the construction industry).
