Building Report | Campus-wide IT Rooms Renovations

6.21.19

The following are pictures from week of 6.17.19 - 6.21.19 in regards to the Campus-wide IT Rooms Renovations Project. This is the first official report for this millage project. This project is key to several other initiatives we have on campus as far as supporting several information systems infrastructure projects. This project will cover areas in every regularly occupied building on both Main Campus and at the Whitman Center other than the Career Technology Center, and entails the necessary renovations to either create new or enlarge existing spaces to support all of the new computer equipment being installed to support upcoming items such as the new campus-wide phone, security camera, cell phone repeater, and access control systems. This project from a construction standpoint is set to be completed prior to the start of the upcoming Fall Semester, and once completed will each house several new racks for servers, ports, switches, etc. that will greatly increase communication and safety on campus for now and numerous years to come.

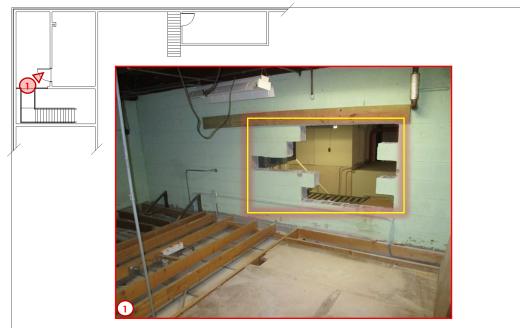
Photo #1 was taken after demolition was basically completed in the space above the offices and locker room in the second floor of the Physical Plant where the new IT room will be located. Here some additional structural work will be required after some forensic engineering investigation was completed. Basically the floor framing system is currently inadequate to support for future purposes so additional wood framing and anchorage is needed in order to be sufficient enough for future needs. Also you can see the opening where the old wall mounted airconditioning unit has been removed and the existing masonry demoed enough so new cmu can be toothed in to properly seal off the future space for both security and heating/cooling purposes.

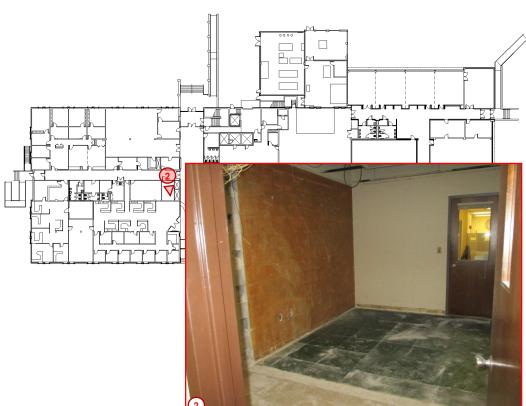
Photo #2 was taken in the first floor in the Student Services/Administration Building where an old masonry wall was removed between the existing IT closet and adjacent office in the Admissions Office Suite. These two rooms are being combined in order to create a new room sufficient in size in order to house of the new equipment that will be located in this space. The existing ceiling in both rooms was removed, and the structure will remain exposed to as new cable trays and lighting will be installed in the next few weeks. All of the old doors and frames will be removed and openings closed up and this room will have only one means of access as the College moves towards the goal of better information assurance campus wide.

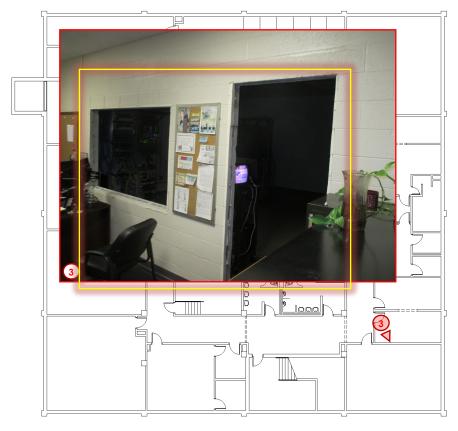
Photo #3 shows the work happening in the area of the Main Server Room in the Basement of the Campbell Learning Resource Center and adjacent office.

Again, in order to increase the security of this space the old window and door that connected this office and adjacent server have been removed. This way the way to access the Main Server Room will be through a controlled entry off the Main Corridor. These openings will be filled in with new masonry units to match existing.
